## OPERATION AND MAINTENANCE REPORT

COLORADO RIVER RECOVERY PROGRAM  
FY 2017 ANNUAL PROJECT REPORT

RECOVERY PROGRAM  
PROJECT NUMBER 01-WC-40-7050

I. Project Title: Operation and Maintenance of the Fish Screen and Fish Passage Facility at the Grand Valley Irrigation Company Diversion in Palisade.

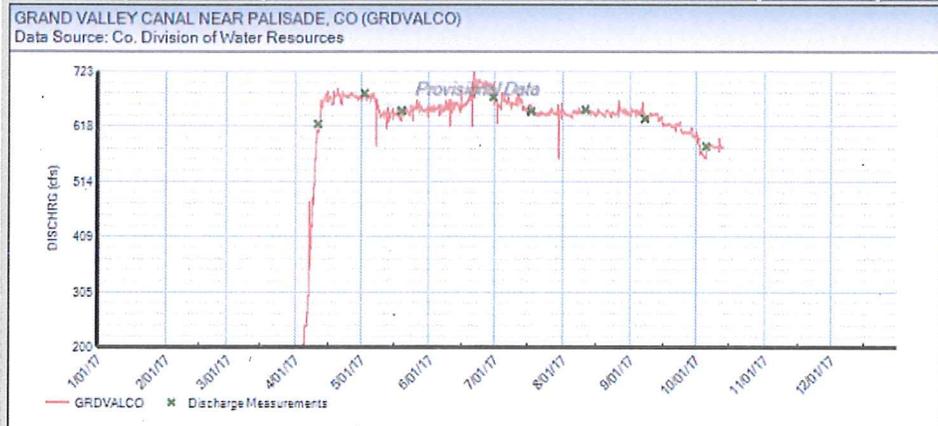
GRAND VALLEY IRRIGATION CO. DIVERSION APRIL 1-OCT 30 2017

All down spikes in above graph are directly related to fishscreen plugging operations.
