COLORADO RIVER RECOVERY PROGRAM
FY 2018 ANNUAL PROJECT REPORT

RECOVERY PROGRAM
PROJECT NUMBER: C-9

- I. Project Title: O&M for Elkhead Release and Elkhead Lease
- II. Bureau of Reclamation Agreement Number(s): 05-WC-40-420
- Project/Grant Period: Start date: 02/17/05
End date: Ongoing
Reporting period end date: 09/30/18
Is this the final report? Yes _____ No XX
- III. Principal Investigator(s): Ray Tenney
Colorado River Water Conservation District
P.O. Box 1120
Glenwood Springs, CO 81602
Telephone: (970)945-8522
Cell: (970)379-1492
Fax: (970)945-8799
Email: rtenney@crwcd.org

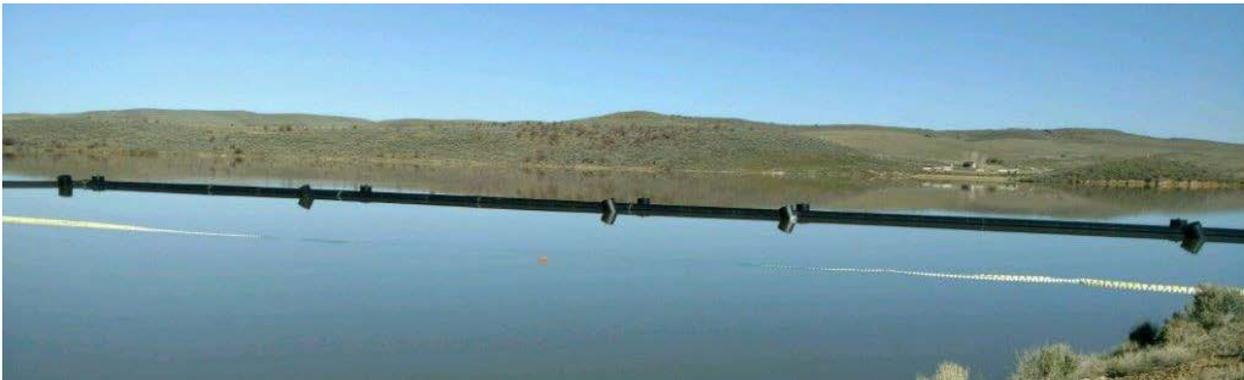
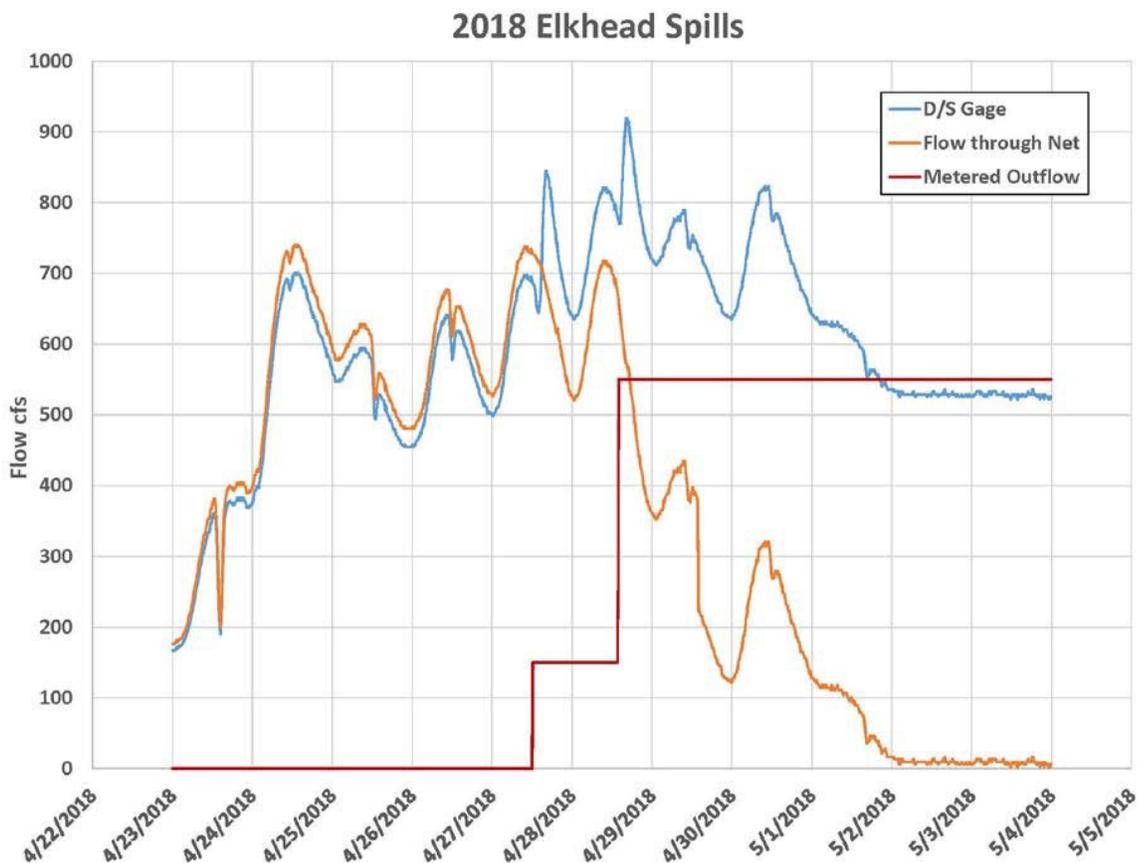
Spillway fish barrier net and debris boom installed in September 2016 remained in place over the second winter. The net efficacy evaluations by Colorado Parks and Wildlife (CPW) suggest some fish leakage. The net is designed to pass 2,500 cfs at 1.5 feet of surcharge on the downstream labyrinth weir. The net was observed to overtop in late April 2018 at flows exceeding 600 cfs. The operating practice since the installation of the net has been to reduce outlet works utilization and allow spills through the net during the 2 year warranty period to “test” the net. The figure below shows that opening the outlet works during the April 27th observation of net overtopping quickly reduced flow through the net and alleviated the overtopping. Outlet works operation avoided any further overtopping of the net.

On April 27th the reservoir was turbid from spring runoff and little visibility was available. CPW contractors were on site at the time of the observed over topping hand cleaning the net. The CPW contractor's assessment of the net condition from the cleaning can be obtained from CPW.

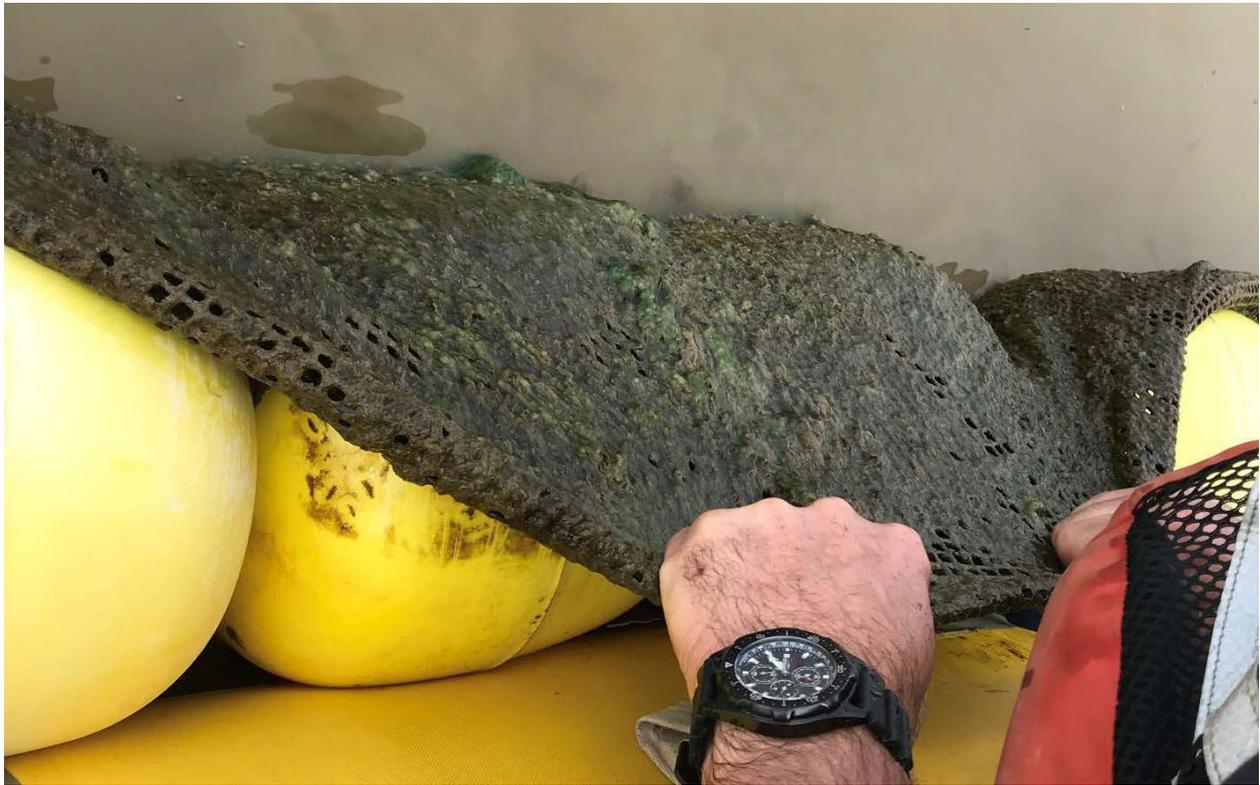
Representatives from Pacific Netting Products (PNP) were on site May 17th to inspect the net to the extent possible considering runoff water conditions. By this time all reservoir outflow was being routed through the screened outlet works. Conditions were only observable in the top several feet of net which could be pulled to the surface. Depth measurements were made along the net at mooring lines (anchor points) to confirm the net as constructed had adequate height in place. PNP recommended more thorough cleaning of the net using mechanical means such as pressure washing or pressure washer powered scrubbers as used in the aquaculture industry. CPW has worked to implement a more aggressive cleaning schedule and net conditions have been observed to be much better subsequent to the spring runoff.

Elkhead Net Fouling Observed May 17th

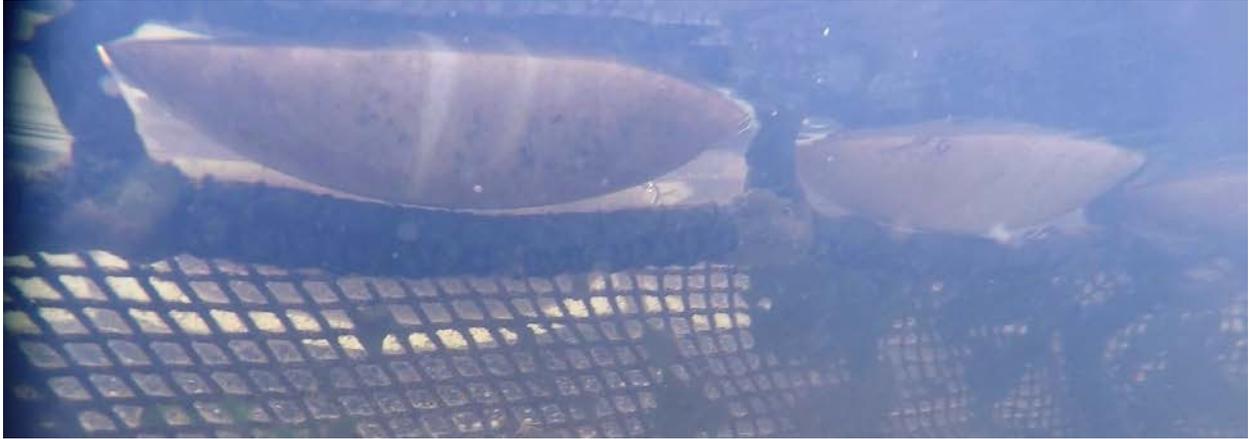
An observation of the net in August using a River District underwater camera revealed a potential source of fish leakage through the net. The space between the main cork line of the net and the top of the net shown in the photo below might allow fish passage. While there is a downstream skirt to prevent wave overtopping of the cork line from passing fish, the skirt cork line has similar smaller gaps.

Gap Between Top of Net and Water Surface

PNP implemented a remedy for the net gap using the attached downstream skirt raised in front of the gap with a second cork line lashed to the original cork line. The raised skirt will cover the gaps left where the main cork line attaches to the net body. The additional cork line will add flotation to the net body.

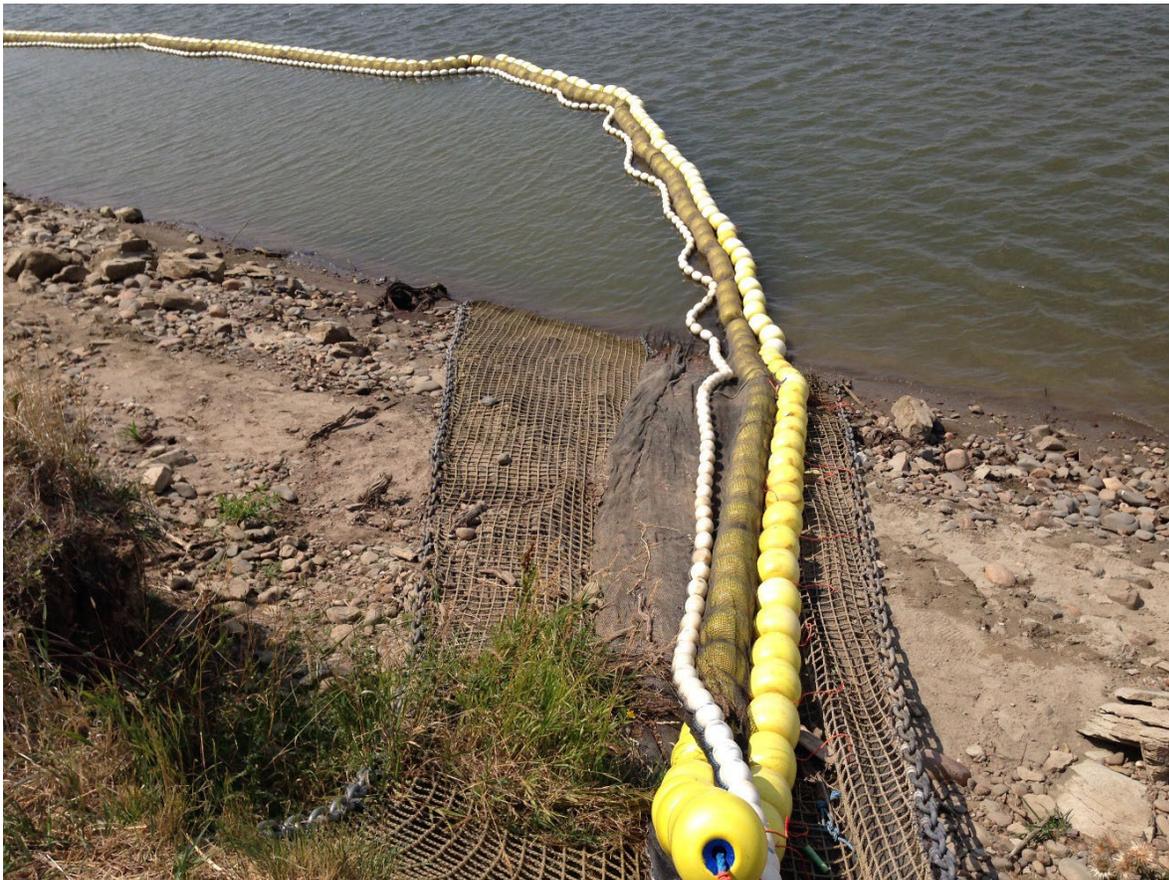
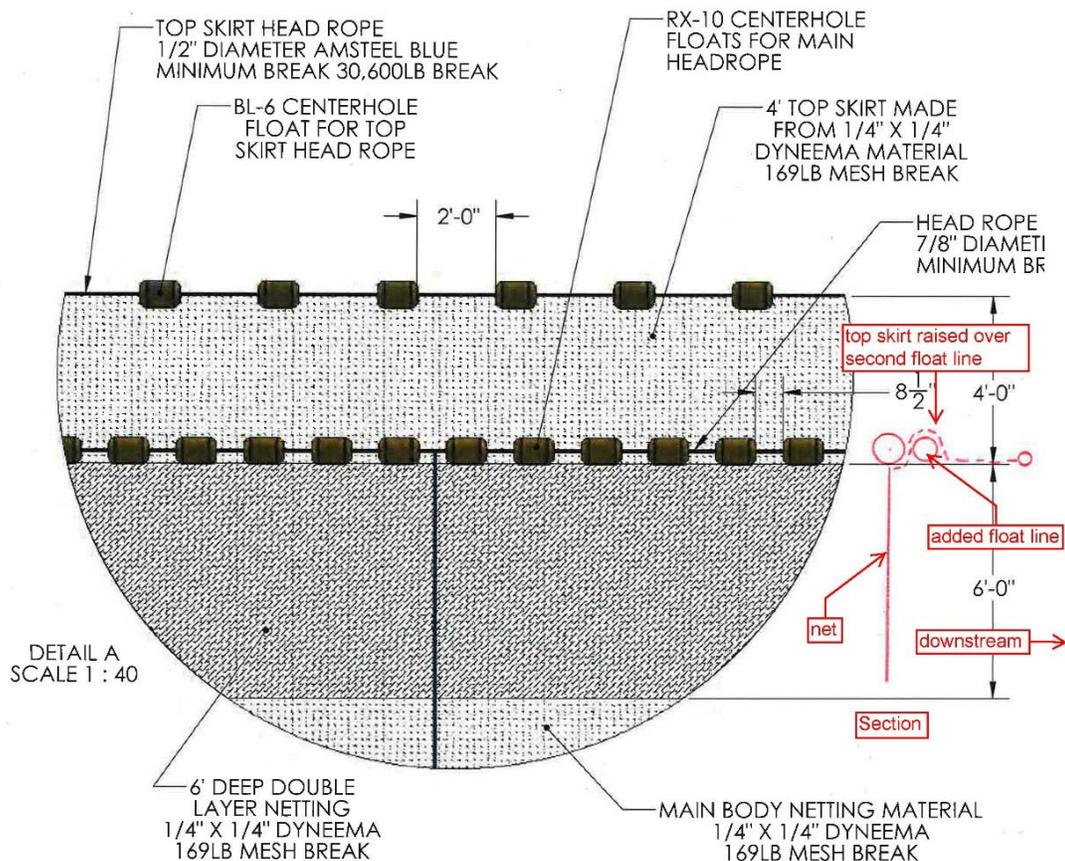
Elkhead Net with Added Second Cork Line

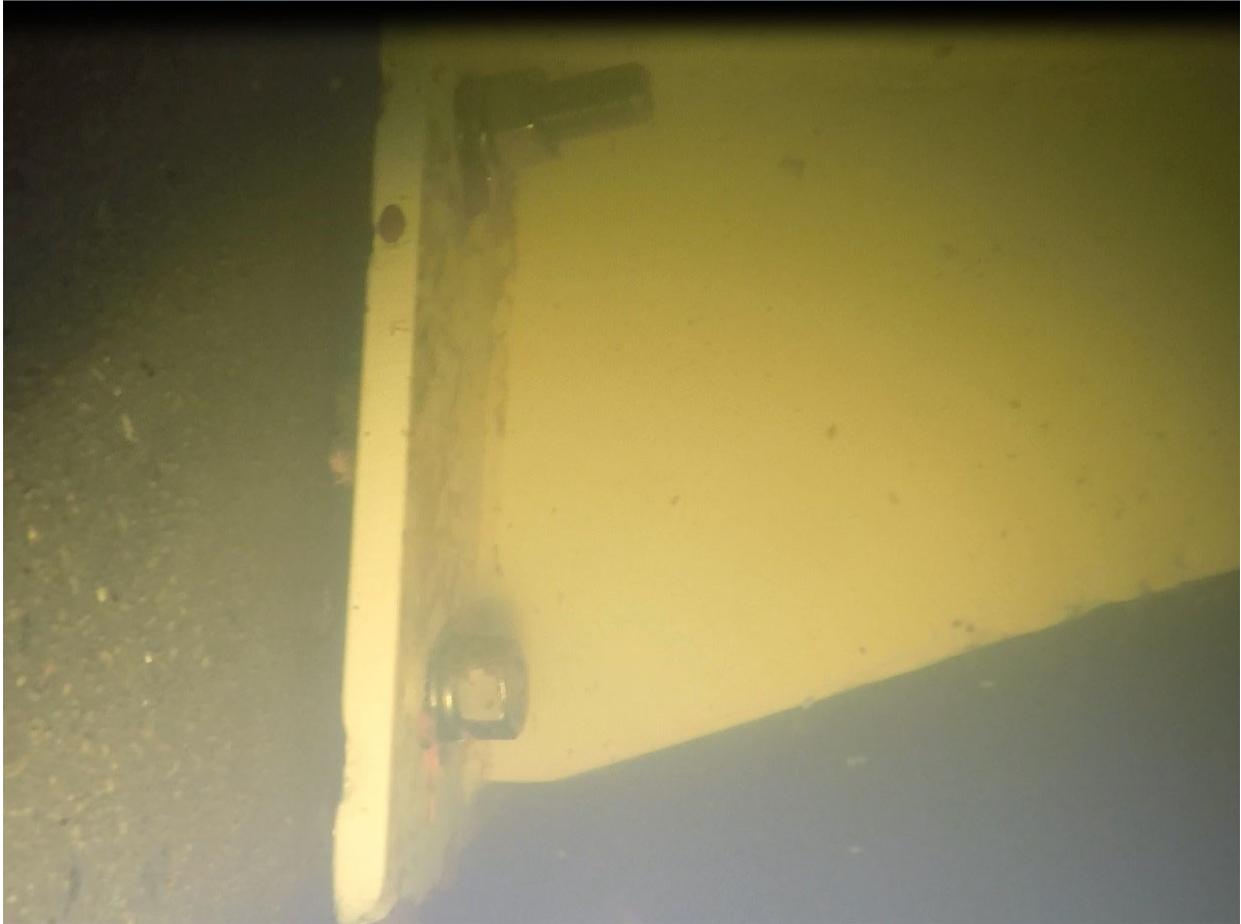
The effort to replace the substandard anchor bolts from the original construction on the movable fish screen and other gate stem guides boiled over into 2018 when the RD discovered unacceptable work on the submerged fish screen guide anchor bolts using our underwater camera rig. The contractor returned to the site and replaced all the previously installed anchor bolts at no cost to the project. Some minor RD charges related to providing full time observation of the work were realized.

Example Stem Guide Anchorage Which Was Remedied

Stem guide anchor bolt remediation successfully completed and tested.

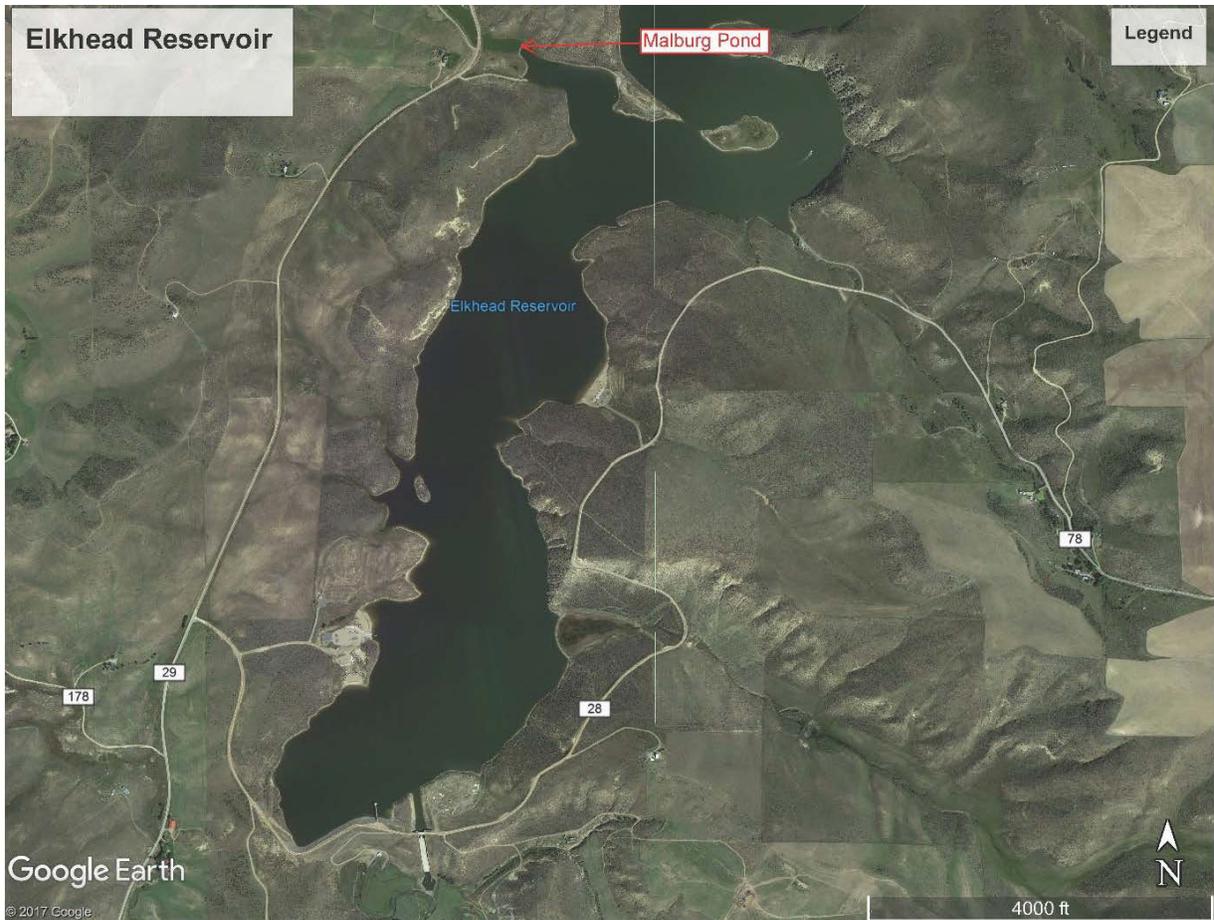
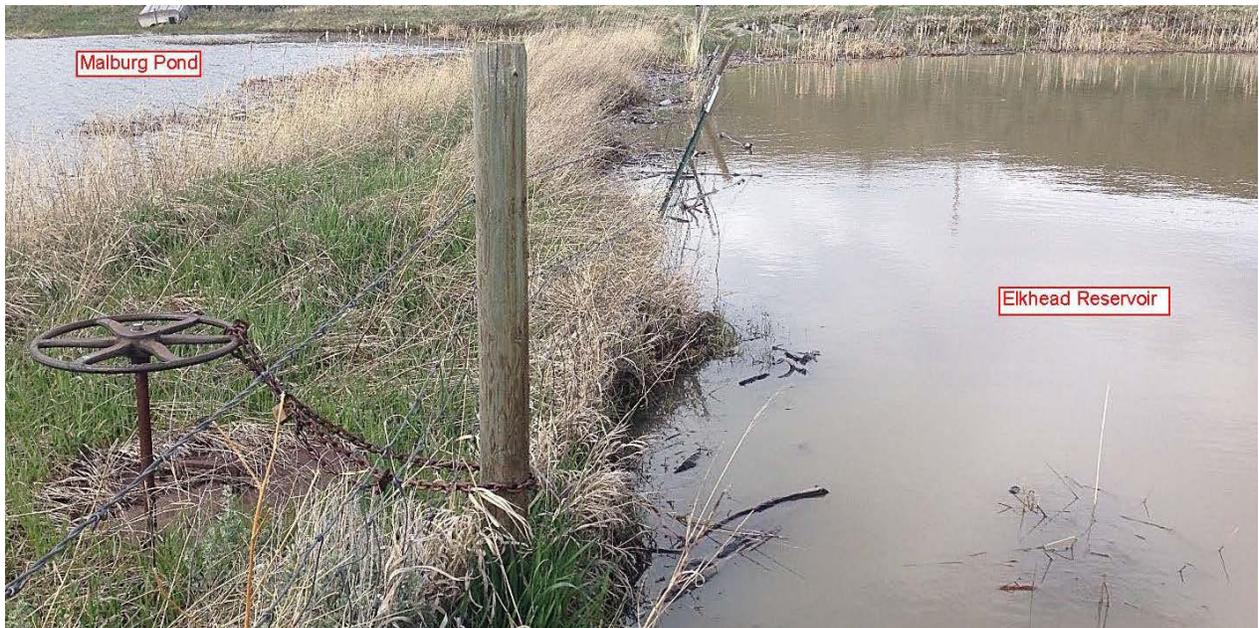
The Malburg Pond is a small stock pond of less than 10 acre-feet adjacent to the reservoir. The original pond was inundated by the 2006 reservoir enlargement and as part of the acquisition of private land for the reservoir enlargement and mitigation for the inundation of the Malburg Pond the project built a replacement pond, with the Elkhead Reservoir project owners taking responsibility for maintenance of the pond embankment.

Malburg Pond Embankment Crest at Elkhead Reservoir Full Pool 2017

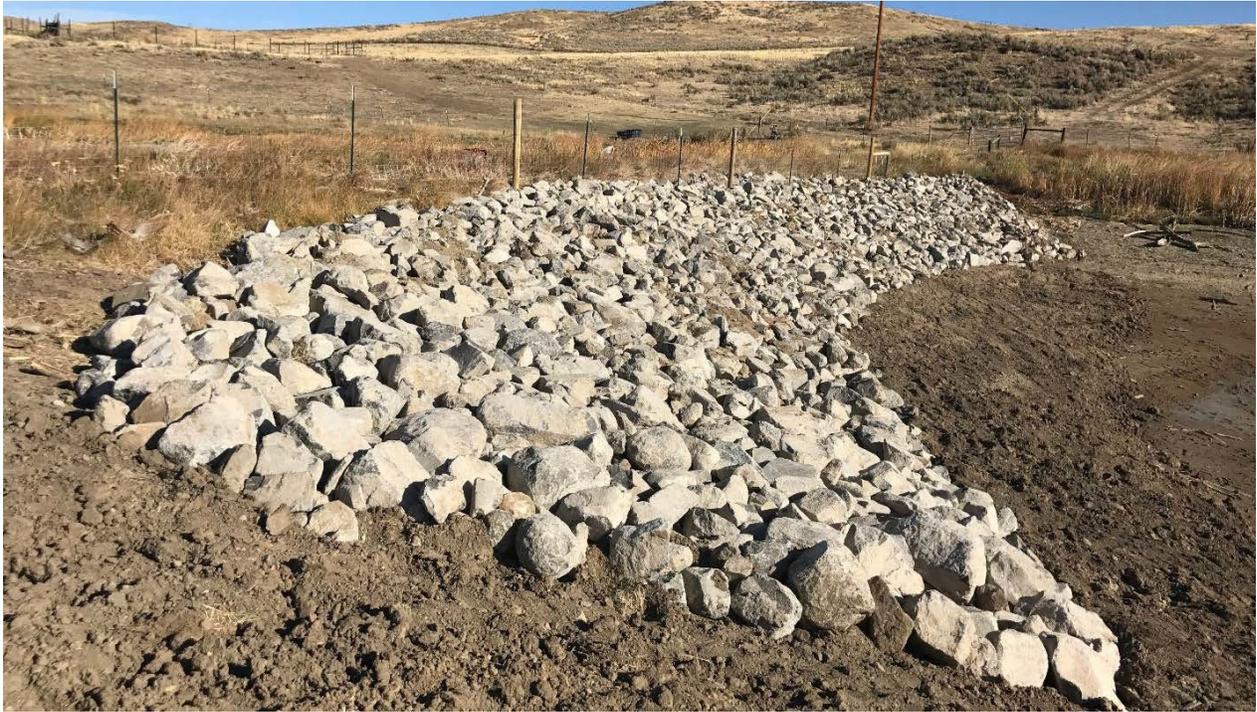
Malburg Pond Revetment

Malburg Pond embankment maintenance completed.

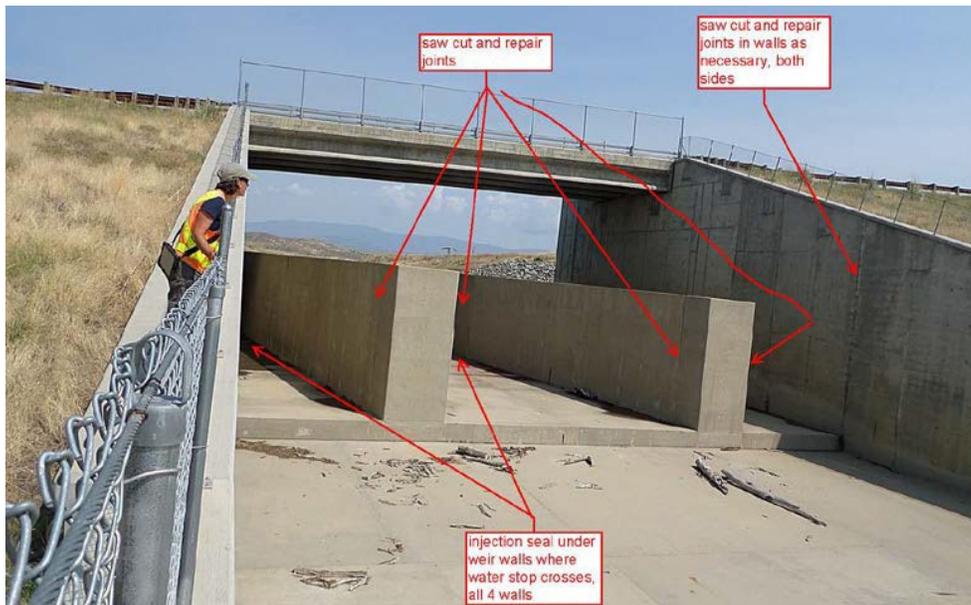
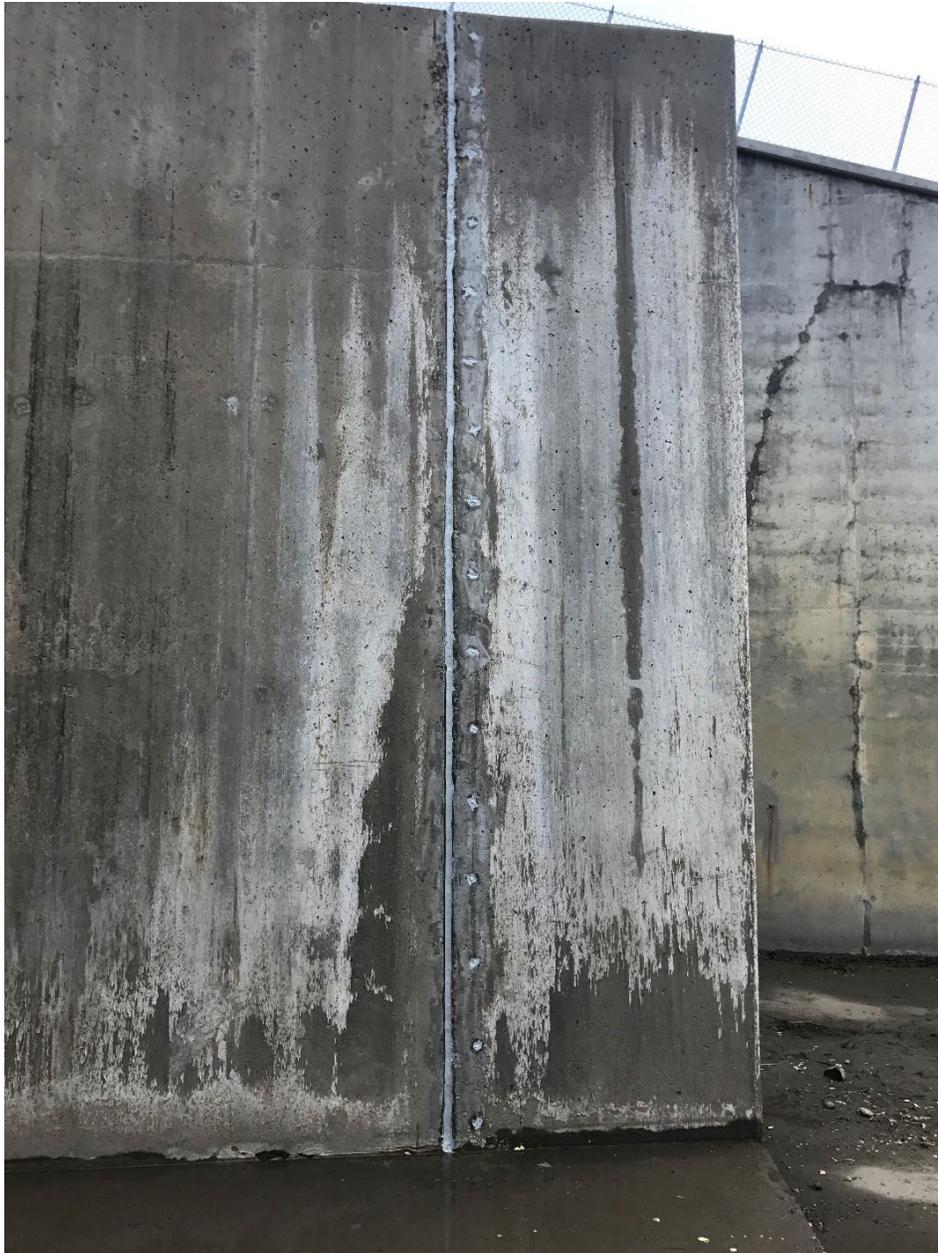
The concrete spillway at Elkhead Dam has some damaged concrete work at the construction joints. These have been identified in the annual dam safety inspection and were addressed this year by a recommended contractor. Billing for this work occurred after September 30, 2018 and will be included in the annual 2018 calendar year reporting and 2018 operations invoice.

Example Concrete Repair

Spillway weir wall concrete repairs completed.
