AN EVALUATION OF
ECOSYSTEM RESTORATION
AND MANAGEMENT OPTIONS
FOR THE
OURAY NATIONAL WILDLIFE REFUGE, UTAH

U.S. FISH AND WILDLIFE SERVICE
REGION 6
DENVER, CO

Mickey E. Heitmeyer and Leigh H. Fredrickson
Gaylord Memorial Laboratory
University of Missouri - Columbia
Puxico, MO

February 2005

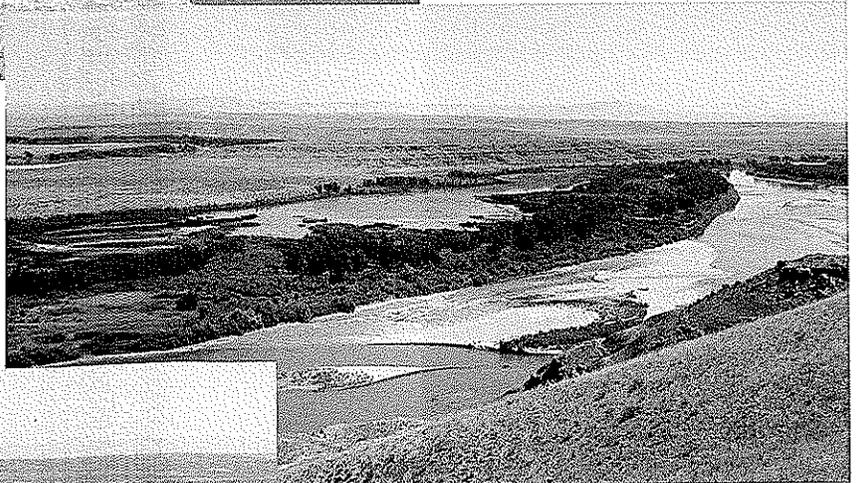
Green River channel dynamics creating ridge-and-swale surfaces.
