# Streamflow Gain-Loss Characteristics of Elkhead Creek Downstream from Elkhead Reservoir near Craig, Colorado, 2009

Scientific Investigations Report 2010–5198

By Barbara C. Ruddy

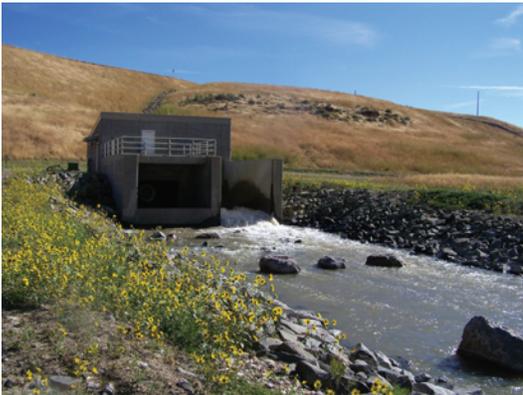
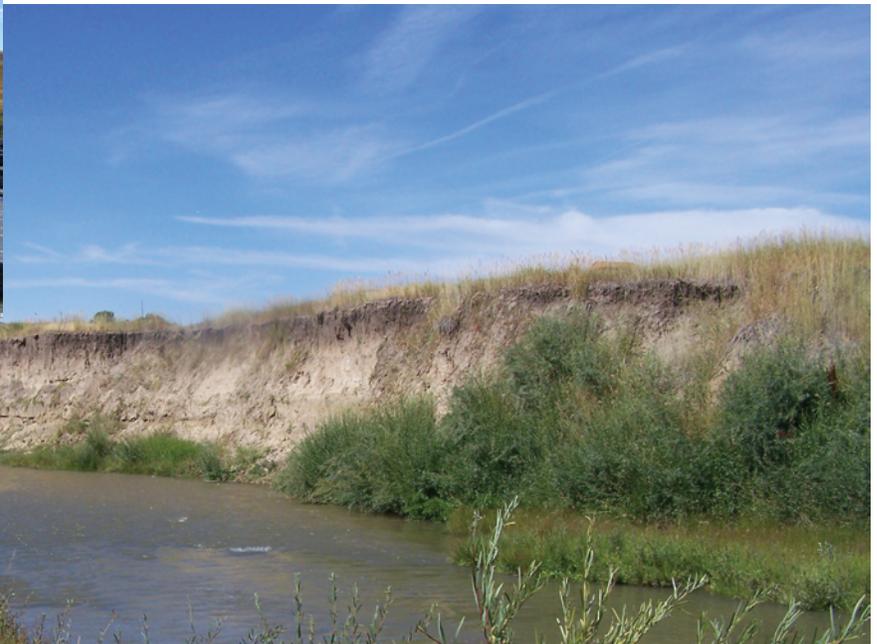
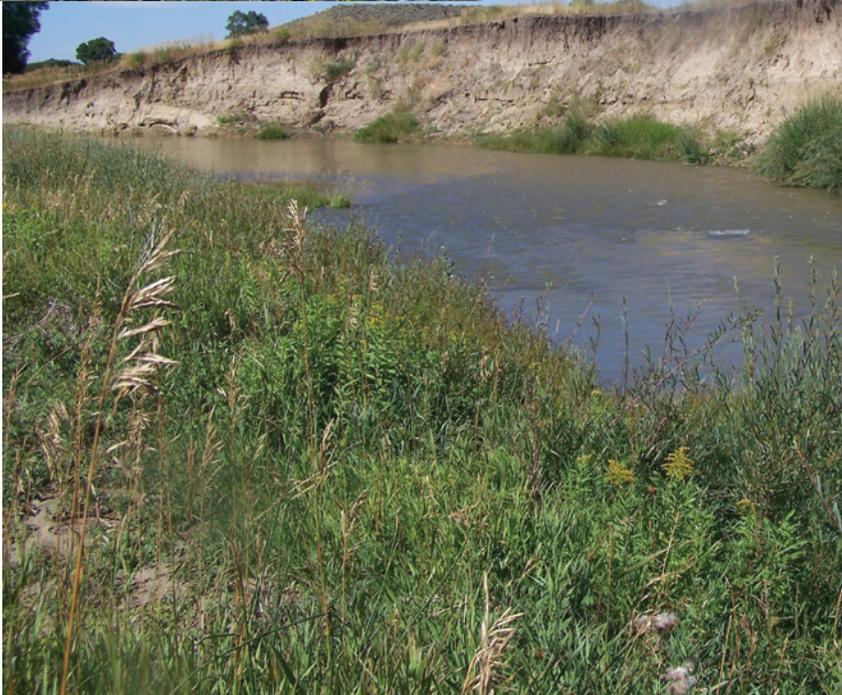
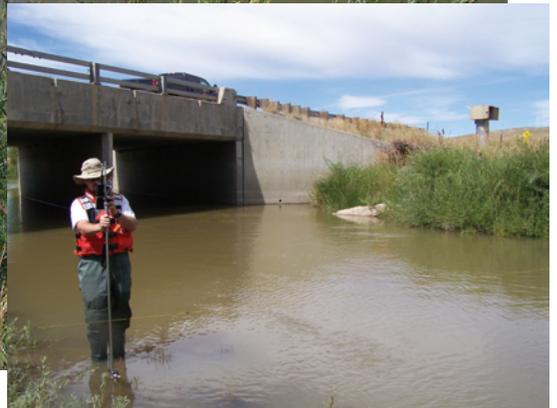
Top left photo: Outlet works at Elkhead Reservoir near Craig, Colorado. Photo taken by Barbara C. Ruddy, U.S. Geological Survey, September 5, 2008.

Middle photo: Looking downstream on Elkhead Creek near discontinued streamflow-gaging station 09246400, Elkhead Creek below Maynard Gulch near Craig, Colorado. Photo taken by Barbara C. Ruddy, U.S. Geological Survey, September 5, 2008.

Bottom right photo: Hydrographer Kevin Murphy making a streamflow measurement at streamflow-gaging station 09246500, Elkhead Creek near Craig, Colorado. Photo taken by Barbara C. Ruddy, U.S. Geological Survey, September 5, 2008.

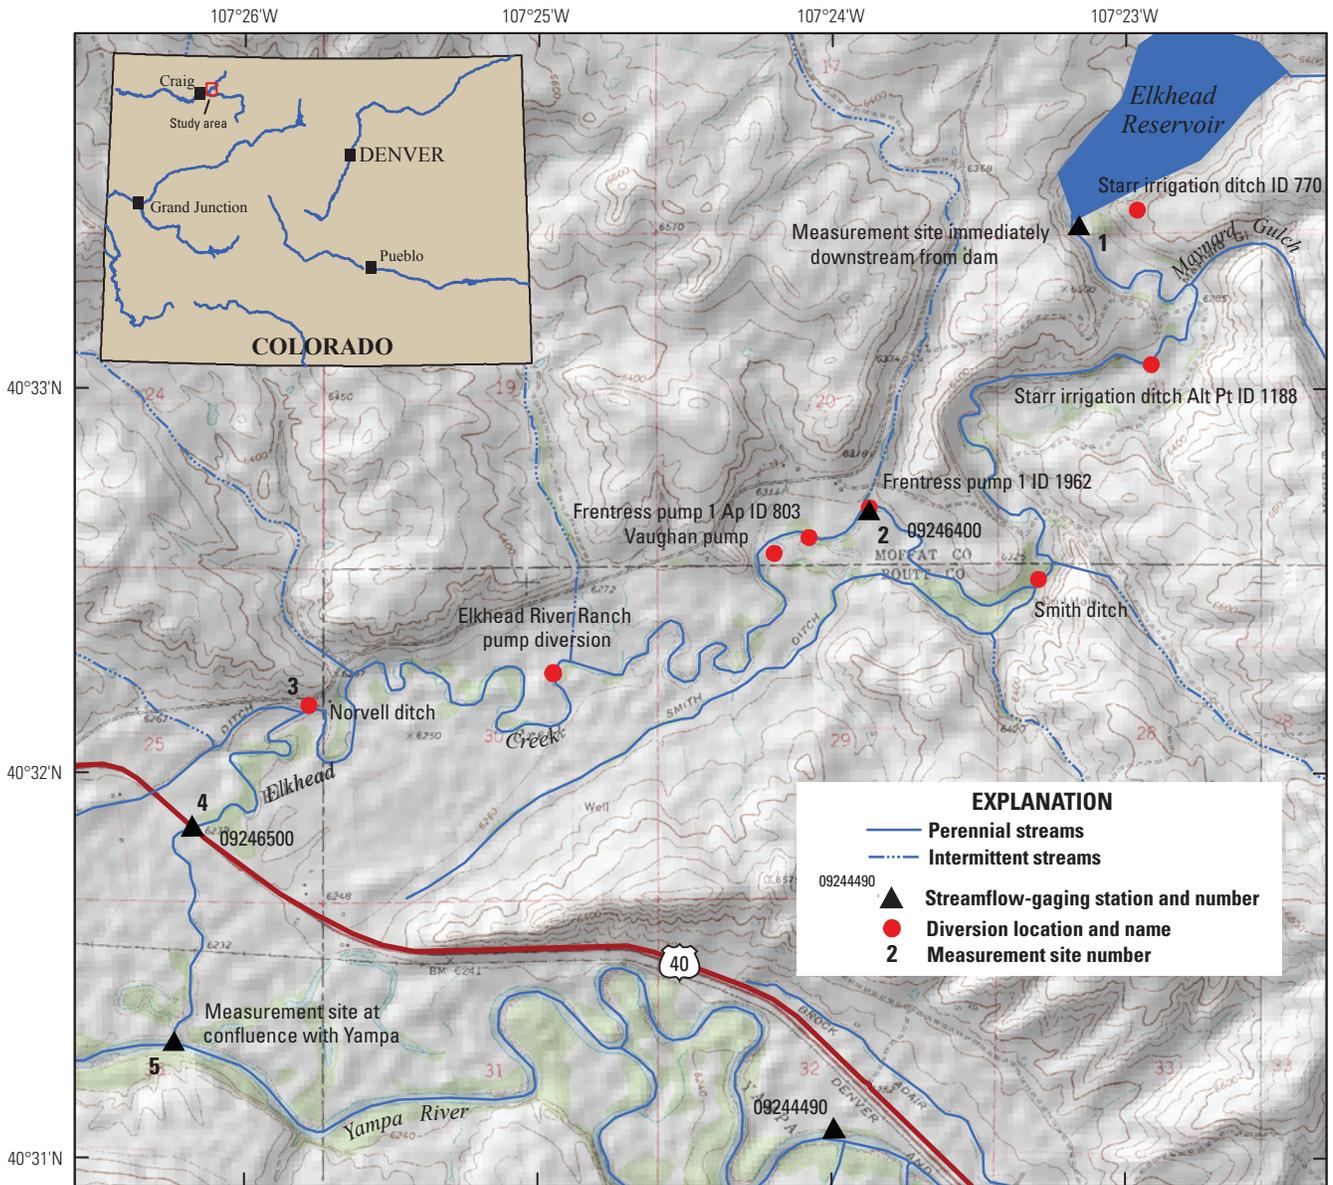
**Figure 1.** Location of Elkhead Creek study area and measurement sites downstream from Elkhead Reservoir near Craig, Colorado.

Elkhead Reservoir, northeast of Craig, Colo. (fig. 1), provides supplemental streamflow to the Yampa River to support increased water-supply needs including cooling water for a power-generating station at Craig, maintenance of minimum streamflows within critical habitat reaches for endangered fish, and diversion and withdrawal of streamflow for agricultural, domestic, and municipal uses.

Streamflow was measured at four sites downstream from Elkhead Reservoir on Elkhead Creek and at one diversion, Norvell ditch (table 1). These sites were selected based on having good measurement sections (uniform cross section and consistent flow) that were located along the reach from the reservoir to the confluence with the Yampa River.

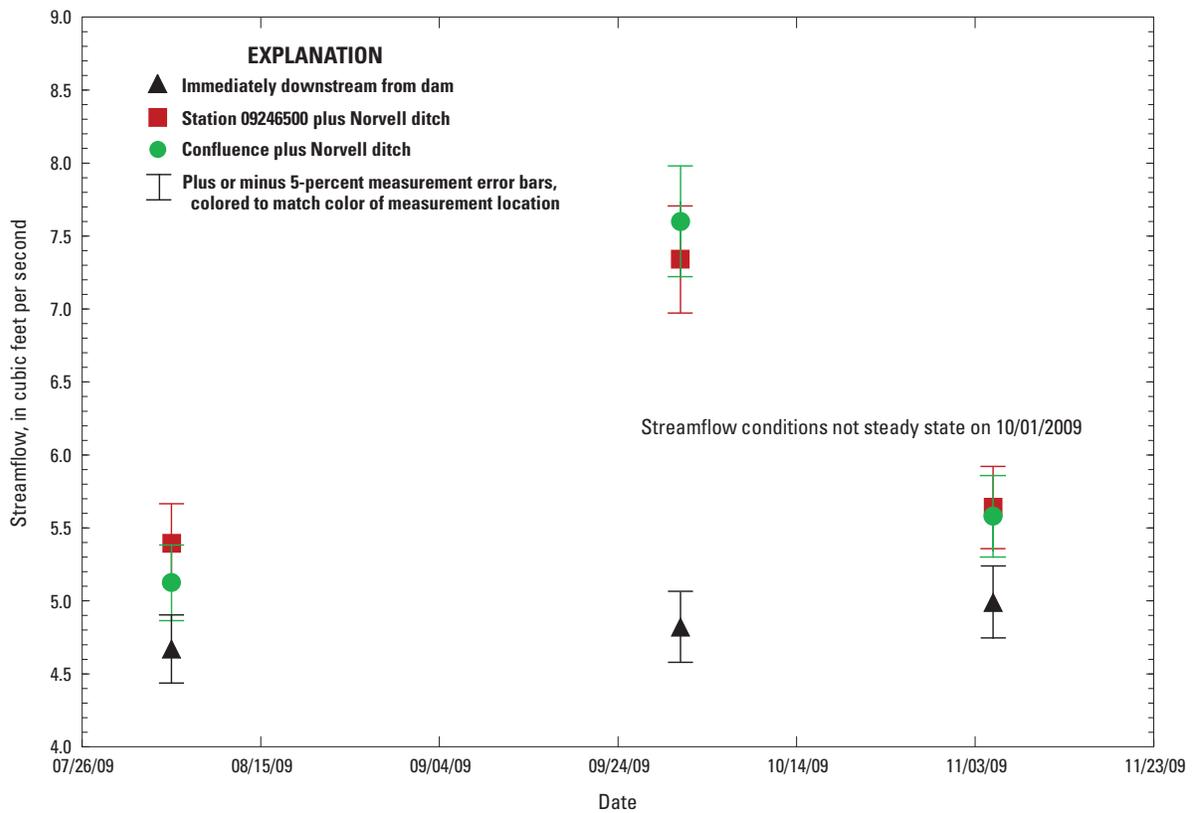
**Figure 2.** Instantaneous streamflow measurements at selected sites, August 5, October 3, and November 5, 2009.

Eight instantaneous measurement sets were made from August 5 to October 1, 2009, and are presented in table 2 and figures 2 and 3. (The additional measurement set made on November 5, 2009, was not included in the analysis because it was after the flow-augmentation period.) The data are presented in two separate figures because of the wide range in streamflows from about 5 ft<sup>3</sup>/s to almost 100 ft<sup>3</sup>/s. Figure 2 shows the measurement sets when the streamflow was less than 10 ft<sup>3</sup>/s, and figure 3 shows the measurement sets when the streamflows were between 40 and 100 ft<sup>3</sup>/s. The measured streamflow downstream from the dam is usually smaller than the combined measured streamflows of station 09246500 plus Norvell ditch, and the metered flow from the reservoir is always smaller than the combined measured streamflows of station 09246500 plus Norvell ditch. The measurement error

of the combined measured streamflows of station 09246500 plus Norvell ditch are within the measurement error of the instantaneous measurement immediately downstream from the dam except for October 1 and November 5. Figures 2 and 3 show the overlap of the plus or minus 5-percent measurement error between the sites. The measured streamflow immediately downstream from the dam is less than that at station 09246500 gage plus Norvell ditch except for August 13, August 24, and September 3. For August 13 and the September 3, 8, 14, and 21 measurements, the combined streamflow at station 09246500 gage plus Norvell ditch was within the measurement error of the measured instantaneous streamflow at the dam. On August 24, the combined streamflow at station 09246500 plus Norvell ditch was about 1 ft<sup>3</sup>/s less than the measurement error of the measured instantaneous streamflow at the dam. On August 5, October 1, and November 5, the combined streamflow at station 09246500 plus Norvell ditch was greater than the measured streamflow at the dam.

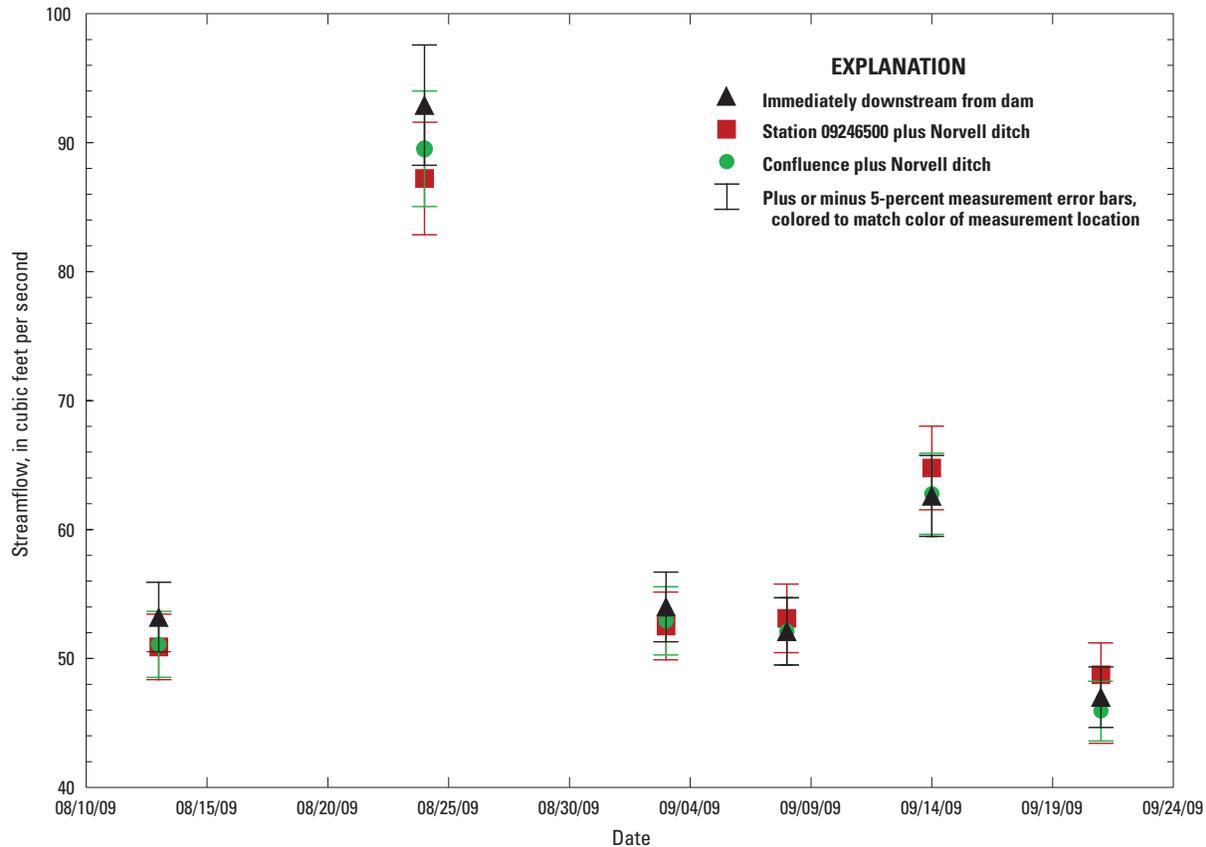
Figure 3. Instantaneous streamflow measurements at selected sites, August–September 2009.

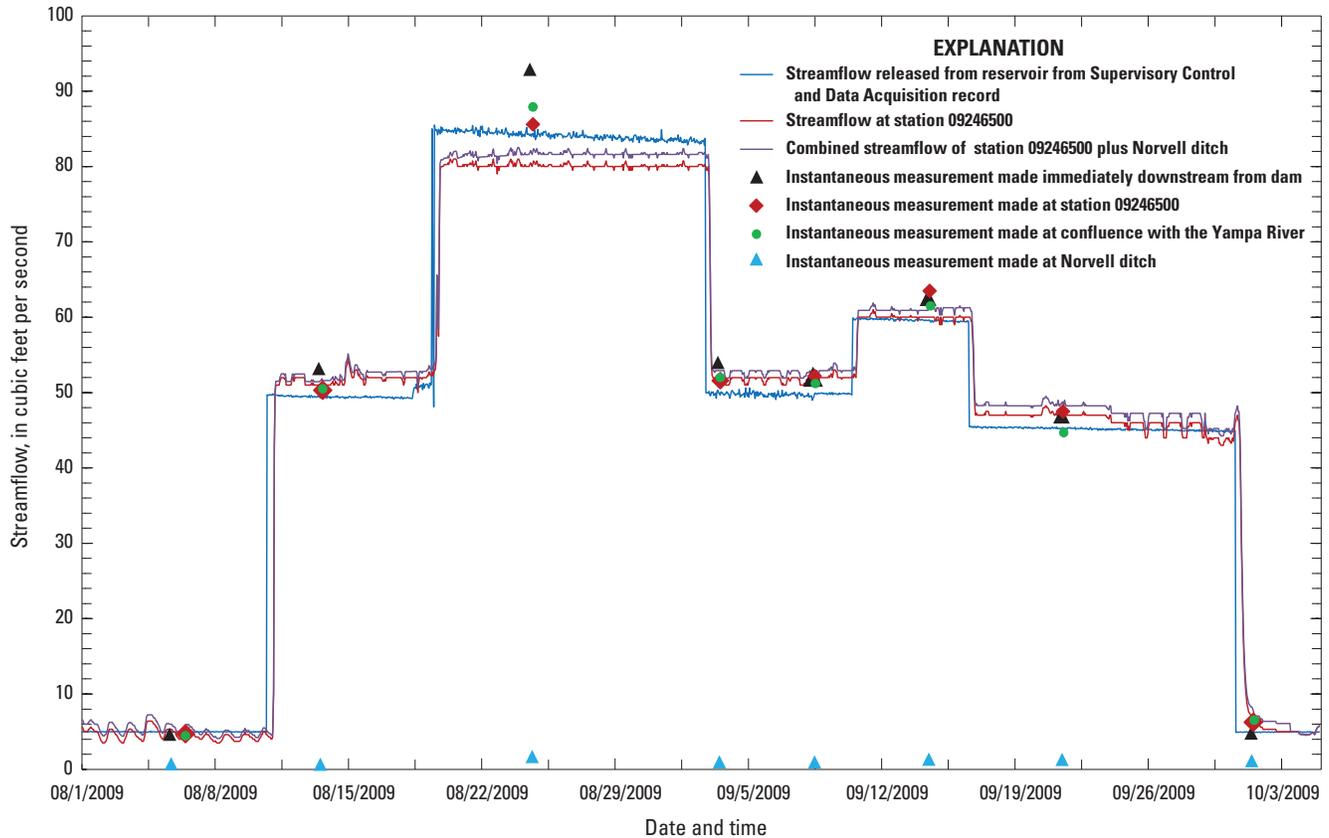
Figure 4. Instantaneous and continuous record of streamflow downstream from Elkhead Reservoir, August 1 to October 4, 2009.
