COLORADO RIVER RECOVERY PROGRAM
FY 2013 ANNUAL PROJECT REPORT

RECOVERY PROGRAM
PROJECT NUMBER: C-28a

Stationary PIT detection system in the Green River Canal, Green River, UT

Date: Nov 19, 2013

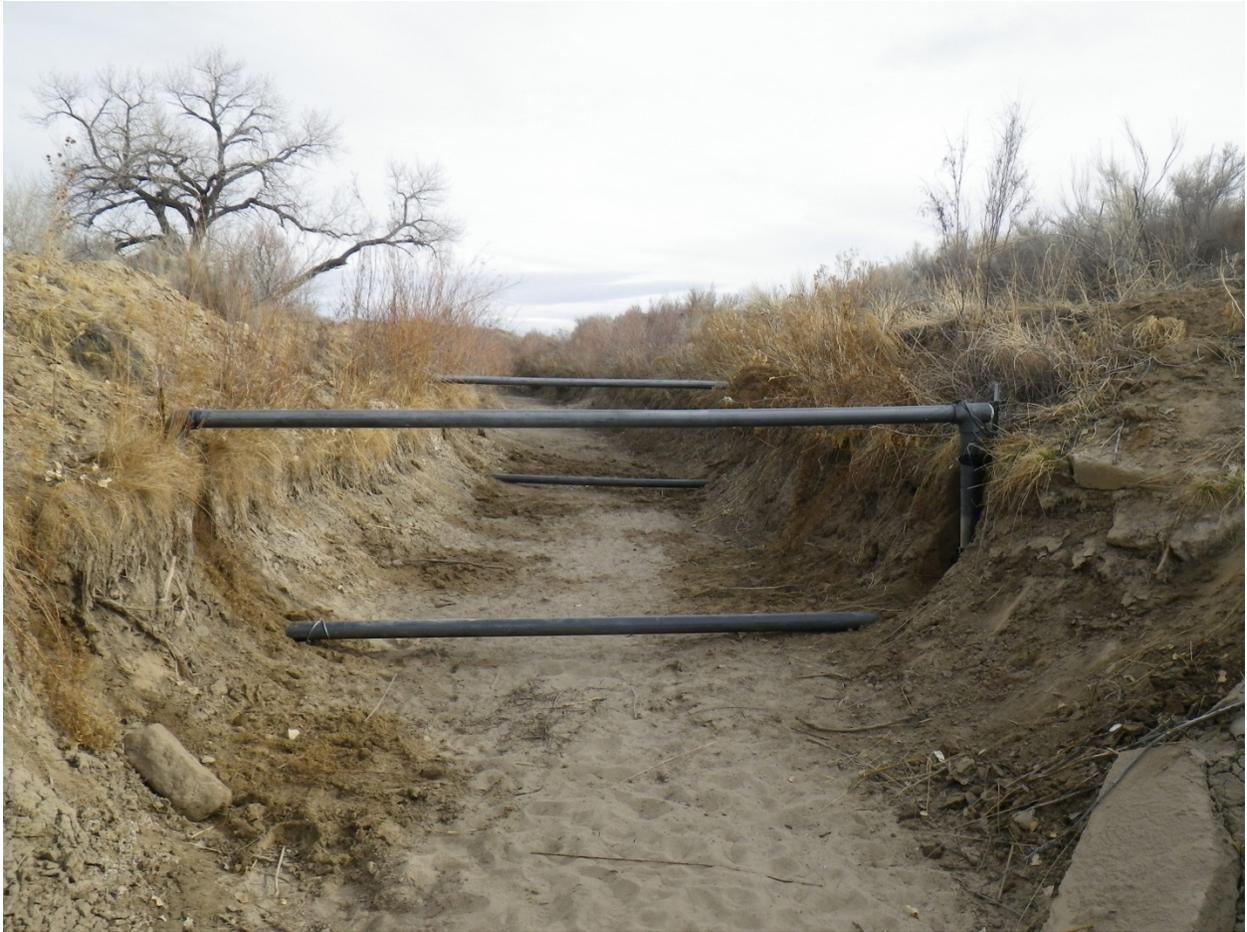
Figure 1. Completed PIA antenna loops, Green River Canal (looking downstream), March 20, 2013.

Task 1: Installation, testing and activation of PIA in the Green River Canal. We obtained permission to install the PIA by January 7, 2013 through a signed memorandum of understanding (MOU) between the Recovery Program and the Green River Canal Company. Minor changes to this MOU regarding antenna size were made on Feb 6. On March 20 we installed the PIA at the agreed upon location (about 100 m below the canal head gates). The PIA system was constructed from components from the Maybell Ditch PIA (Recovery Program project 146) and is shown in Figure 1. Antenna loops were two 4' X 16' rectangles constructed from schedule 80 PVC which house the antenna wiring. The loops were fastened in upright position to t-posts driven into the canal substrate at the channel margins. The antenna loops were connected to the scanner and data logger via cables buried in a shallow trench (6-8" deep). All electronics are located in a sealed job box placed next to at the solar panel mounting (Figure 2). The power system consists of two, 160 Watt solar panels with a 256 amp hour battery bank. The system was tuned to read PIT tags passed through the dead center of the rectangular loops which ensures good readability (about 20-24") across the entire antenna. We had to increase amperage to the loops to attain this level of performance due to unusually high ambient noise levels.

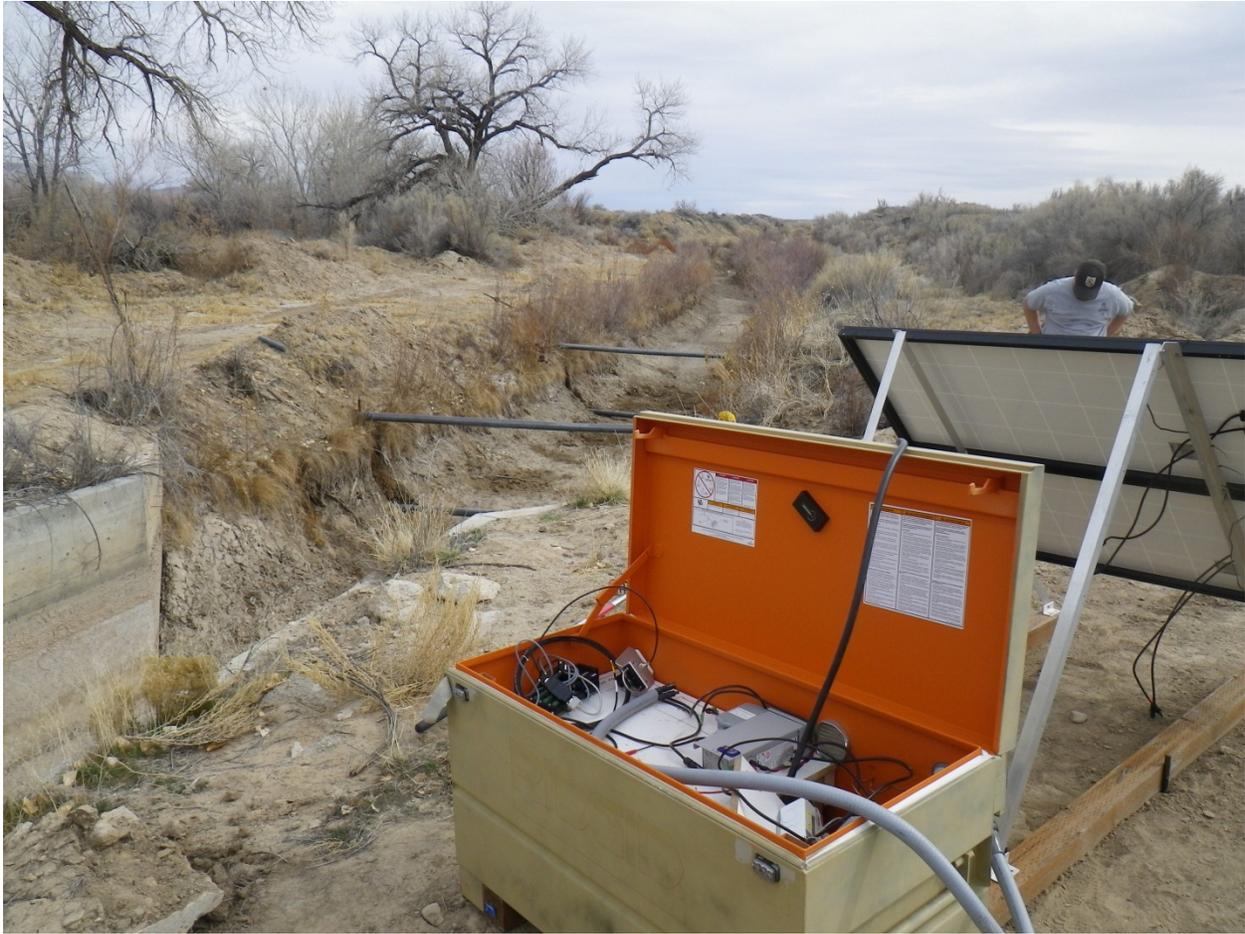
Figure 2. PIA electronics job box (foreground) in front of solar panel. PIA antennas can be seen in the background. Green River Canal, March 20, 2013.
