I. Project Title: **GVIC Fish Screen Return Pipe Monitoring**

II. Bureau of Reclamation Agreement Number: R11PG40021

III. Principal Investigators:

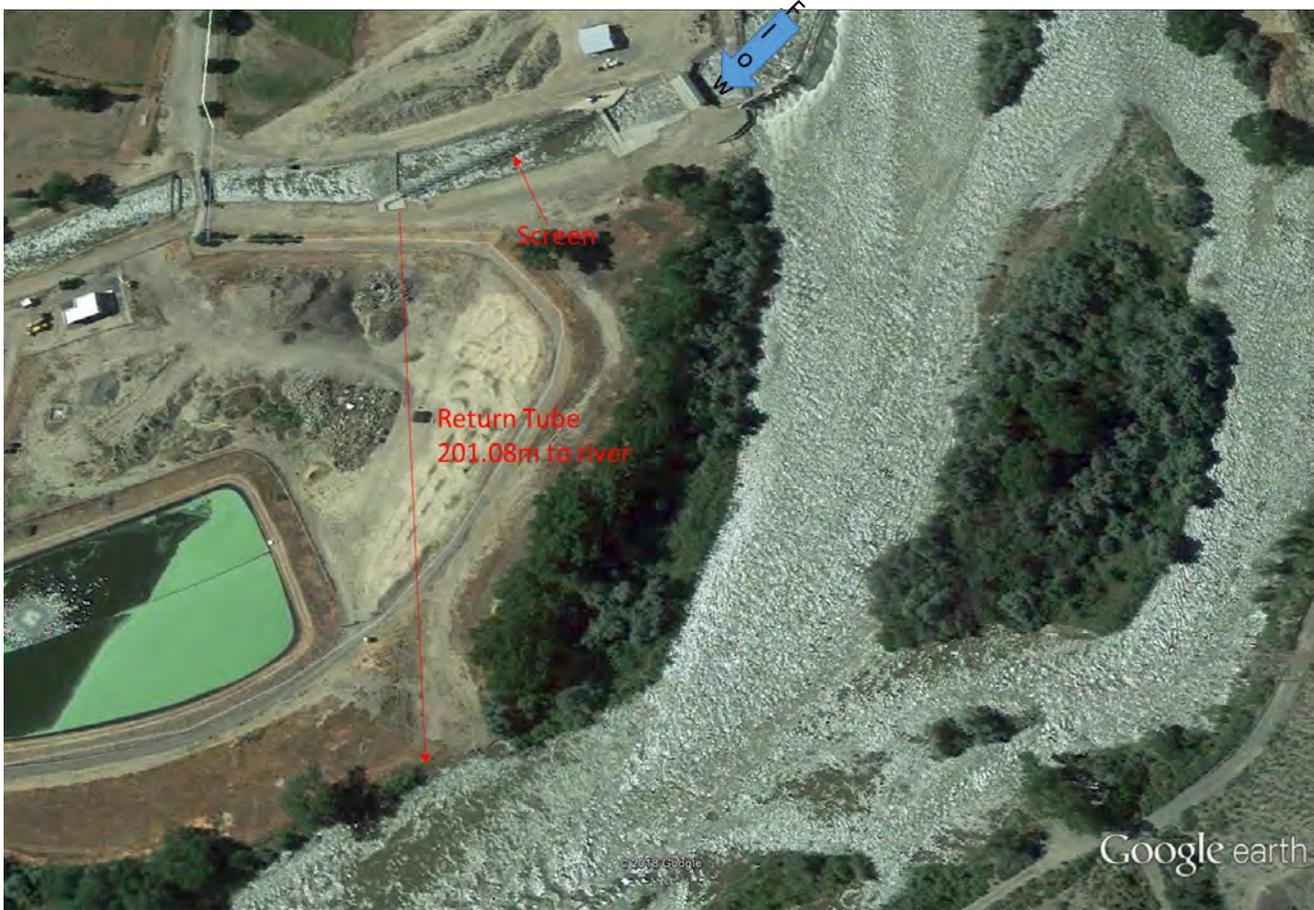
Google earth image of GVIC canal intake, fish screen and return tube at an altitude of 5855 ft.

The terminal end of the GVIC canal is located in the town of Palisade, Colorado at RM 185.1. The terminal end of the fish return tube is located 129.63 m (0.08 miles) from the dam at 39.100726° latitude and -108.351408° longitude on the south side of the canal. A water control gate is located at the beginning of the return tube and there is a ~1m fall to a 1.22m diameter pipe (or tube) that hits a hard 90° angle ~ 6m from water control gate. The distance to the basal end (end that delivers fish back to the Colorado River) from the terminal end is 201.08 m (0.12 miles). Depending on Colorado River flows (because of downstream water rights) and the needed "head" to deliver water to the basal end of the canal's water users, GVIC staff operate the water control gate at various heights throughout the irrigation season.

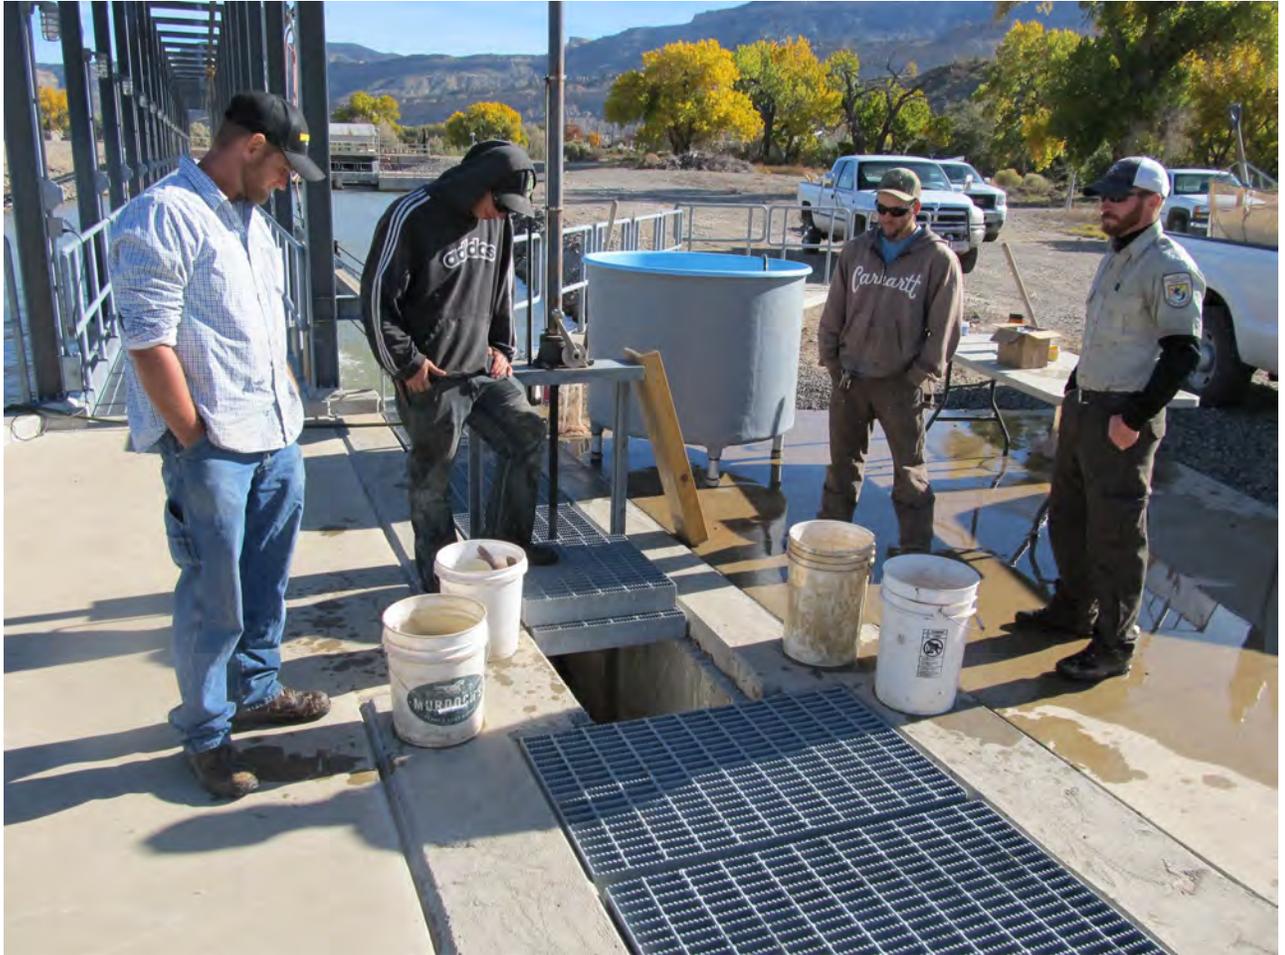
Terminal end of GVIC return tube. Water control gate next to GVIC employee with black hoodie. Fish were released for test where grate has been removed.

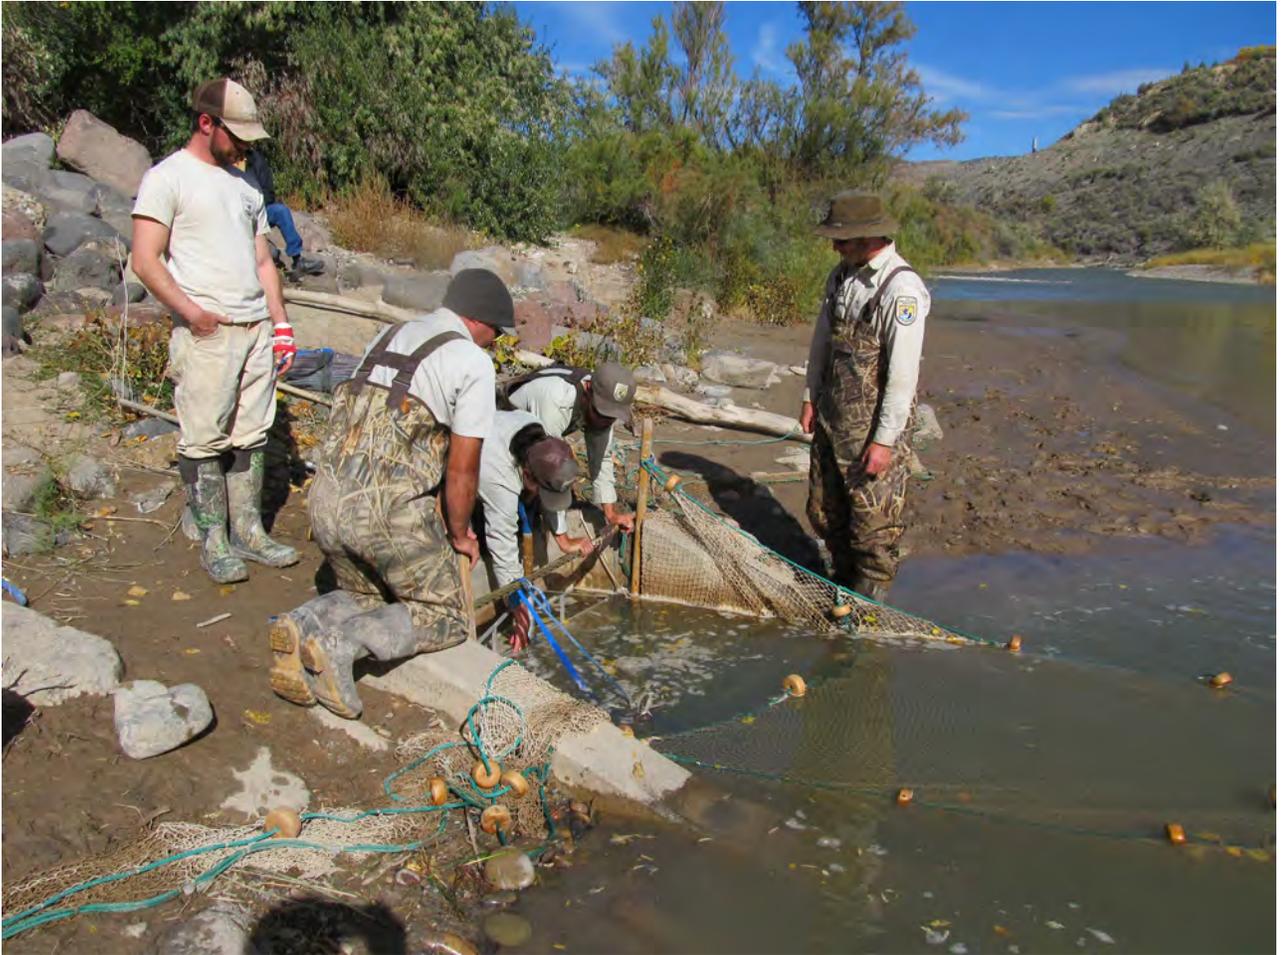
Basal end of GVIC return tube. 201.08m (.12 miles) from terminal end. Return tube diameter is 1.22m (4ft.). Technicians are manning the purse seine for fish collection.
