COLORADO RIVER RECOVERY PROGRAM
FY 2017 ANNUAL PROJECT REPORT

RECOVERY PROGRAM
PROJECT NUMBER: C-9

I. Project Title: O&M for Elkhead Release and Elkhead Lease

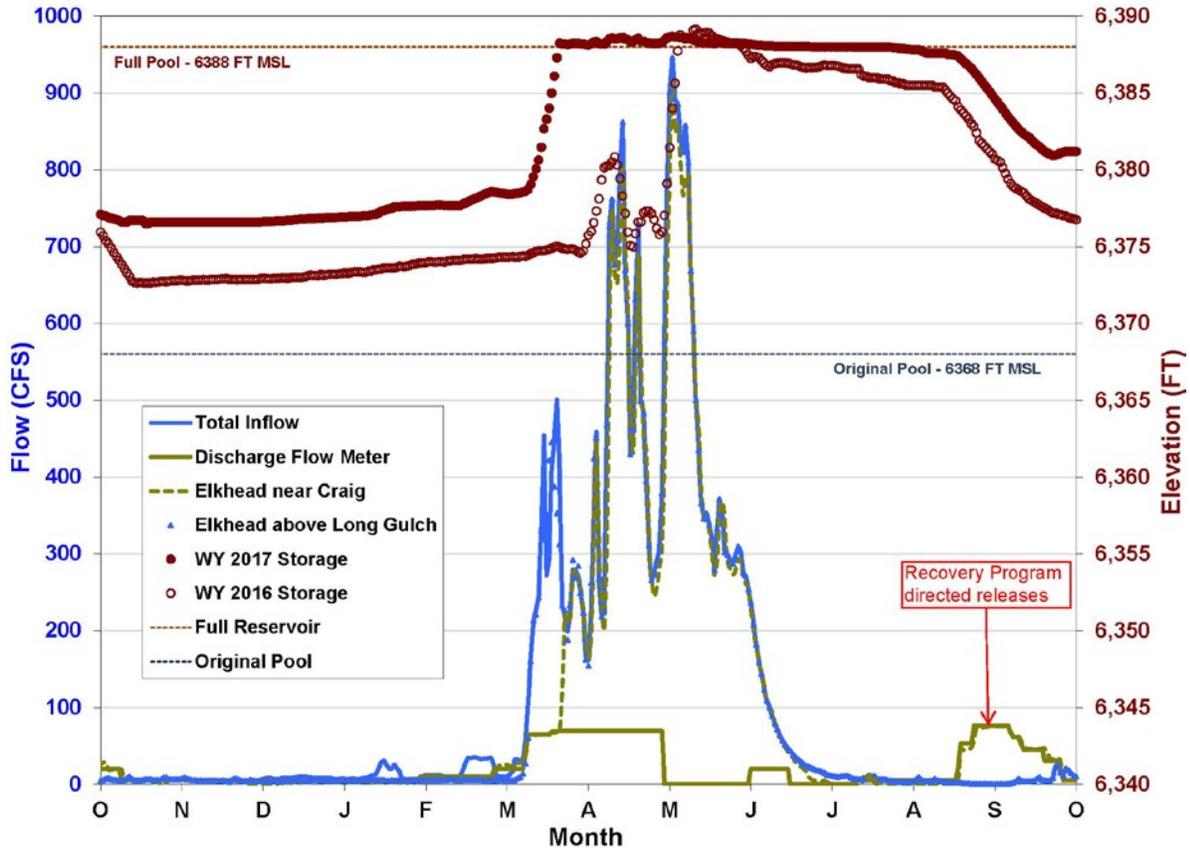
Elkhead Reservoir WY 2017 Flows and Elevation

Elkhead Reservoir was operated in 2017 to release the Recovery Program's 5,000 acre feet of water as requested. Weekly coordination calls hosted by the USFWS Regional Hydrologist set the release rate for the upcoming week. Releases were generally made from mid-August through late September following the Maybell gage flows. In the early fall river conditions improved and releases were truncated. In 2017 4173 acre-feet of the Recovery Program's 5,000 acre-foot pool was released and 827 acre-feet left in the reservoir.

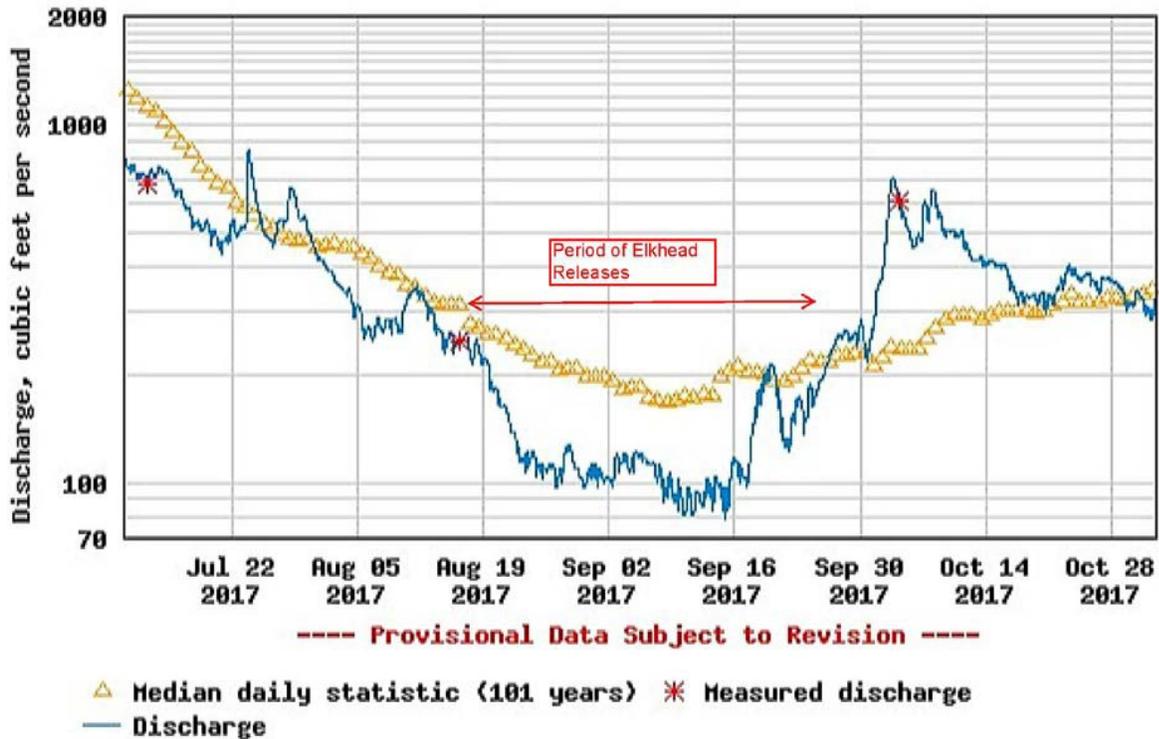
USGS 09251000 YAMPA RIVER NEAR HAYBELL, CO

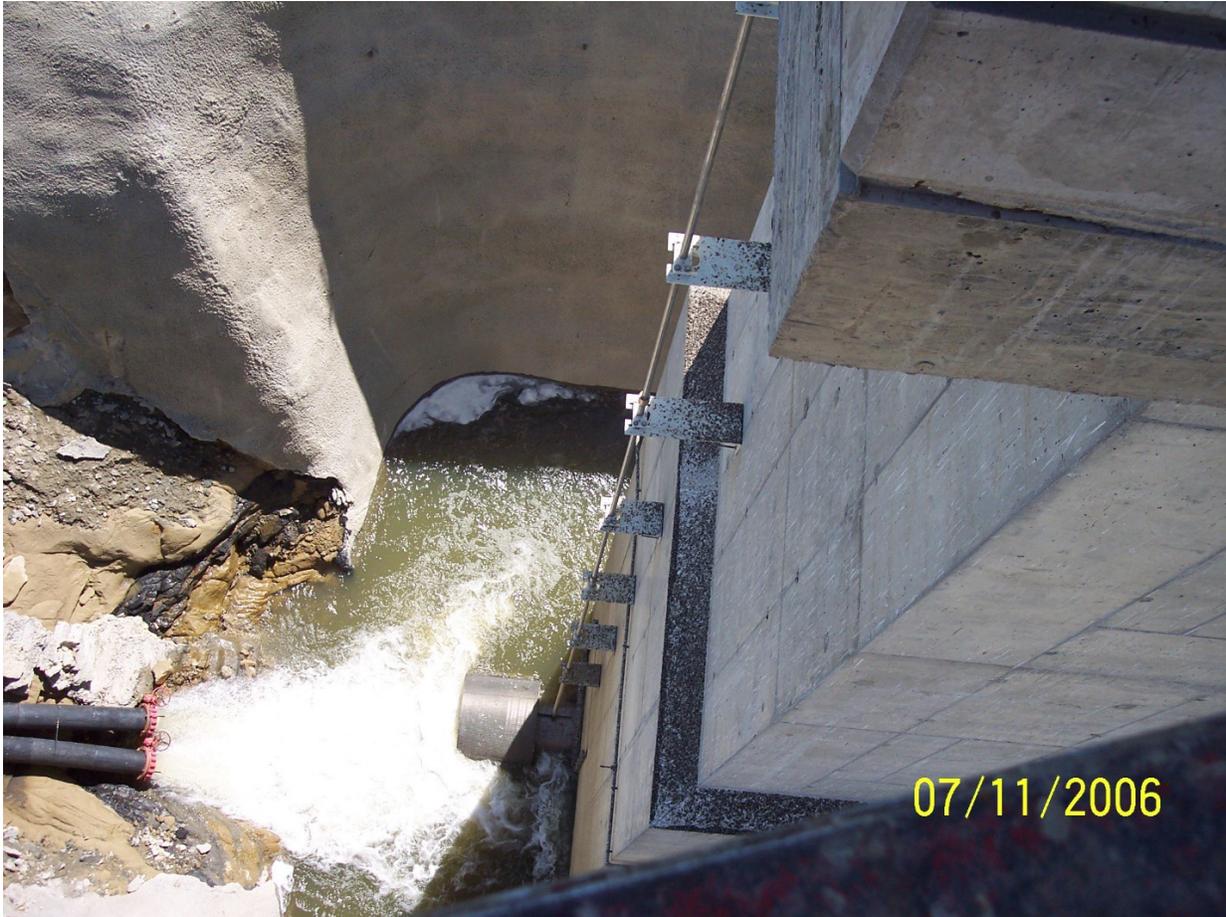
Elkhead Reservoir Outlet Tower
Movable Fish Screen Stem and Guides
During Original Construction

In addition to the spillway barrier net expenditures in FFY 2017 the project experienced repair costs related to the replacement of the anchor bolts for the gate and movable outlet tower fish screen stem guides. The original construction was done with expansion anchors 2-1/2" into the concrete rather than the 10" embedded anchor bolts provided by the gate manufacturer to the original construction contractor. Failure of these substandard bolts caused operational problems in 2016. Efforts to replace all the bolts have been successful in FFY 2017 on all stem guides inside the outlet tower where work was performed "in the dry." Work on the 8 stem guides for the movable fish screen on the outside of the outlet tower under Elkhead Reservoir have been challenged by some replacement bolt failures. Parts have been ordered and a remedial effort is being scheduled. Expenditures in FFY 2017 for stem guide anchor bolt replacement total \$265,491.96 not including any River District labor related to this effort.

Stem Guide Anchor Bolt replacement completed inside the outlet tower. Problems persist with the anchor bolt replacement on the tower movable fish screen on the outside of the tower.

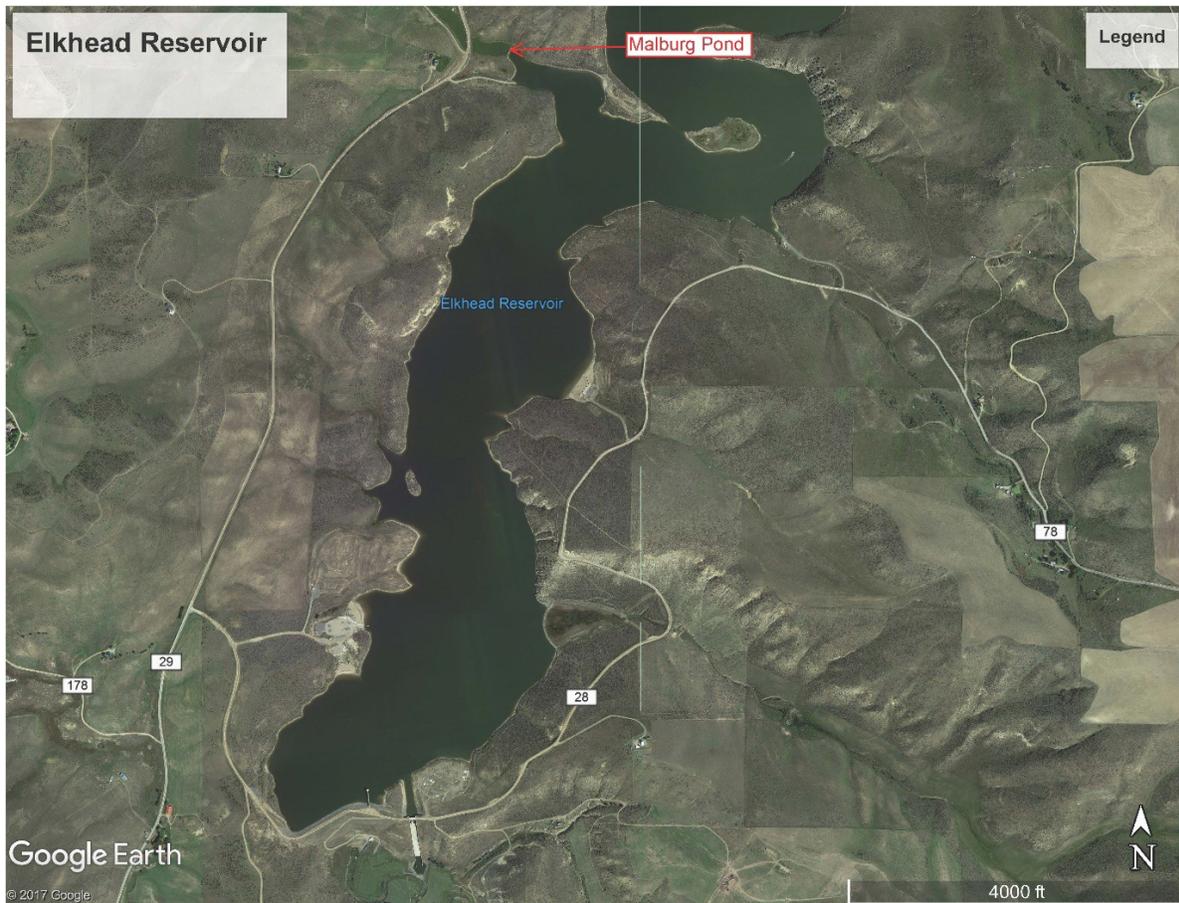
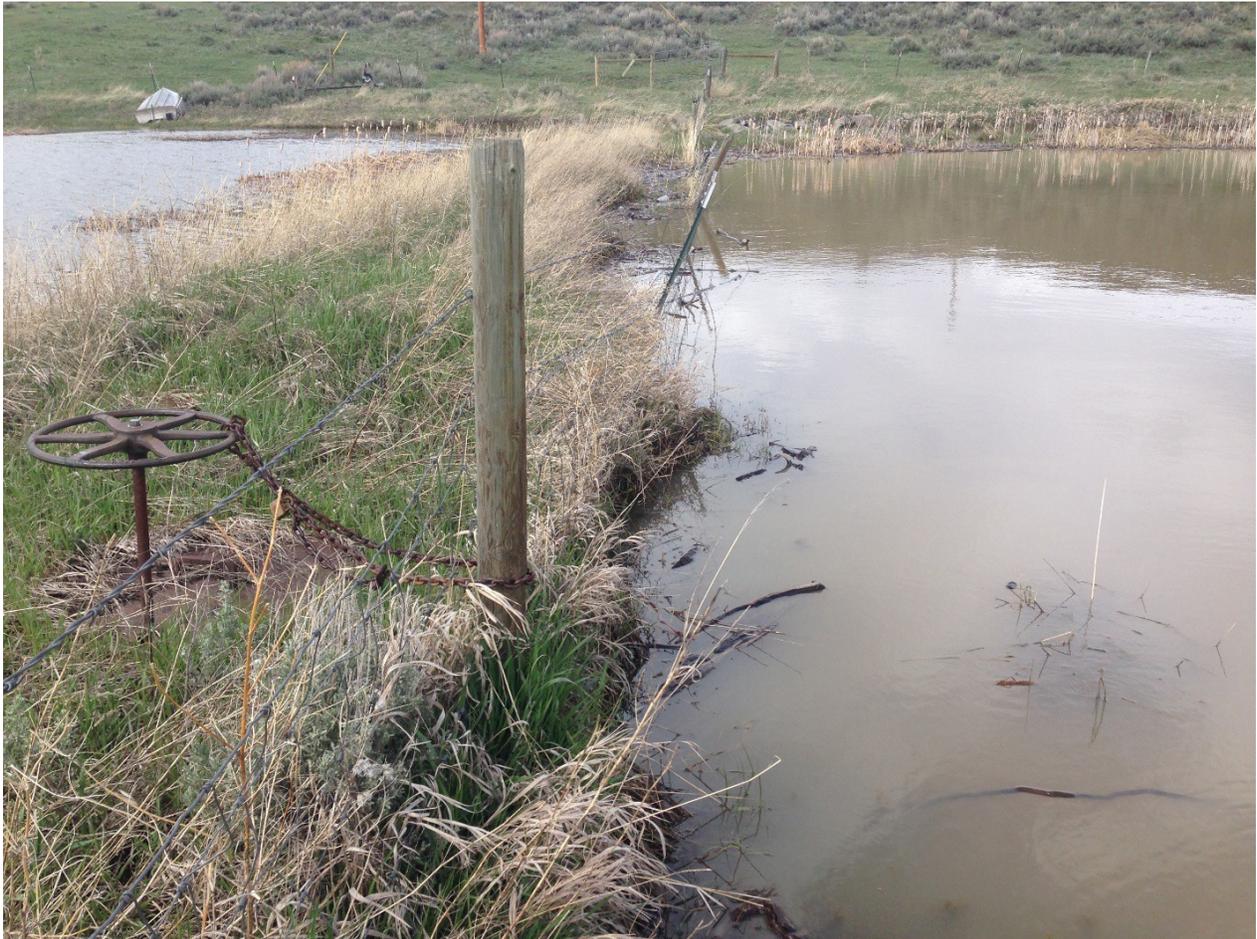
Malburg Pond Embankment Crest at Elkhead Reservoir Full Pool 2017

While the original design for the Malburg Pond embankment included riprap top to bottom on the east and west sides of the embankment the west side does not appear to need erosion protection. The original riprap erosion protection was deleted during construction as there was a shortage of “on site” derived riprap and the engineers didn’t believe with the location and exposure of the Malburg Pond embankment erosion would occur. Another similar embankment built in a more exposed area on the shore of Elkhead Reservoir has performed well with only 5 vertical feet (15 feet slope projection on a 3:1 slope) of riprap protection which is the plan for remediation of the Malburg Pond in 2018.
