I. Project Title: Matheson Preserve Larval Razorback Sucker Entrainment

II. Bureau of Reclamation Agreement Number: R14AP00007

In 2019, modification 006 to R14AP00007 repurposed \$171,000 for completion of Task 1 on the modification/rehabilitation of the Matheson Preserve project (Project 176). The work prescribed work included installation of a gate and fish screens with the goal of managing wetlands in the preserve to benefit the razorback sucker. Gate and screens were installed as planned in FY 2019.

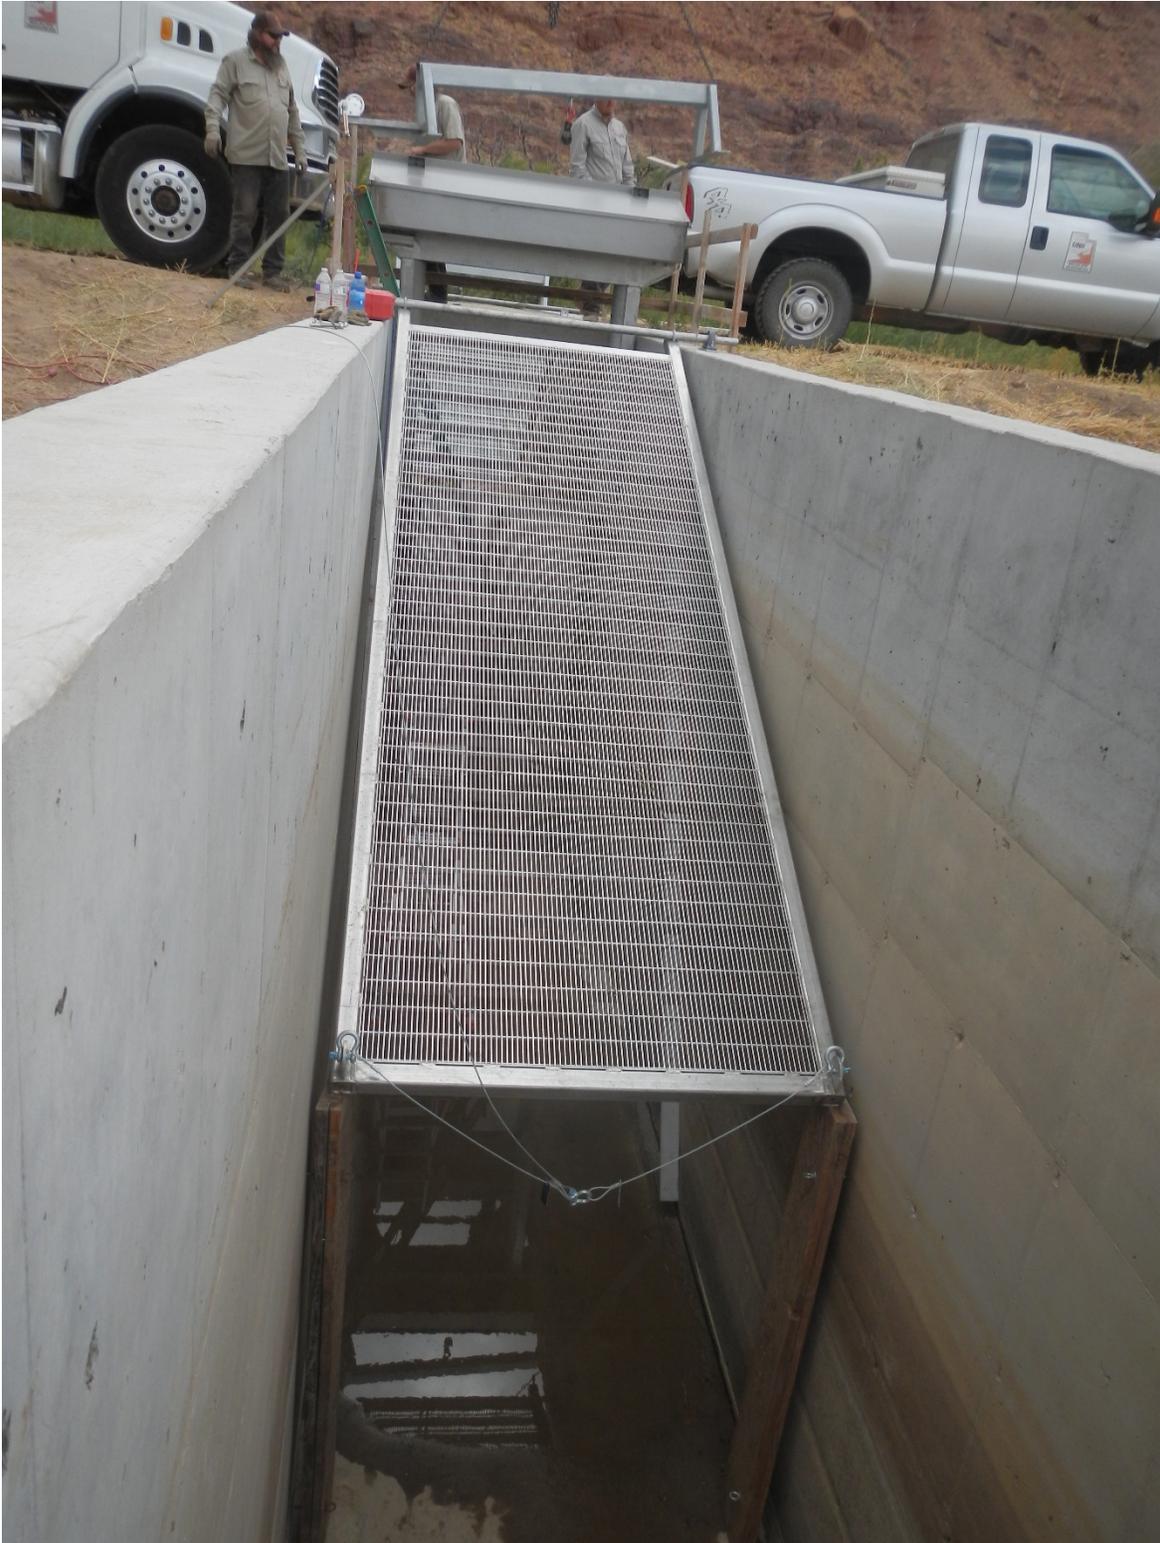
Photo 1. One of two opposing fish screens at the Matheson Preserve wetland water control structure.

- *Dual fish screens* (in and out) with ½-inch openings to exclude large bodied non-native fishes while allowing passage of fish larvae (Photo 2).

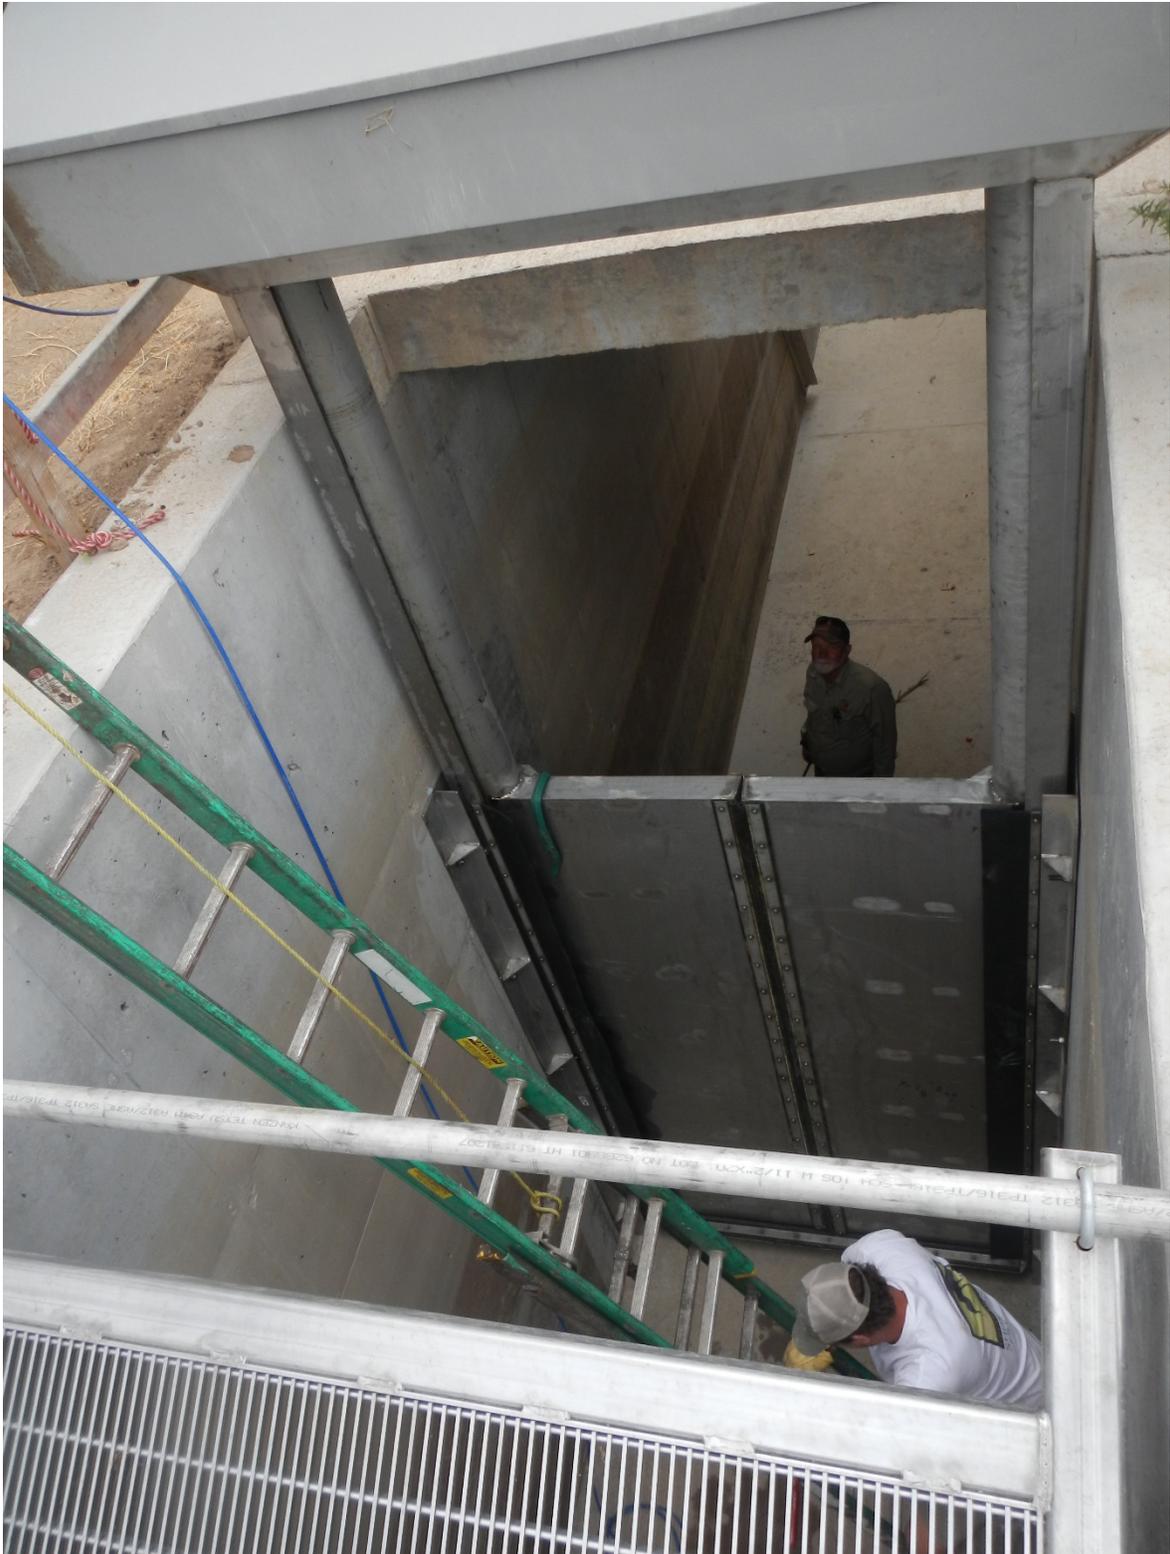
Photo 2. Installation of LOPAC vertical leaf gate in Matheson Preserve wetland water control structure.

- *Vertical leaf gate* to manage flooding, water storage and draining (Photo 1).

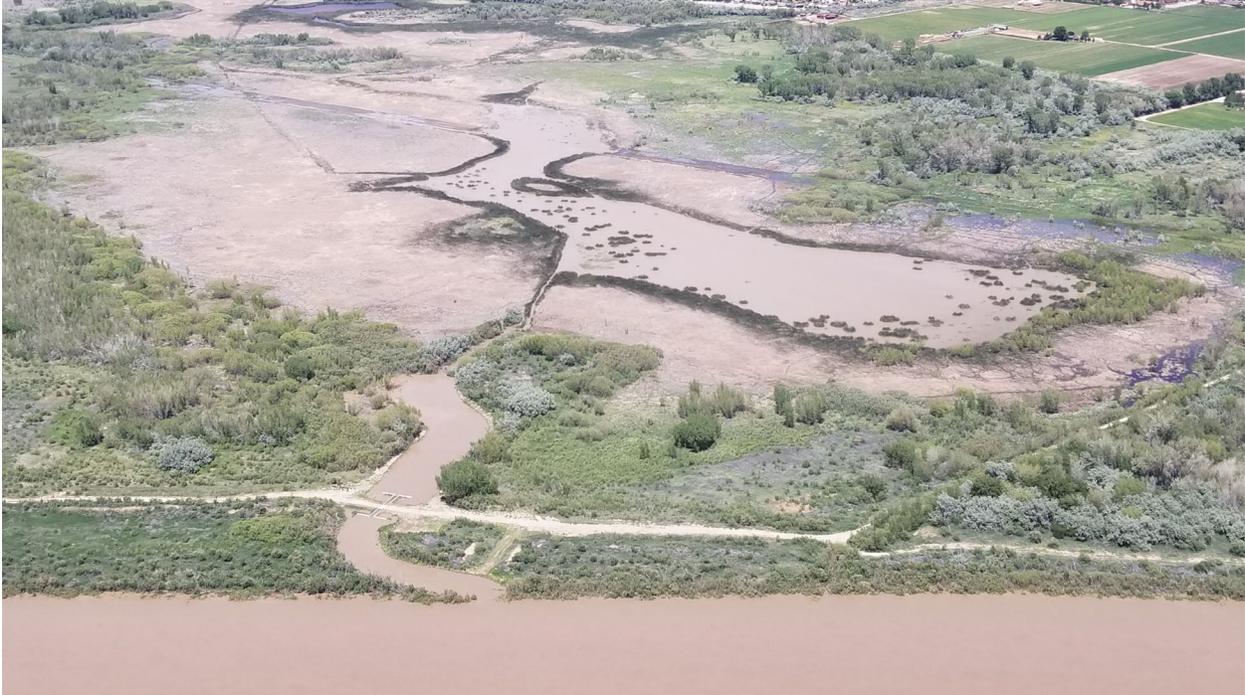
Early June 2019: Debris carried by peak flows destroys improvised fish screen. Large bodied nonnative fish (common carp *Cyprinus carpio*) enter wetland. River elevation nears bank-full height at Preserve (Photo 3).

Photo 3. Central Pond of the Matheson Wetland Preserve at near maximum functional capacity (i.e. below elevation river elevation at which over-bank flow occurs), 12 June 2019, approximately 33,000 cfs at USGS Potash gage. Inlet channel, control structure and excavated linear pond are visible in foreground on left. Extent of flooding can be seen as clear water around margins of Central Pond (right). Future work will extend linear pond further inland to connect with open water habitat of the Central Pond.

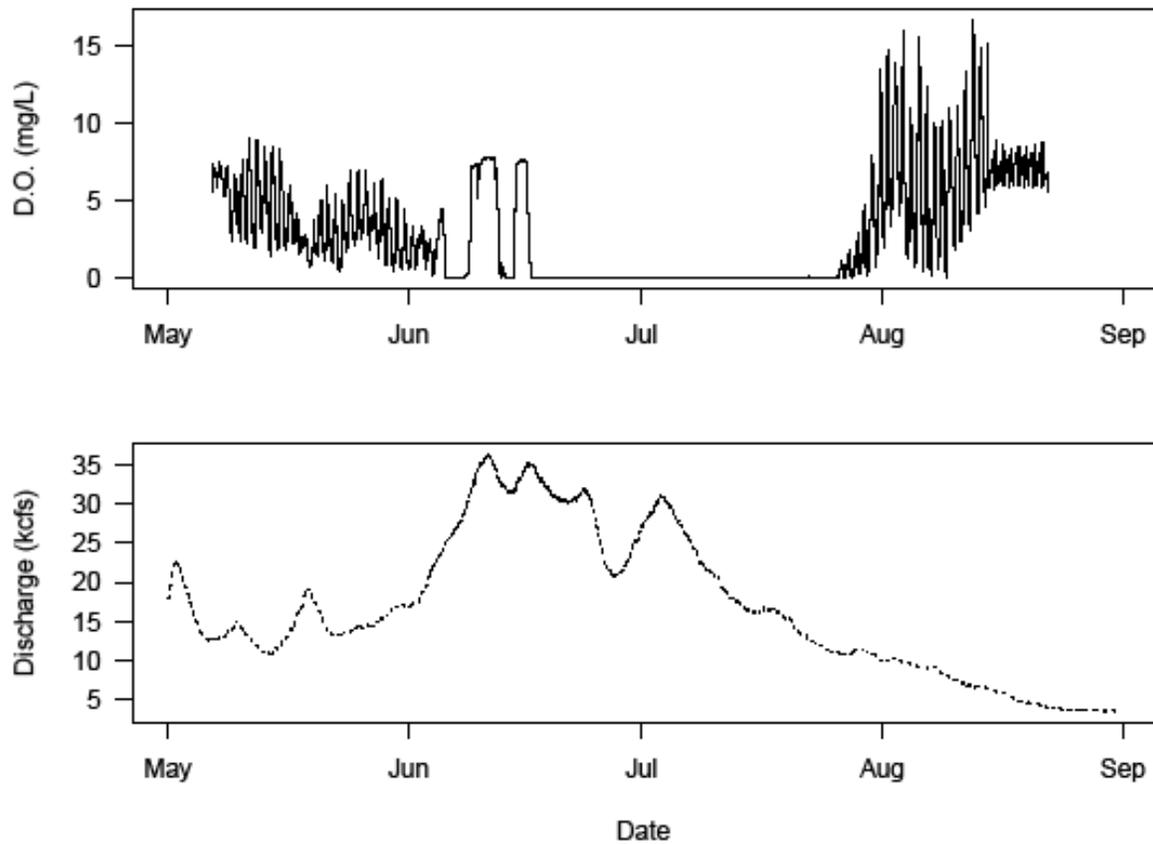
16 June 2019: Smell of decomposition and observed fish mortalities indicate anoxic conditions in wetland. Data from MiniDOT loggers deployed throughout runoff season confirm rapid decline in dissolved oxygen concentration (Figure 1). Decomposition of submerged terrestrial vegetation is suspected to have contributed to anoxia in the wetland. This has been observed at other wetland sites in their first year of operation (Jones et al. 2017).

Figure 1. Dissolved oxygen concentration in the Matheson Preserve wetland (top) and Colorado River discharge (USGS Potash gage; bottom) during 2019 runoff. The decline in dissolved oxygen associated with peak discharge coincides with observed fish mortalities and may be the result of rapid decomposition of submerged terrestrial vegetation.
