- I. **Project Title: Operation, maintenance, and fish escapement evaluation of the Highline Lake spillway net (fish barrier); operation, maintenance, and fish escapement evaluation of the Elkhead Reservoir spillway net (fish barrier)**
- II. Bureau of Reclamation Agreement Number(s): No agreement currently in place. Previous agreement number was R12AP40001

Project/Grant Period: Start date: NA  
End date: NA  
Reporting period end date: December 31, 2018  
Is this the final report? The study is ongoing.

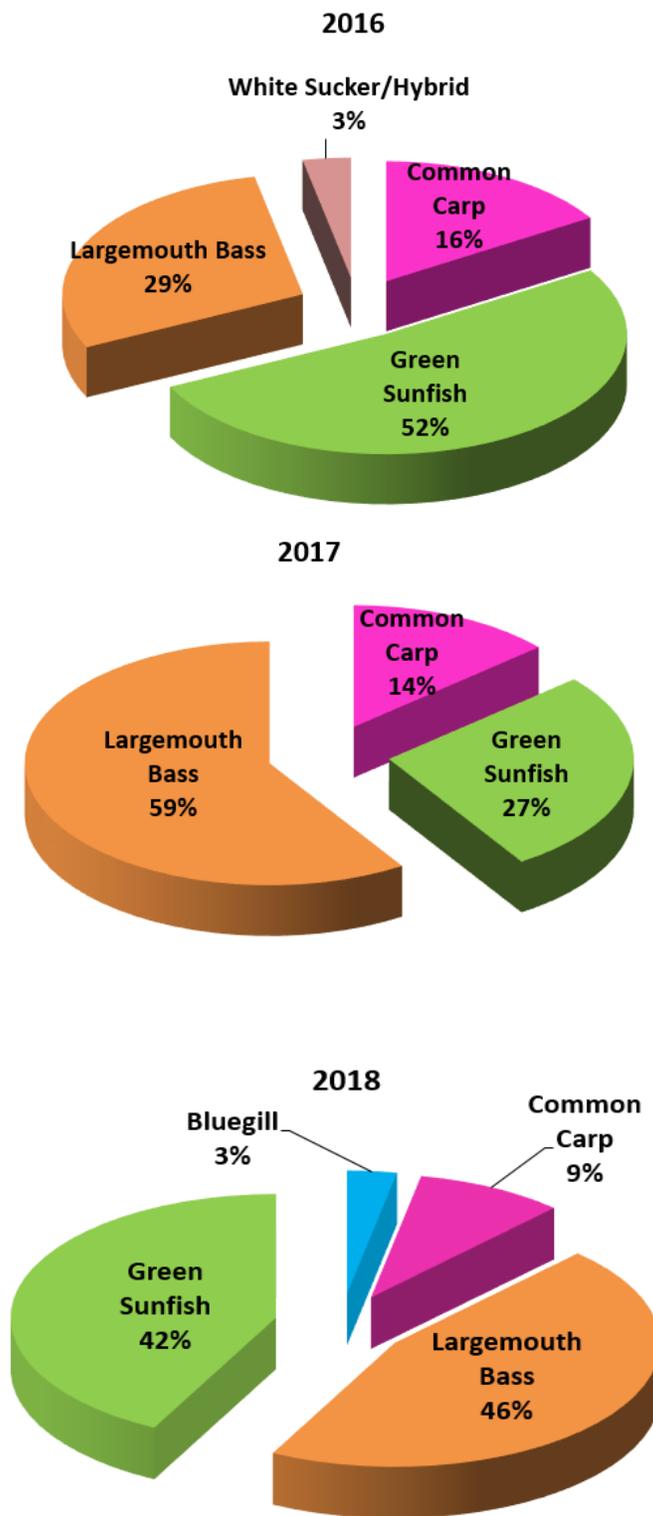
**Figure 2.** Species composition of fish surveyed in Mack Wash at Site #1 (immediately downstream of Highline Lake spillway) in 2016, 2017, and 2018.

The 2018 sample at Site #1 on Mack Wash consisted of bluegill, common carp, largemouth bass, and green sunfish (Table 3, Figure 2). The 2018 sample at Site #2 on Mack Wash consisted of red shiner, white sucker / hybrid sucker, speckled dace, bluehead sucker, flannelmouth sucker, green sunfish, fathead minnow, and largemouth bass (Table 3, Figure 3). Despite their continued presence between the spillway net and the spillway, no gizzard shad were surveyed in Mack Wash at either site. Multiple age-classes of green sunfish and largemouth bass were found in Mack Wash at Site #1. Size structure of green sunfish surveyed was similar to past years. Historically, the largemouth bass surveyed at Site #1 consisted of juveniles and small adults. However, the 2018 survey yielded five largemouth bass that were larger than those individuals observed the last 2 years; the total length of these fish were: 222 mm, 225 mm, 241 mm, 322 mm, and 382 mm. It is possible that these larger fish were present immediately downstream of the spillway due to the canal surges that had occurred approximately five weeks prior to the Mack Wash survey. Minimal increases were seen in electrofishing catch per unit effort in green sunfish and largemouth bass at Site #1, and these catch rates were still much lower than those observed in 2011 and 2012 when the canal surges had compromised the spillway net. At Site #2, species-specific catch per unit effort data indicated that catch rates were slightly higher in green sunfish in 2018 compared to 2017, while catch rates for largemouth bass were slightly lower. Species-specific population size structures and relative abundance of species at Site #2 were similar to data gathered in recent years. These 2018 data do not show any substantial increases in the number of non-native fish present in Mack Wash downstream of Highline Lake despite increases in non-native fish abundance behind the spillway net, and the canal surge in the fall of 2018 which likely reduced the effectiveness of the spillway net. These data suggest that the

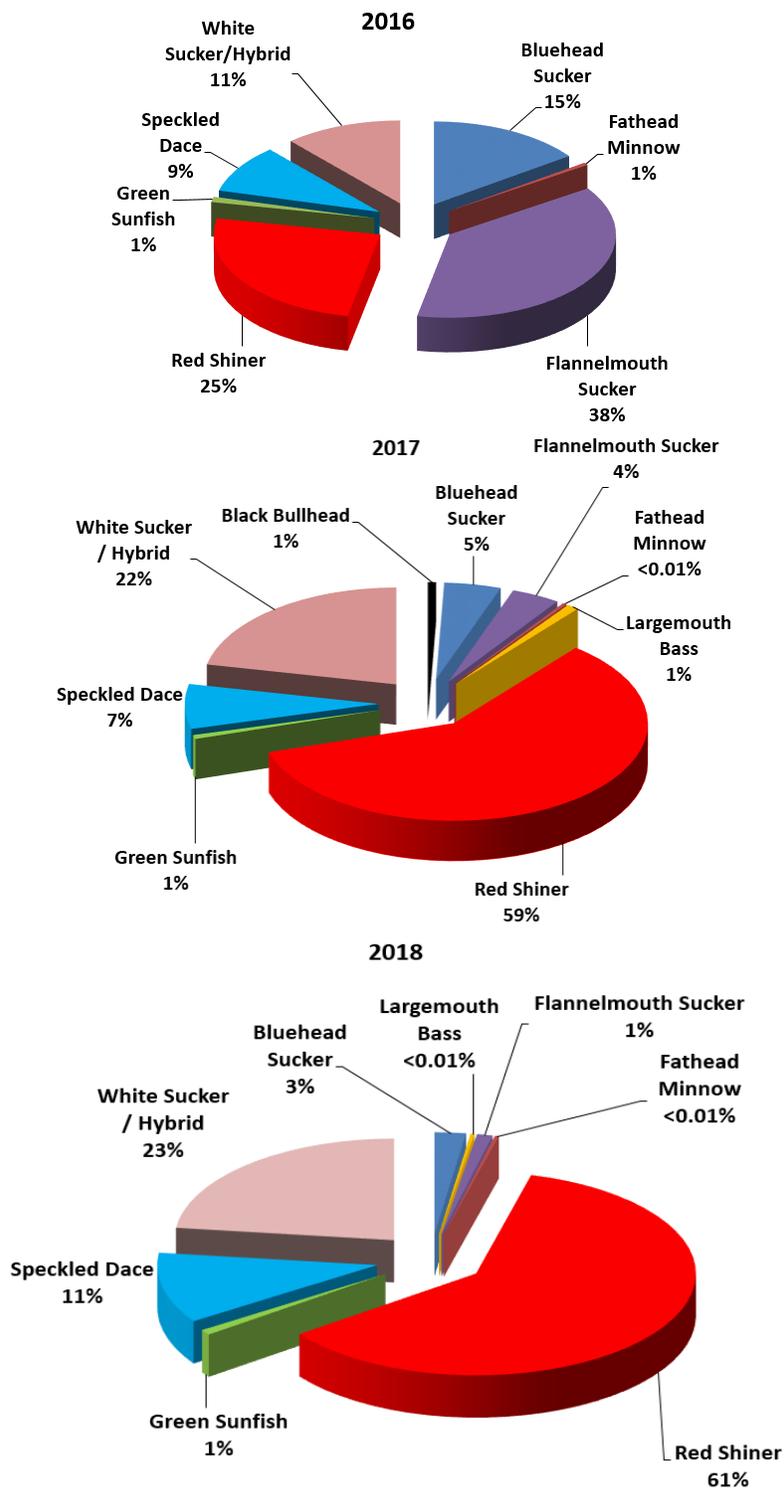
**Figure 3.** Species composition of fish surveyed in Mack Wash at Site #2 (approximately 3 miles downstream of Highline Lake spillway) in 2016, 2017, and 2018.

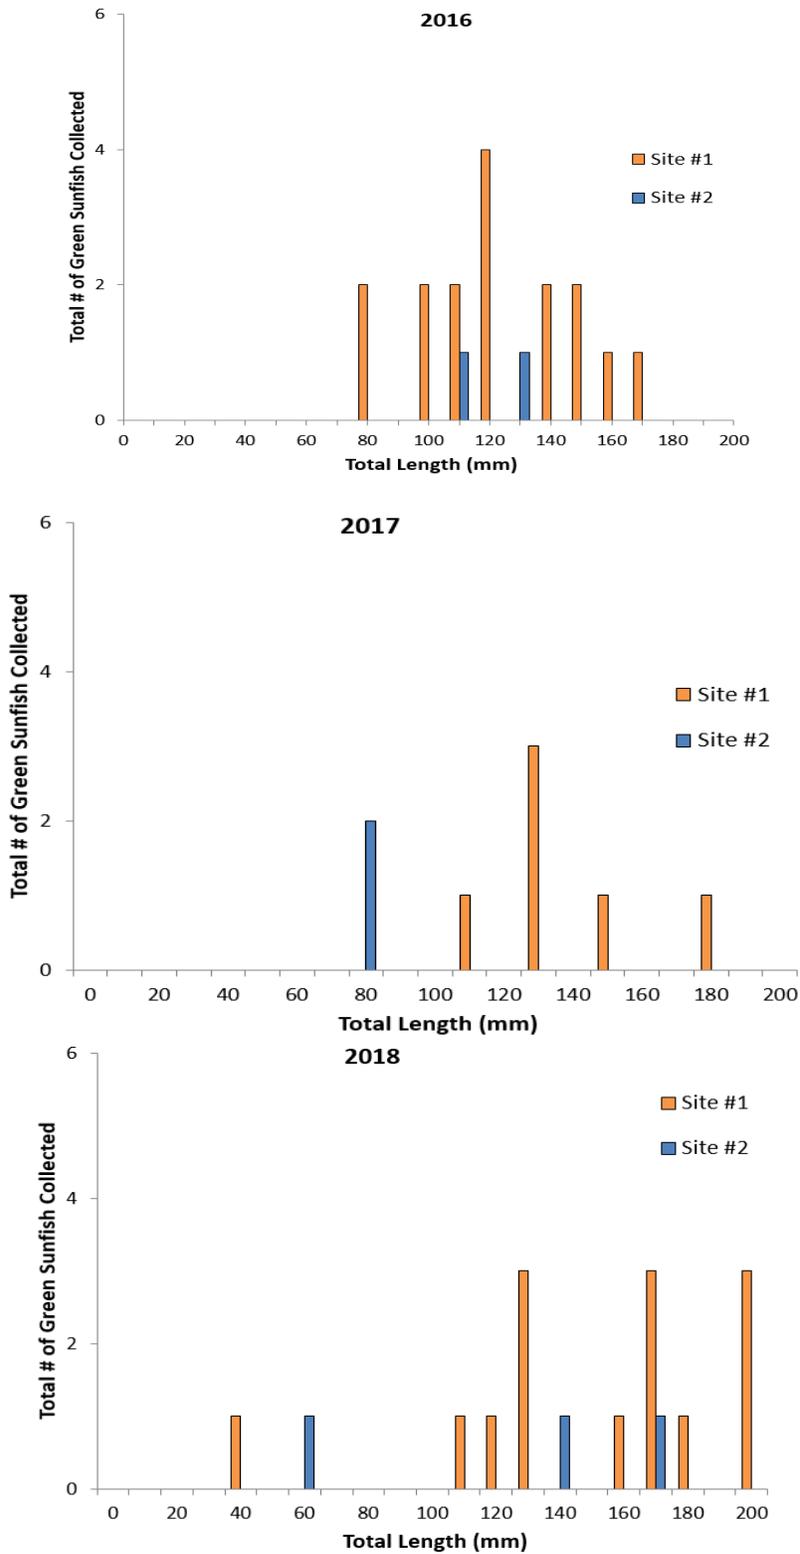
**Figure 4.** Length frequency histograms of green sunfish surveyed in Mack Wash at Site #1 and Site #2 in 2016, 2017, and 2018.

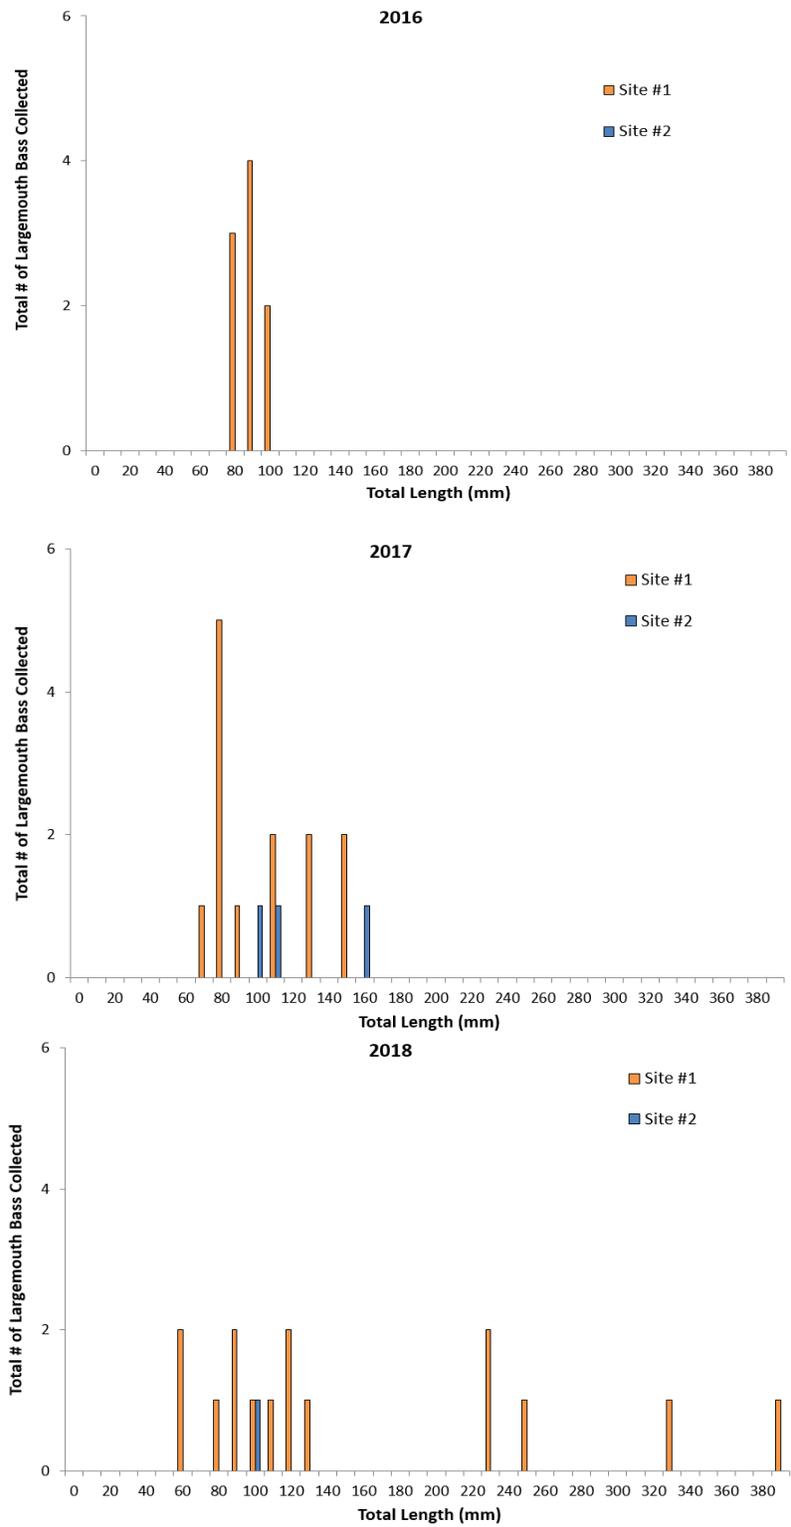
**Figure 5.** Length frequency histograms of largemouth bass surveyed in Mack Wash at Site #1 and Site #2 in 2016, 2017, and 2018.

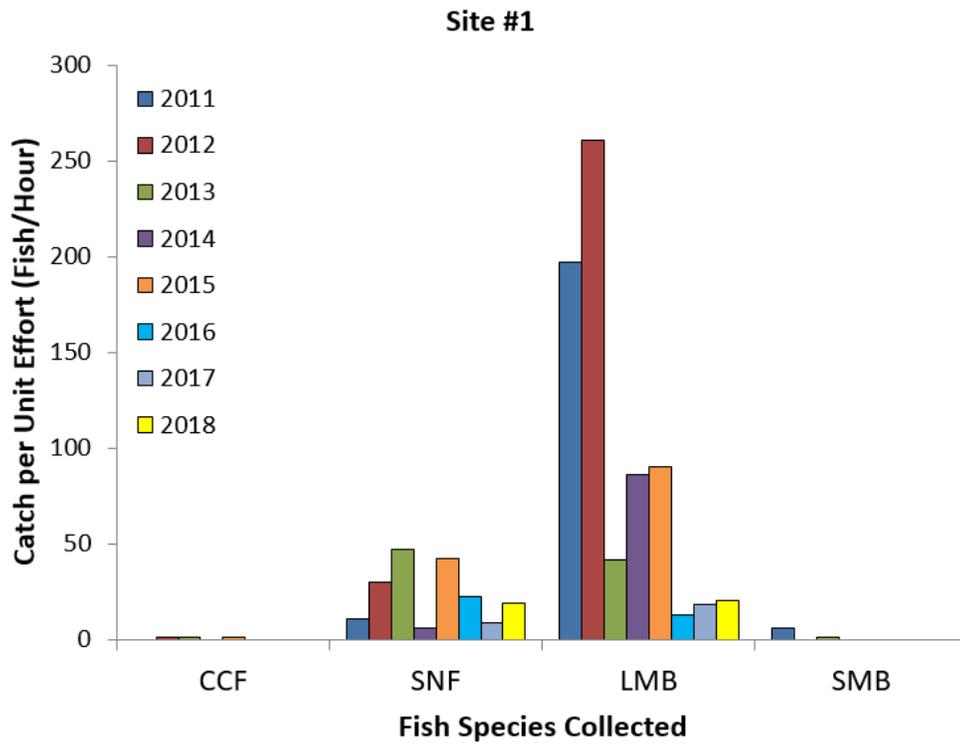
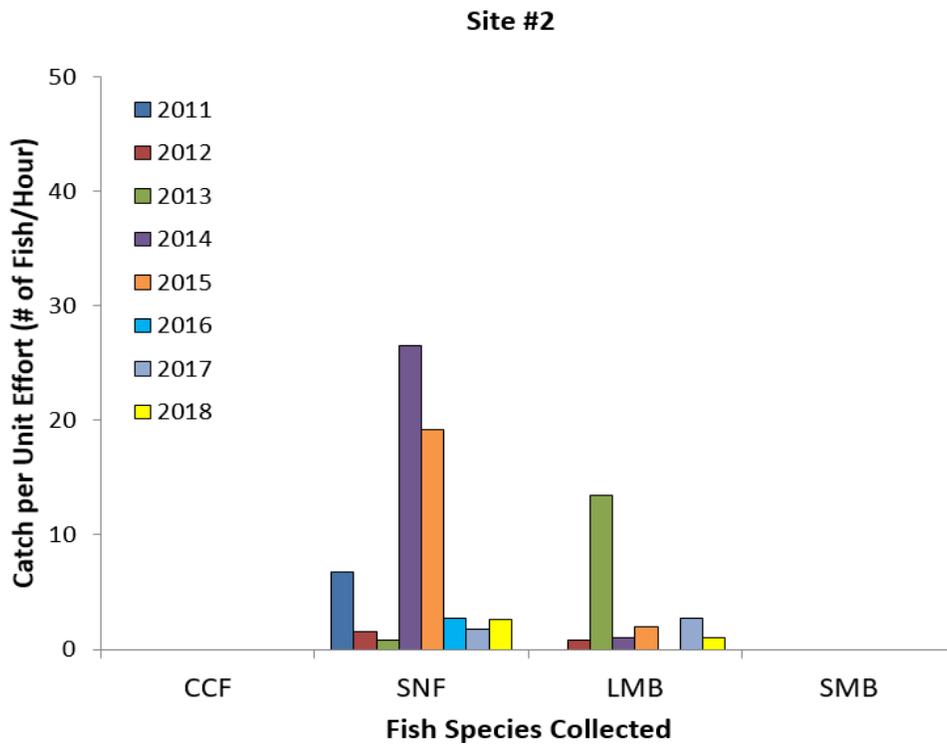
**Figure 6.** Historical (2011-2018) catch per unit effort of channel catfish (CCF), green sunfish (SNF), largemouth bass (LMB), and smallmouth bass (SMB) in Mack Wash at Site #1 and Site #2.

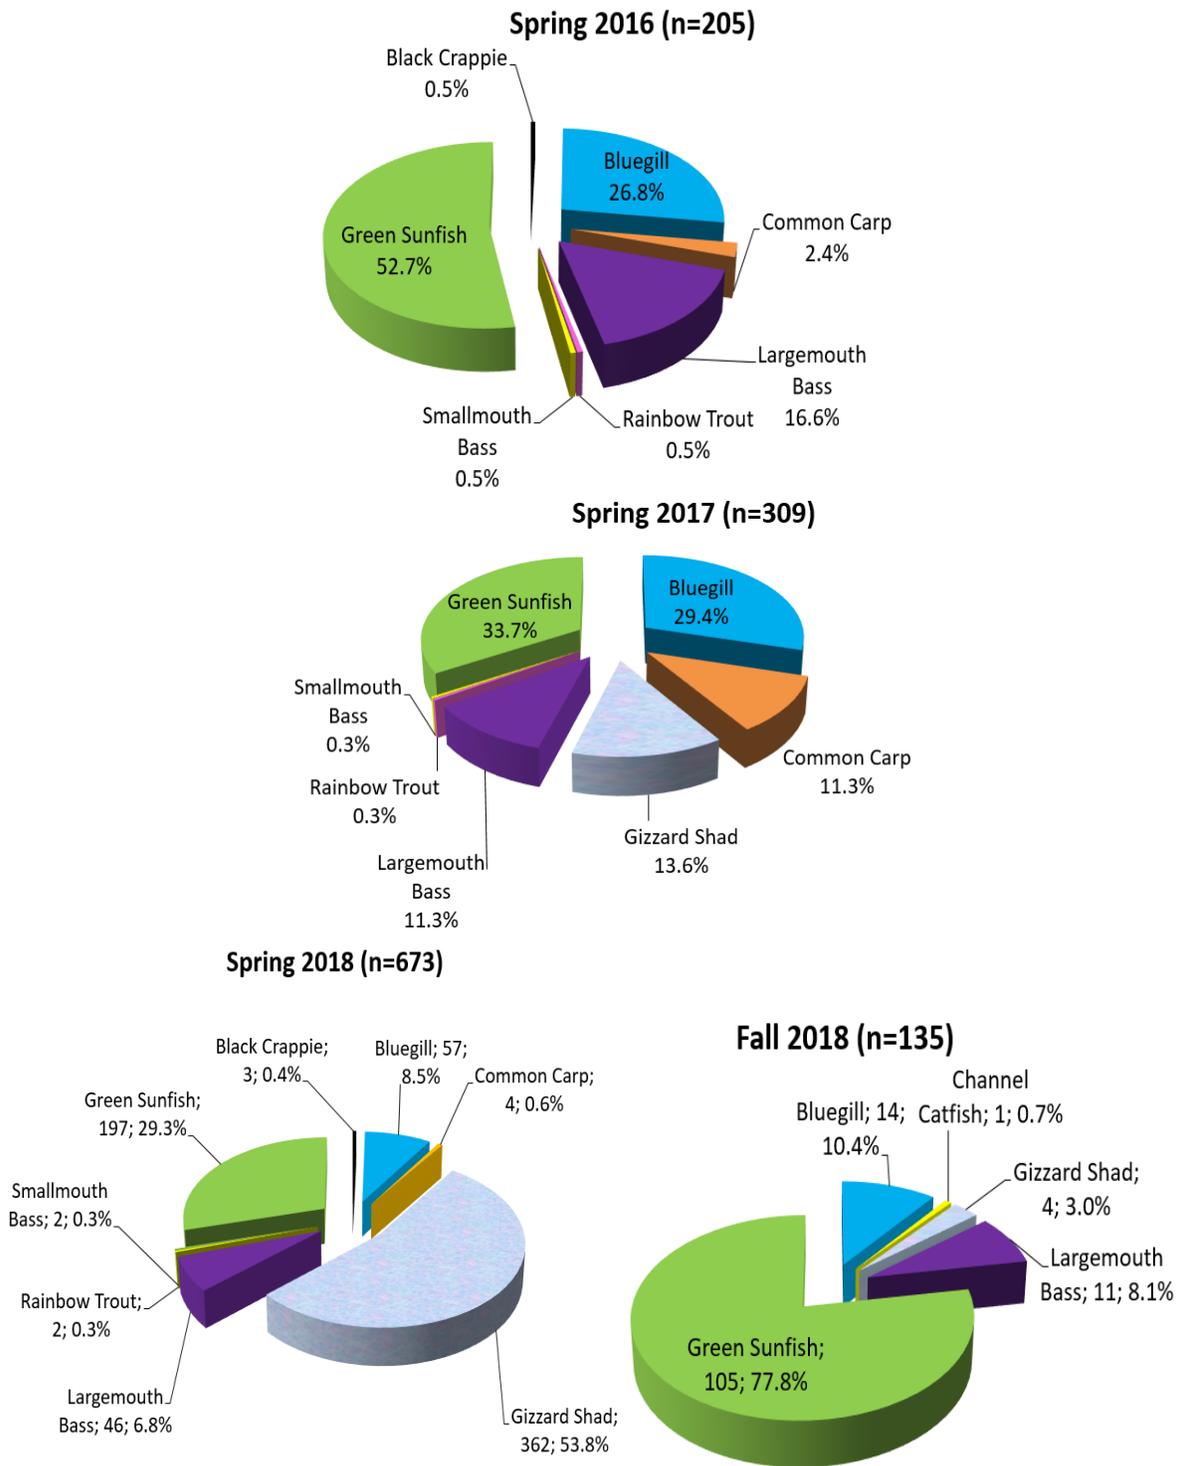
**Figure 7.** Species composition of Highline Lake survey between the spillway net and the spillway from 2016-2018. Charts include fish captured using both gill nets and electrofishing. No gill netting was conducted during the Fall 2018 survey.

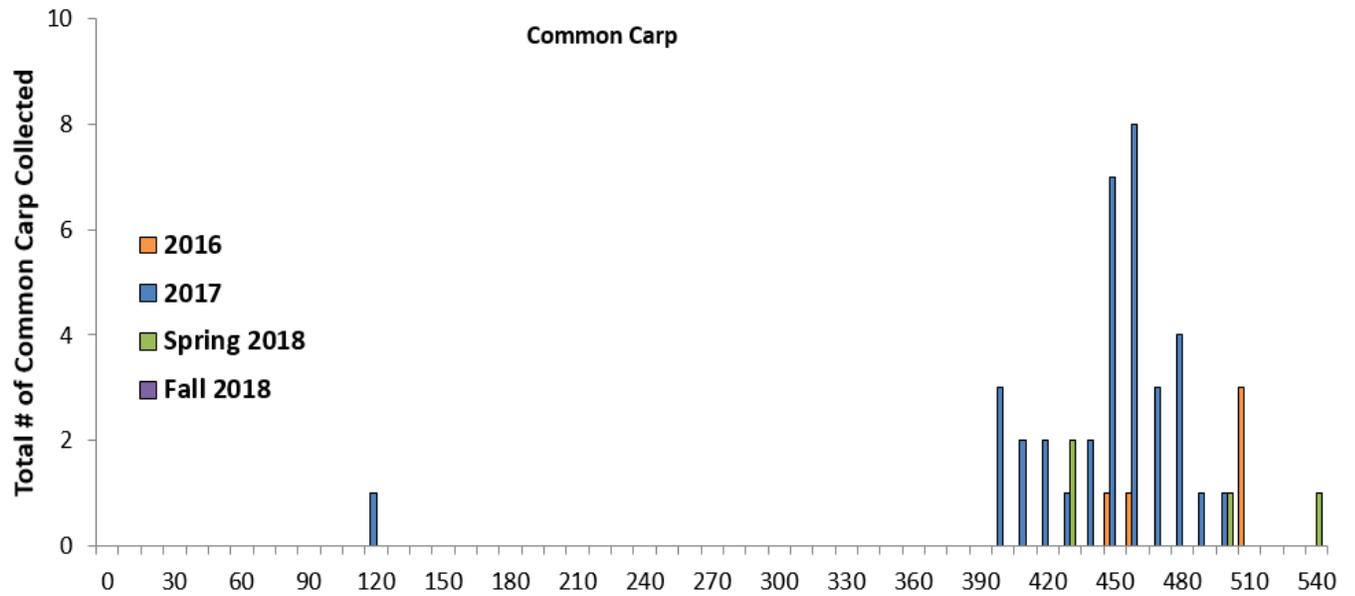
**Figure 8.** Length frequency histogram of common carp surveyed in Highline Lake between the spillway net and the spillway in 2016-2018. Includes fish captured using both gill nets and electrofishing. No gill netting was conducted during the Fall 2018 survey.

A total of 673 fish, including 362 gizzard shad, were surveyed utilizing gill nets and electrofishing in Highline Lake during the pre-irrigation survey in 2018. This represents the largest number of gizzard shad surveyed between the spillway net and the spillway that CPW has seen during these annual surveys. Other species surveyed in the spring sampling event included bluegill, black crappie, common carp, largemouth bass, rainbow trout, smallmouth bass, and green sunfish (Table 3, Figure 7). Multiple age-classes, including adult-sized fish, were observed for common carp, green sunfish, largemouth bass, gizzard shad, and bluegill surveyed behind the spillway net during the pre-irrigation season survey (Figures 8-12).

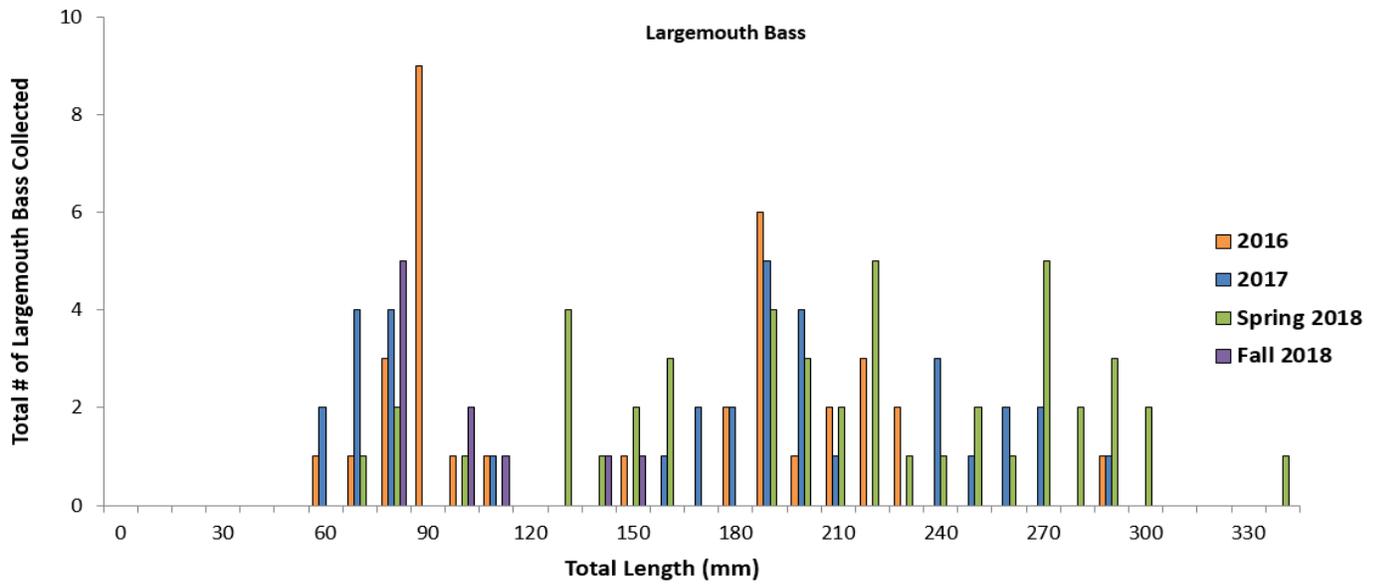
**Figure 9.** Length frequency histogram of largemouth bass surveyed in Highline Lake between the spillway net and the spillway in 2016 and 2017. Includes fish captured using both gill nets and electrofishing. No gill netting was conducted during the Fall 2018 survey.

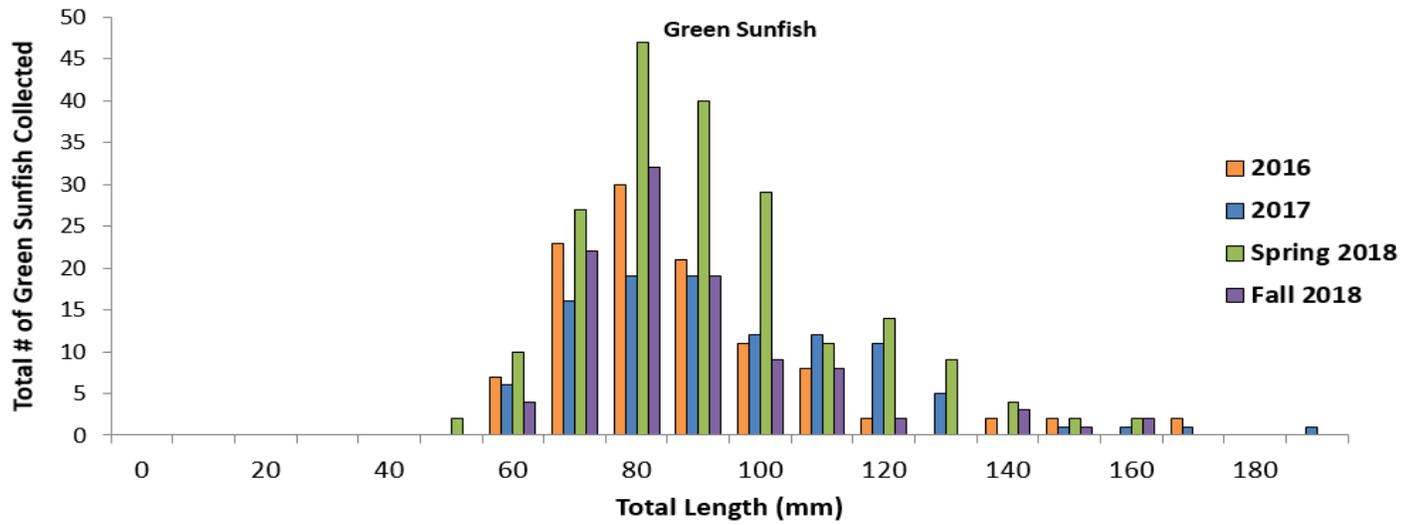
**Figure 10.** Length frequency histogram of green sunfish surveyed in Highline Lake between the spillway net and the spillway in 2016-2018. Includes fish captured using both gill nets and electrofishing. No gill netting was conducted during the Fall 2018 survey.

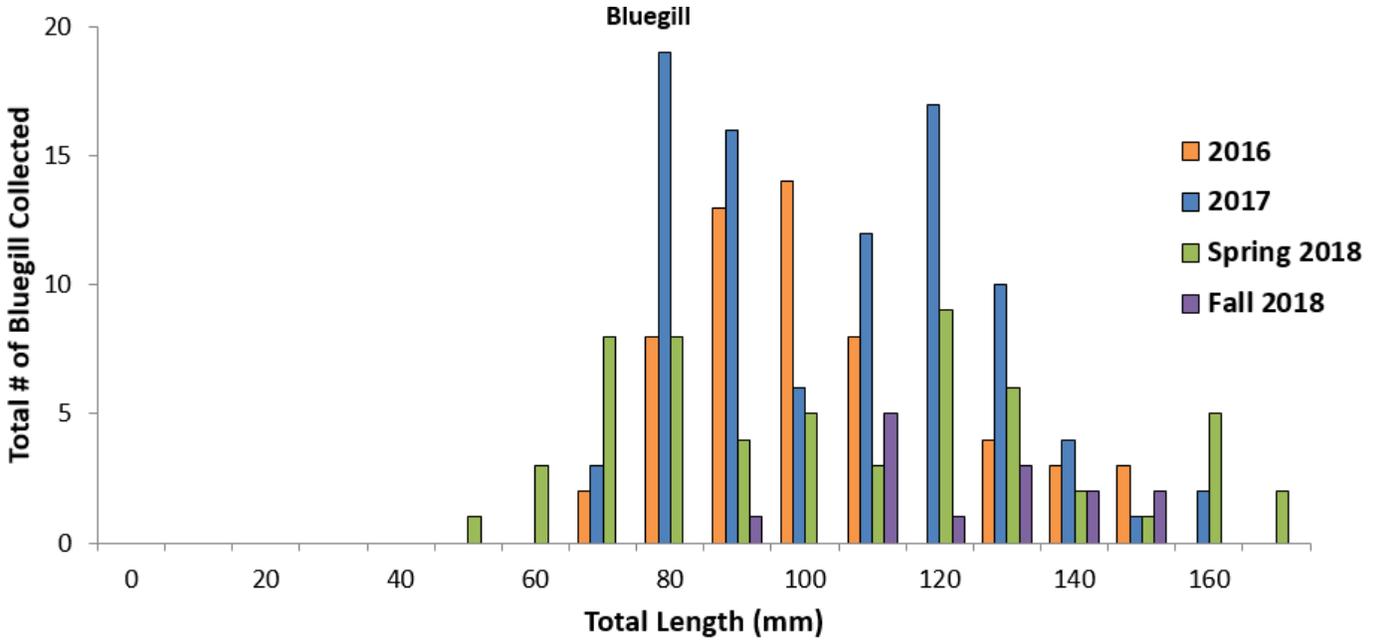
**Figure 11.** Length frequency histogram of bluegill surveyed in Highline Lake between the spillway net and the spillway in 2016-2018. Includes fish captured using both gill nets and electrofishing. No gill netting was conducted during the Fall 2018 survey.

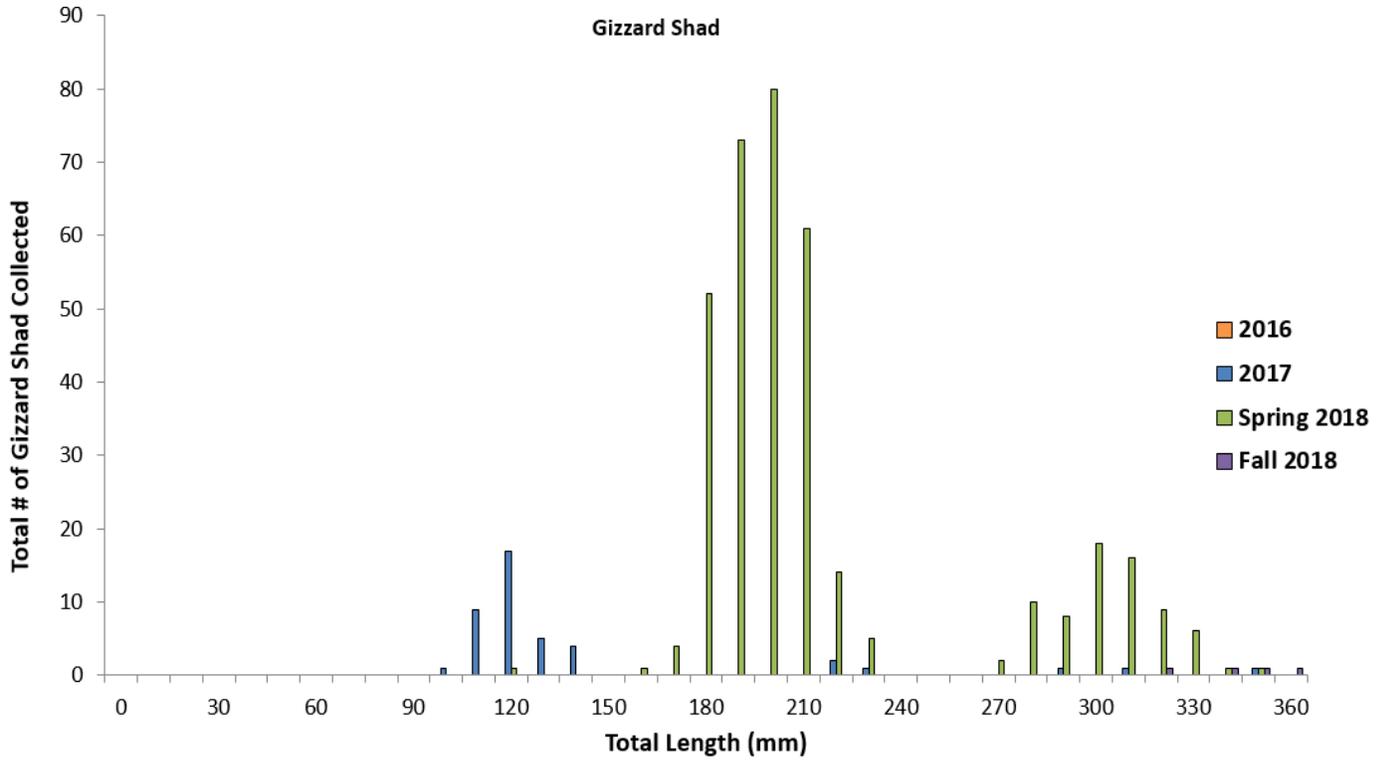
**Figure 12.** Length frequency histogram of gizzard shad surveyed in Highline Lake between the spillway net and the spillway in 2016-2018. No gizzard shad were surveyed in 2016. Includes fish captured using both gill nets and electrofishing. No gill netting was conducted during the Fall 2018 survey.

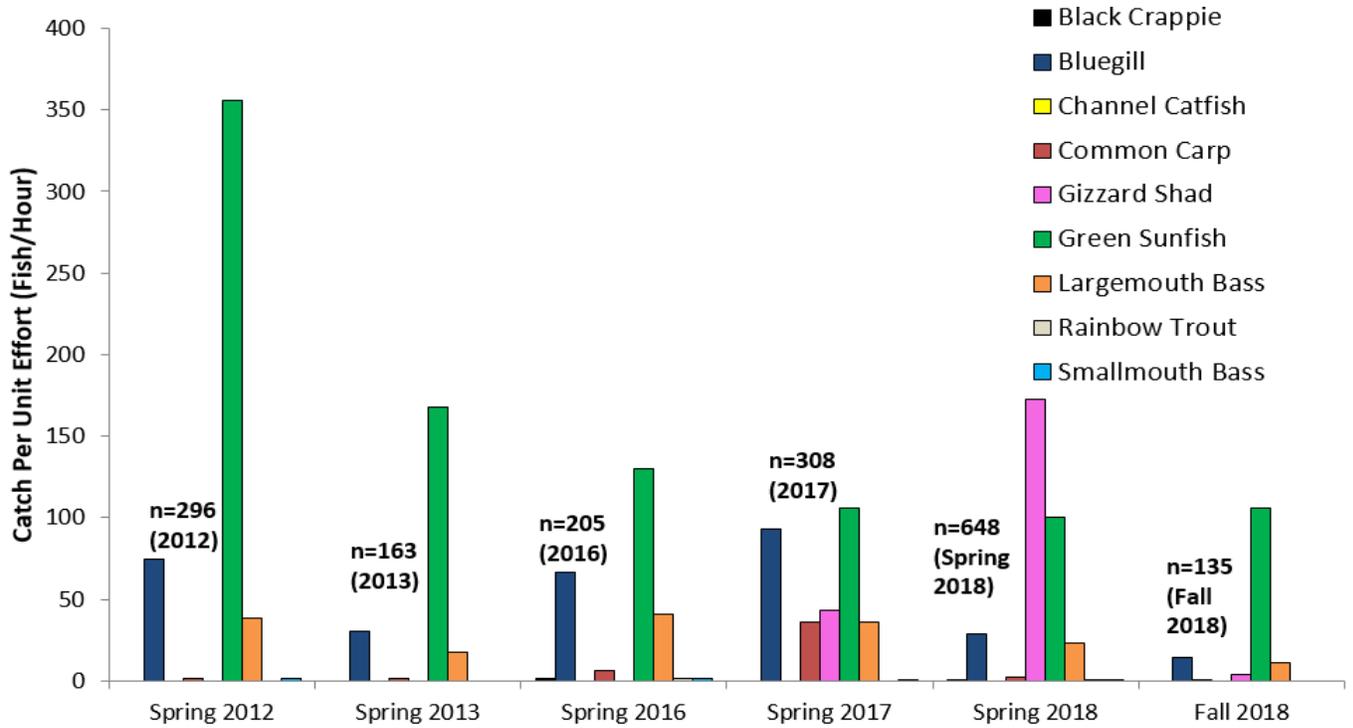
**Figure 13.** Historical electrofishing catch per unit effort (in number of fish captured per hour) of black crappie, bluegill, channel catfish, common carp, largemouth bass, rainbow trout, smallmouth bass, and green sunfish in Highline Lake between the spillway net and the spillway.

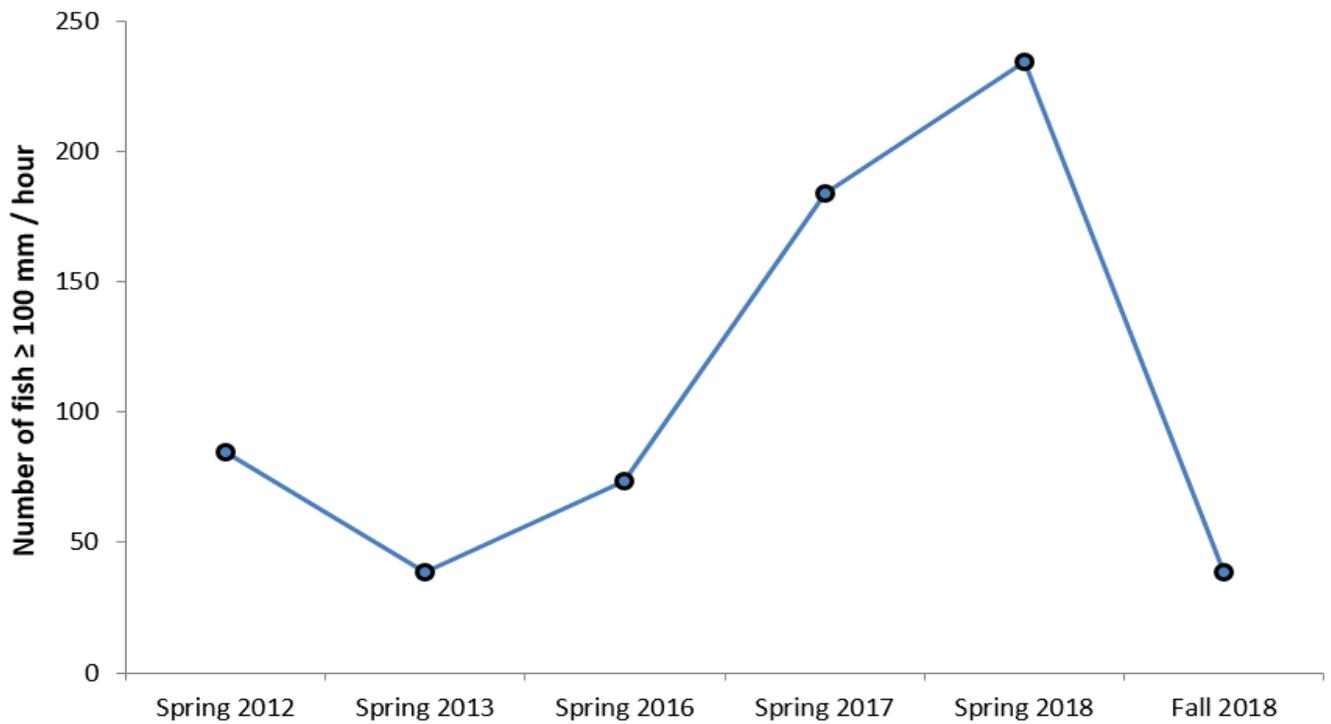
**Figure 14.** Historical electrofishing catch per unit effort (in number of fish captured per hour) of individuals  $\geq 100$  mm of all fish species combined (i.e. black crappie, bluegill, channel catfish, common carp, largemouth bass, rainbow trout, smallmouth bass, and green sunfish) in Highline Lake between the spillway net and the spillway.

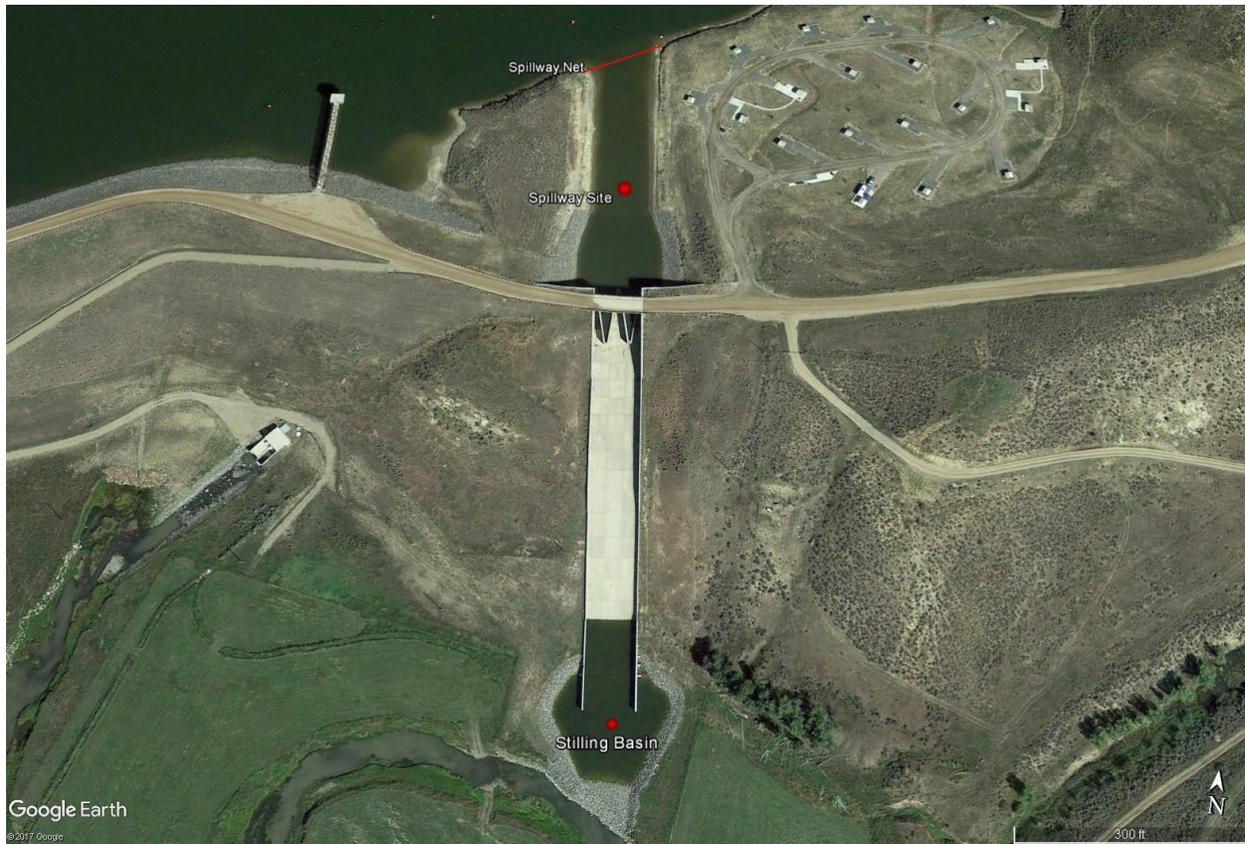
**Figure 15.** Satellite image of the Elkhead Reservoir spillway, fish sampling locations, and approximate location of the spillway net. Image courtesy of Google Earth.

In 2018, CPW biologists completed fish surveys within Elkhead Reservoir, between the spillway net and the spillway, as well as in the stilling basin downstream of the spillway (Figure 14). The objectives of the fish surveys were to determine fish species composition and relative abundance within the reservoir between the spillway net and the spillway, and also downstream of the Elkhead Reservoir spillway net. Experimental gill nets were set before and after water was released over the spillway. Two to three, 150' experimental gill nets were set at the "spillway site," which included the area between the spillway net and spillway (Figure 14). Additionally, CPW surveyed the stilling basin using one, 150' experimental gill net that spanned from one side of the stilling basin pool to the other. Experimental gill nets were set overnight and checked the following day.

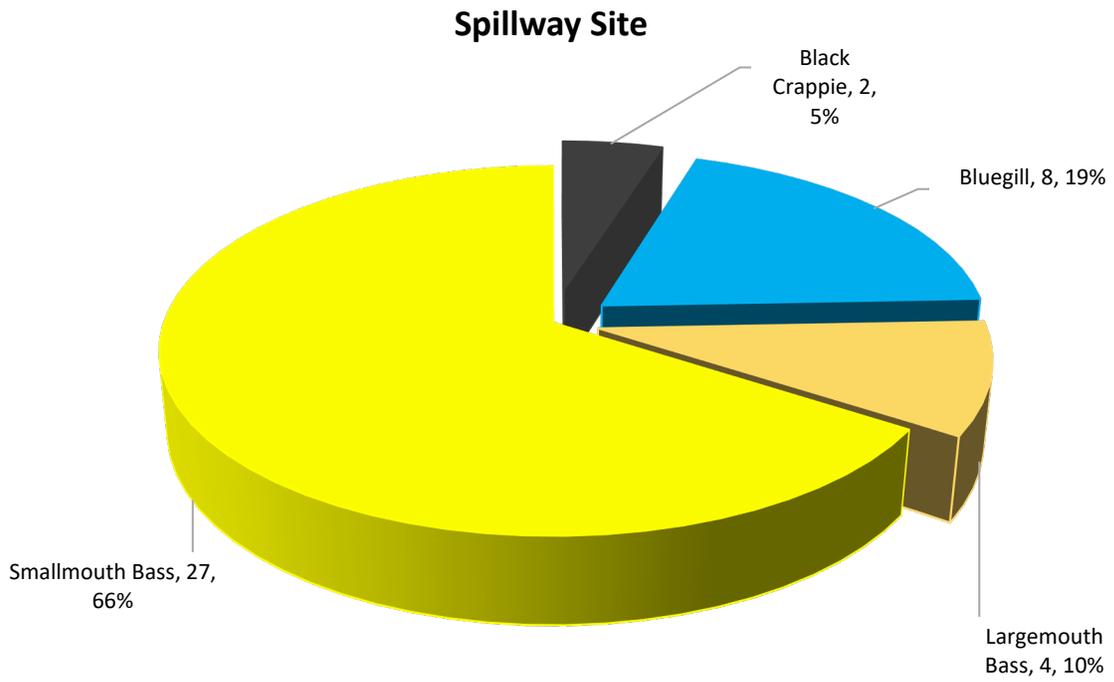
**Figure 16.** Species composition of fish sampled at the spillway site of Elkhead Reservoir in 2018.

Species composition at both the spillway site and within the stilling basin was dominated by smallmouth bass (Figures 6 and 7). It is unclear whether fish found in the stilling basin are fish that escaped over the spillway or fish that swam from Elkhead Creek into the stilling basin when the creek periodically connects with the stilling basin. Additionally, all of the smallmouth bass captured in the stilling basin in 2018 were adults (> 300 mm total length), which could have originated downstream of the spillway. It is also possible that some fish did leave the reservoir after passing over the spillway net when the spillway net was compromised in April 2018.

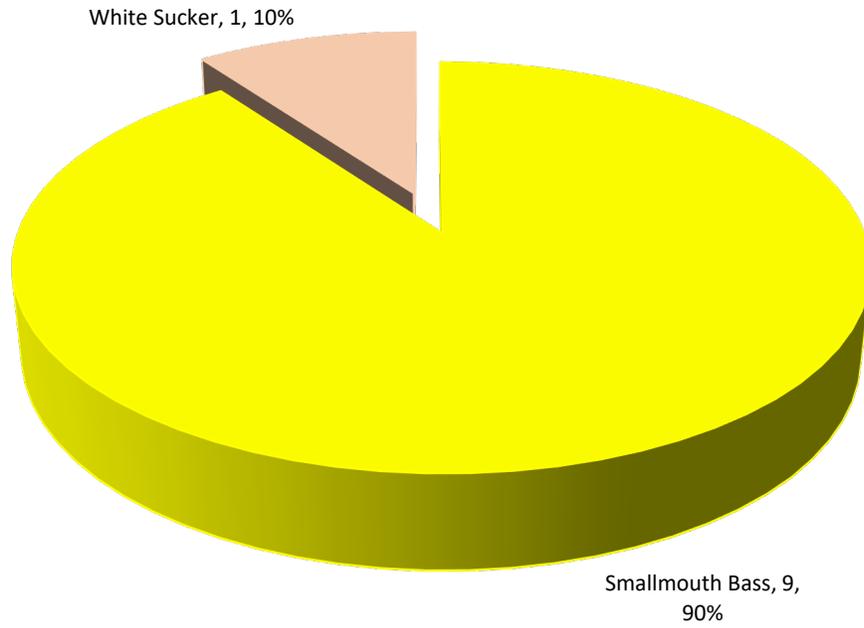
**Figure 17.** Species composition of fish sampled in the stilling basin below Elkhead Reservoir in 2018.
