**MINIMUM FLOW RECOMMENDATION FOR PASSAGE OF
COLORADO SQUAWFISH AND RAZORBACK SUCKER
IN THE 2.3-MILE REACH OF THE LOWER GUNNISON RIVER:
REDLANDS DIVERSION DAM TO THE
COLORADO RIVER CONFLUENCE**

Recovery Program Project Number 57

Final Report

**Bob D. Burdick
Fishery Biologist**

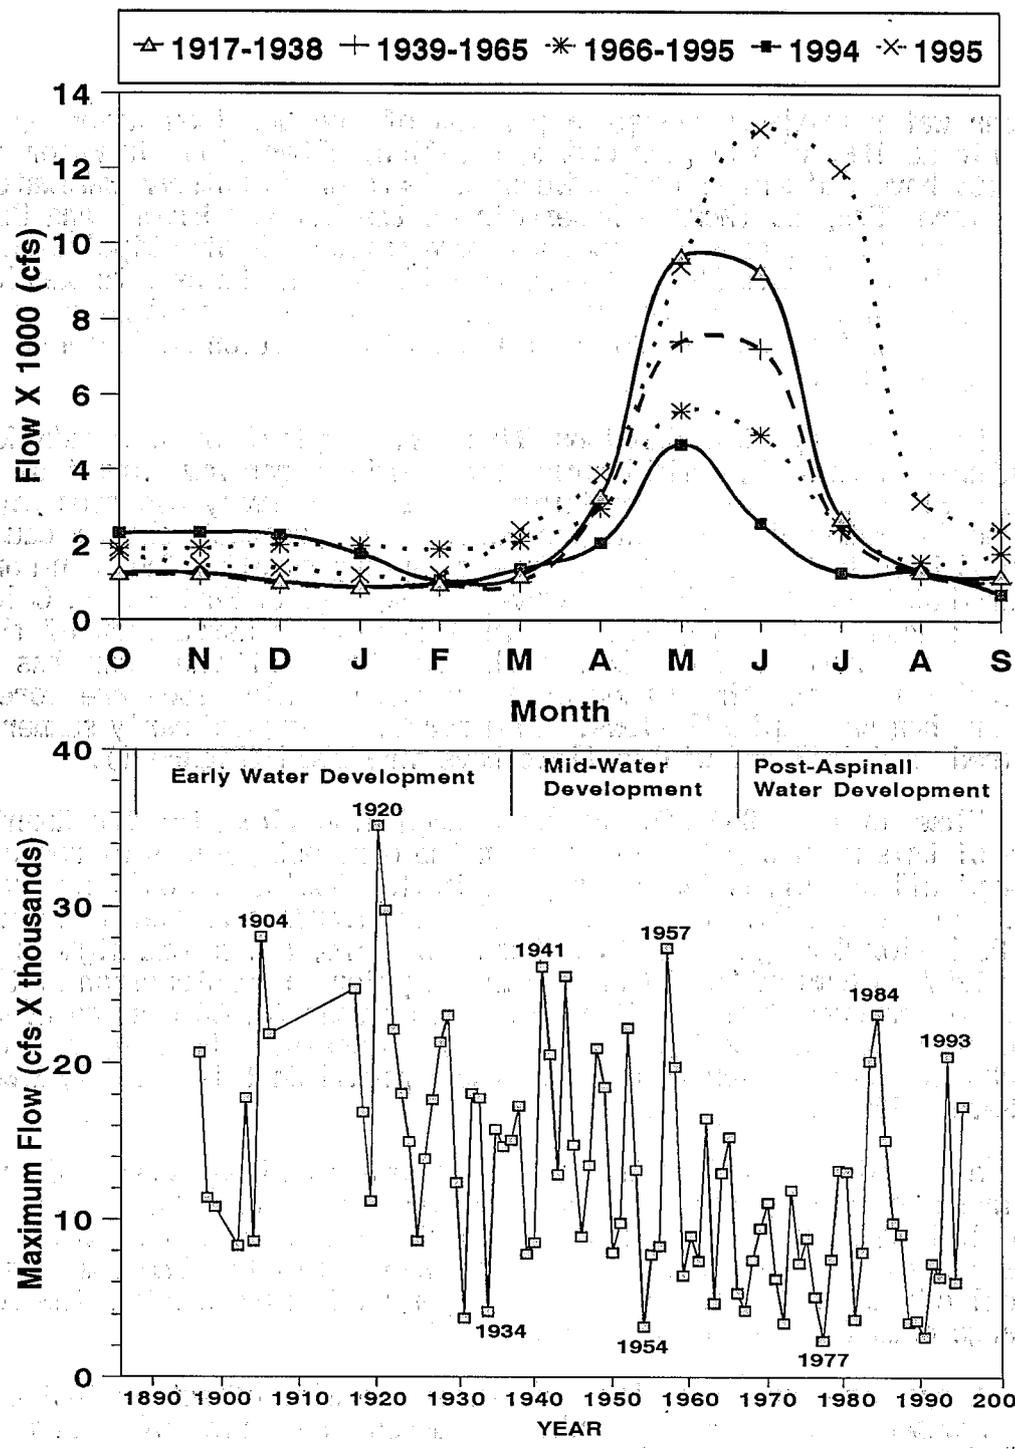
Figure 1. Mean monthly streamflow for the Gunnison River for three time periods: early development (1917-1938), middle development (1939-1965), and post-Aspinall development (1966-1995) and for two water years, 1994 and 1995, that this study was conducted (top), and the maximum daily streamflow for the period of record, 1897-1995 (bottom). Data were obtained from the Whitewater USGS gage near Grand Junction.

Historically, the Gunnison River was typical of Colorado River basin tributaries with high, turbid spring flows and clearer low flows from late summer through winter. However, the timing of water delivery has been significantly altered by water development projects. The greatest change caused by the Aspinall Unit is the reduced magnitude of spring runoff. The mean-monthly flows measured at the U. S. Geological Survey (USGS) gage at Whitewater, Colorado, have declined about 25% in May and 32% in June since construction of the Aspinall Unit. In contrast, flow during the remainder of the year has increased, particularly during the winter when average monthly flows are more than 100% greater than pre-Aspinall flows. In general, spring and early summer flows have declined, and fall and winter flows have increased (Figure 1).

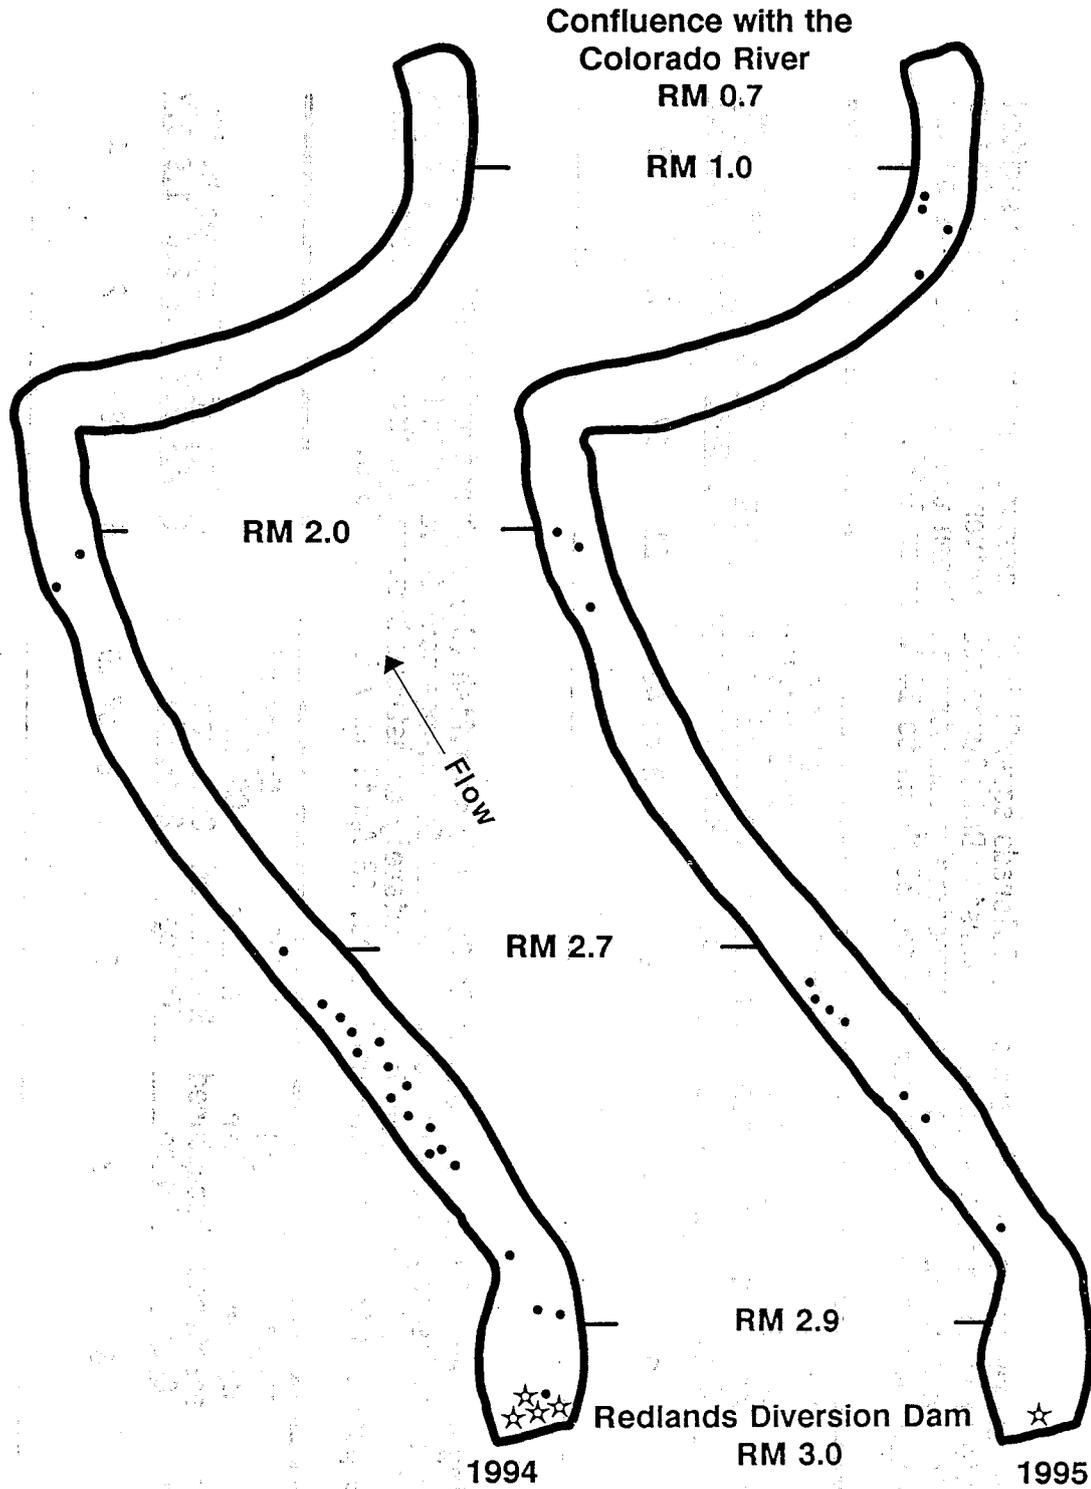
COLORADO SQUAWFISH CAPTURES IN THE 2.3-MILE REACH

Figure 2. Distribution of sub-adult and adult Colorado squawfish captures within the 2.3-mile reach of the lower Gunnison River, Colorado, 1994 and 1995. Each dot represents an individual fish; open stars represent 5 fish.

The plunge pool and a 0.2-mile section (RM 2.9-2.7) immediately downstream of the plunge pool were high-use areas for adult Colorado squawfish during both years. Twenty-one of the 40 Colorado squawfish in 1994 were captured in the plunge pool. In 1995, five of the 19 fish were captured in the plunge pool. Fifty-one of the 59 squawfish (86%) collected during the 2-year study were captured in the plunge pool or the 0.2-mile section immediately downstream (Tables 1 and 2; Figure 2). Between 6 and 22 July 1994, a total of 20 adult Colorado squawfish were found in this 0.3-mile area. At the same time, an aggregation of Colorado squawfish was observed in the Colorado River (RM 169). Although none of the fish handled in the Lower Gunnison River had expressible gametes, the high number of fish observed during this time suggest spawning or post-spawning activity.

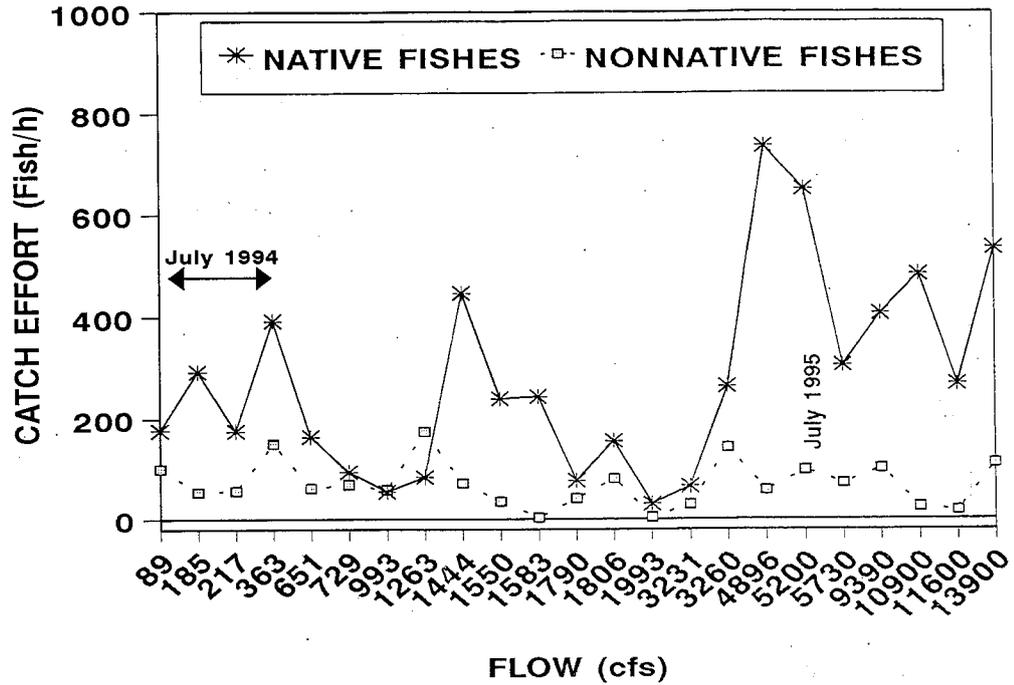
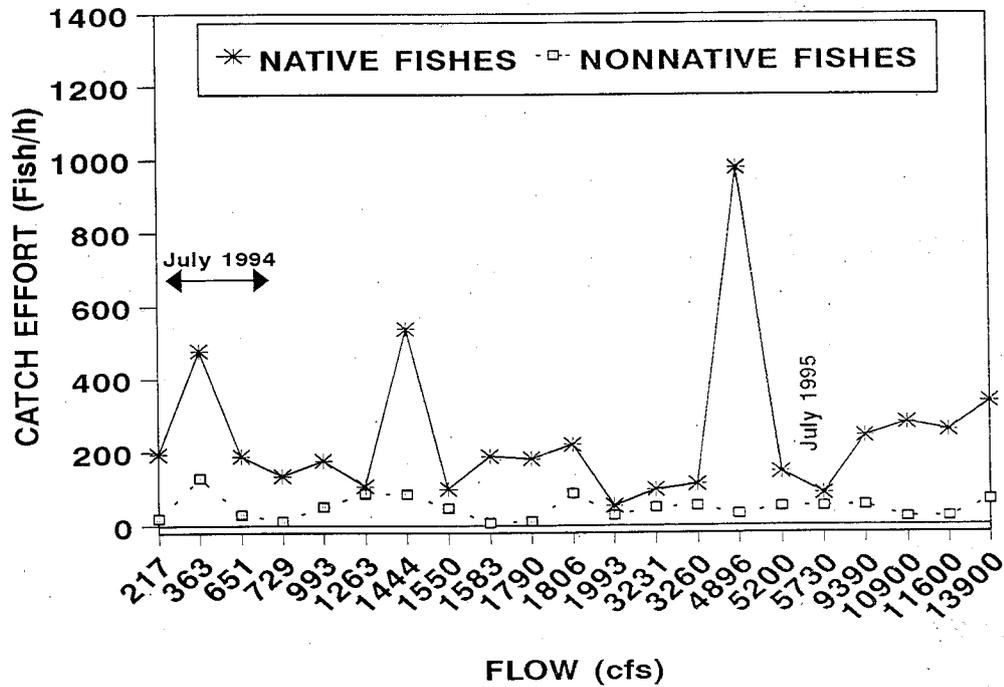
Figure 4. Combined catch per unit effort (Fish/h) versus flow (cfs) for four sub-adult and adult native fishes (BH, FM, RT, CS) and three sub-adult and adult nonnative fishes (CP, WS, CC) collected with electrofishing in the plunge pool and 2.2-mile reach of the Lower Gunnison River, 30 March 1994 to 7 November 1995. Note: refer to Appendix; Table A.1. for two-letter species code.

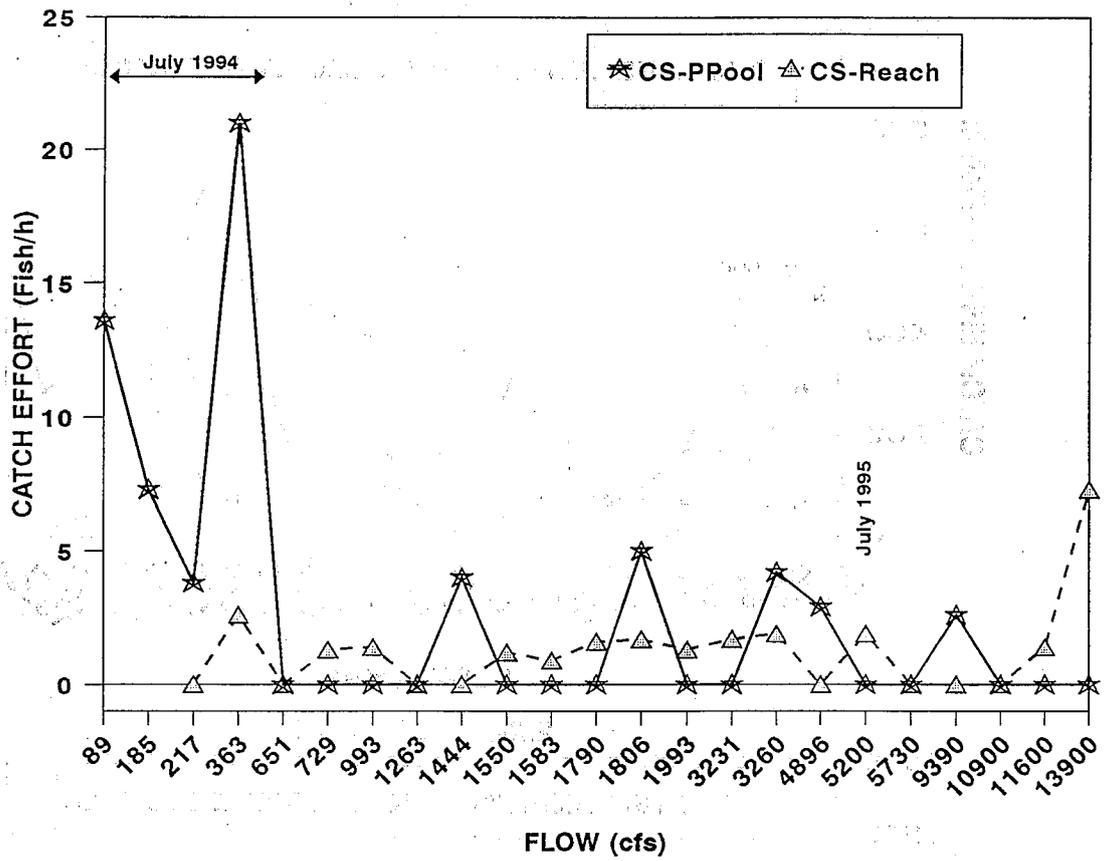
Figure 5. Comparison between total catch per unit effort (Fish/h) for sub-adult and adult Colorado squawfish collected by electrofishing in the plunge pool immediately downstream of the Redlands Diversion Dam and in the 2.2-mile reach of the Lower Gunnison River, Colorado, March 1994 to November 1995.

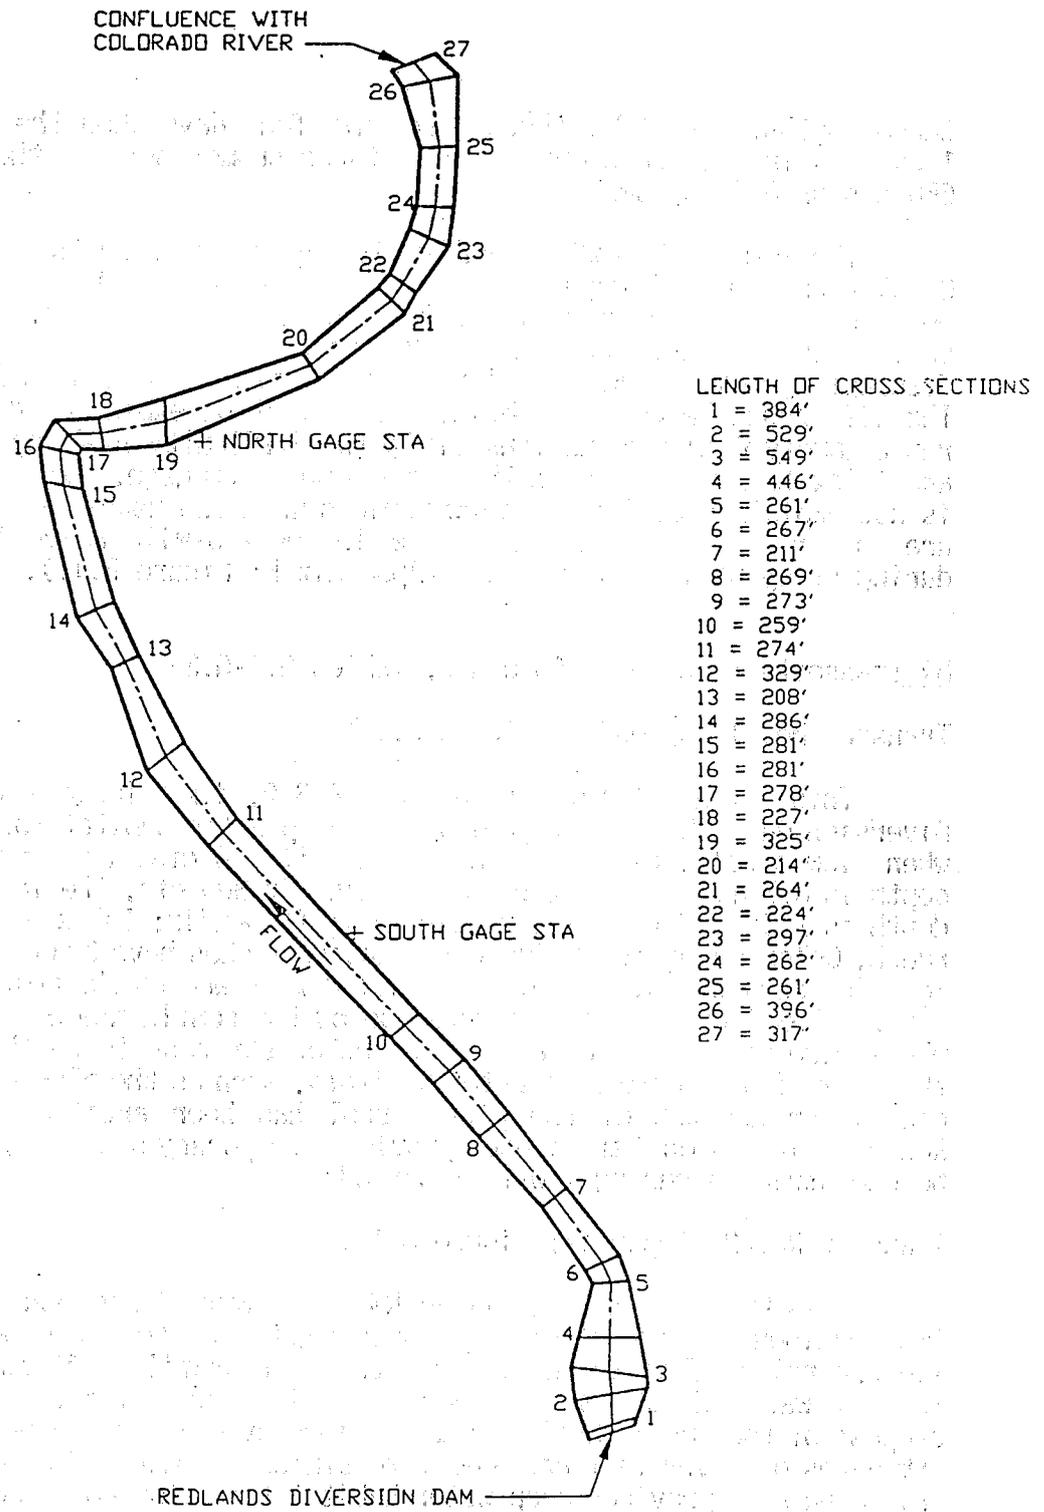
Figure 6. Plan view of the 2.3-mile reach of the lower Gunnison River and the location and widths of the 27 transects surveyed by the Bureau of Reclamation during April 1993. Note: Redlands Diversion Dam is river mile 3.0; the confluence with the Colorado River is river mile 0.7.

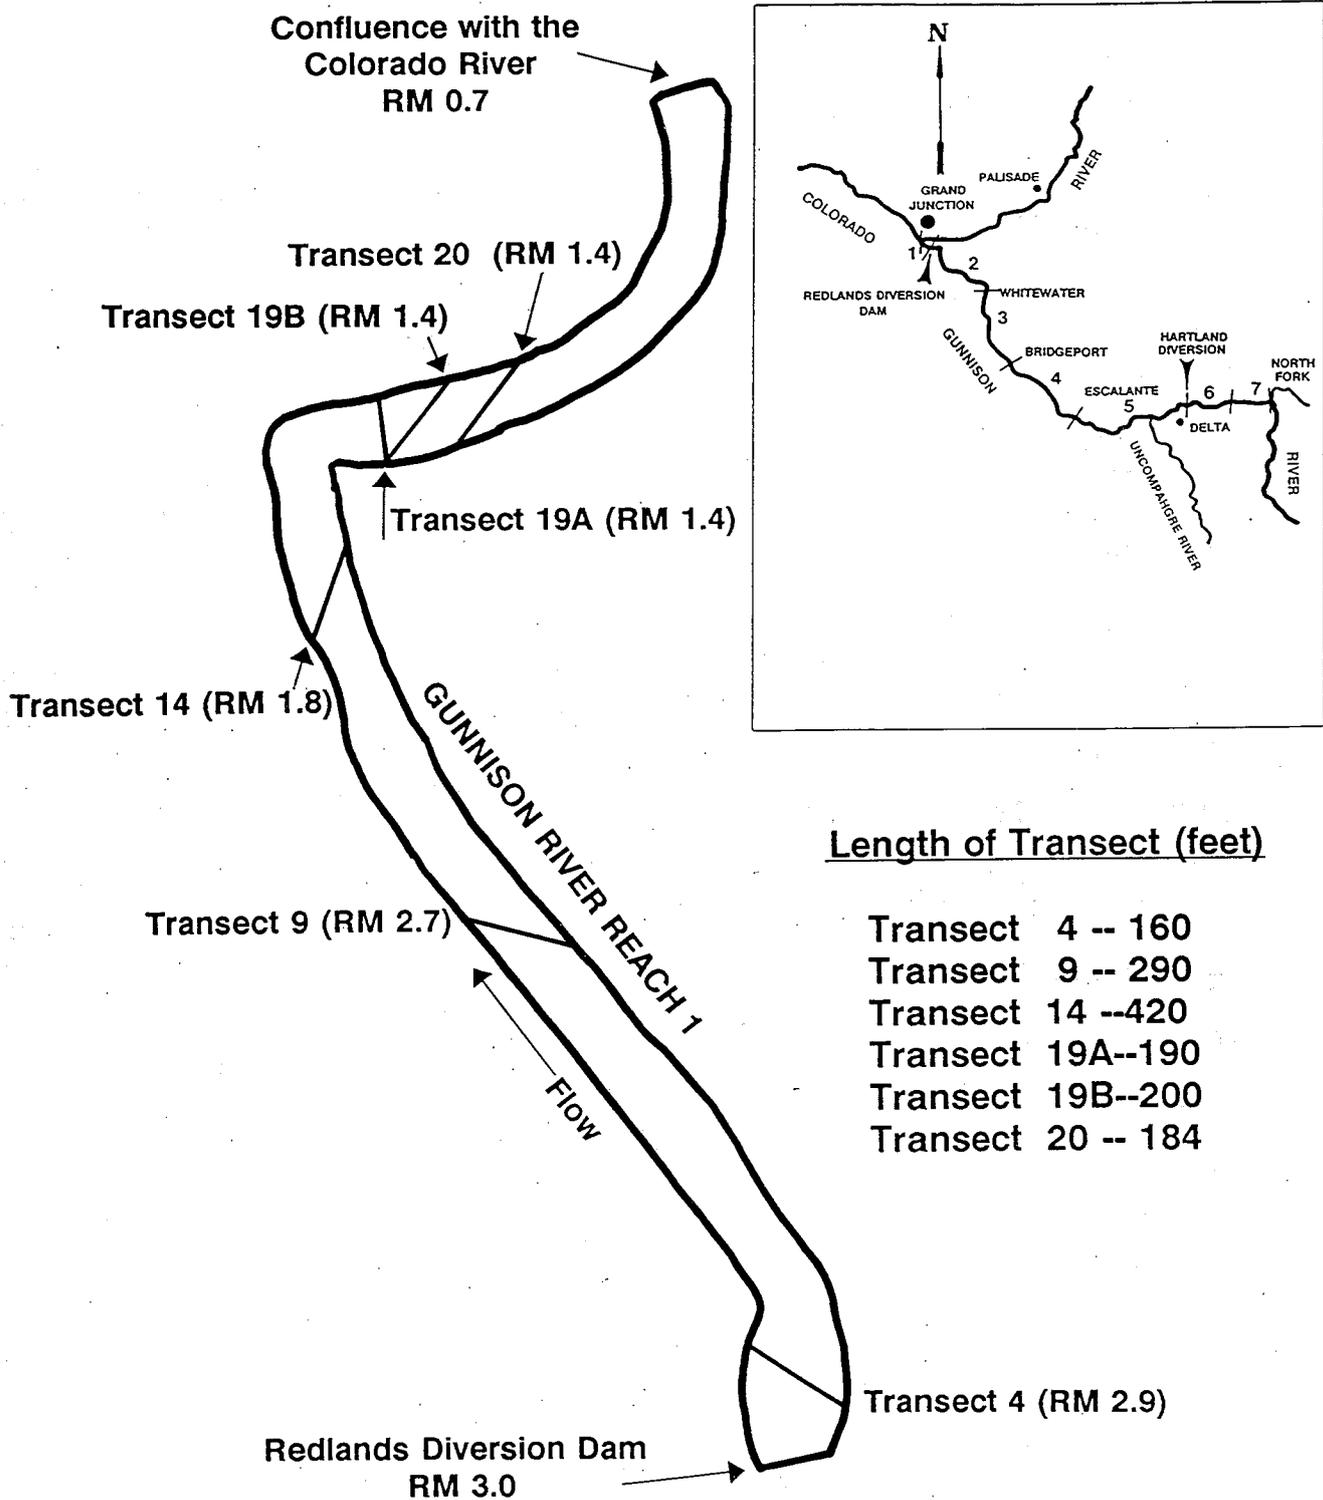
Figure 7. Plan view of the 2.3-mile study area of the lower Gunnison River between the Redlands Diversion Dam and the confluence with the Colorado River. Note: transects numbers correspond closely with those transects established by BR in the spring of 1993 to determine stage versus discharge relationships for this reach.

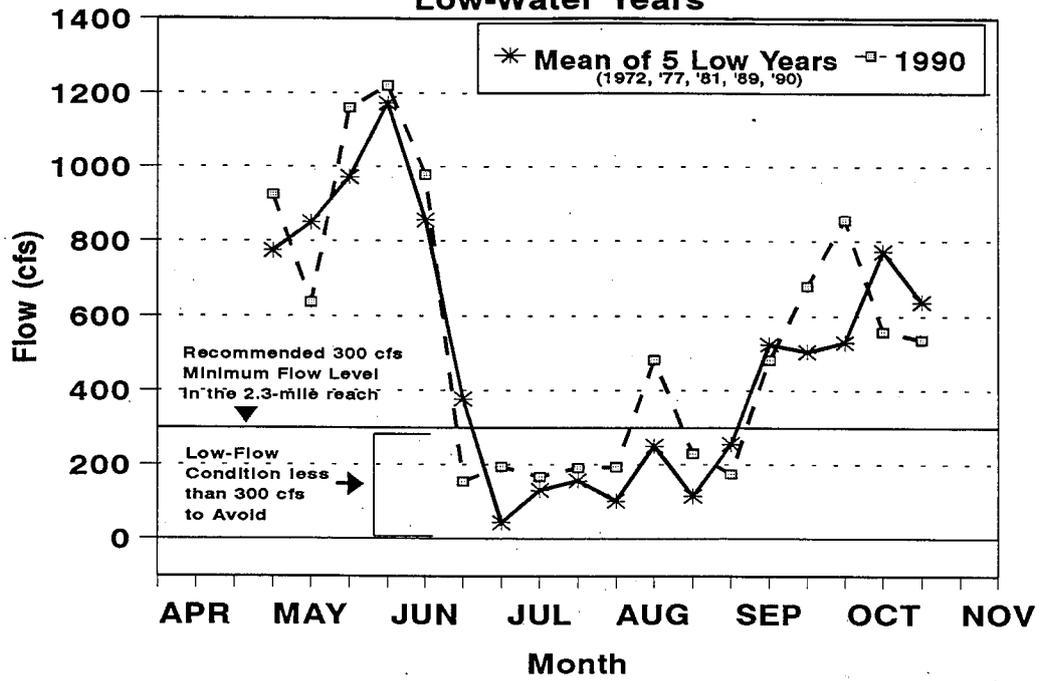
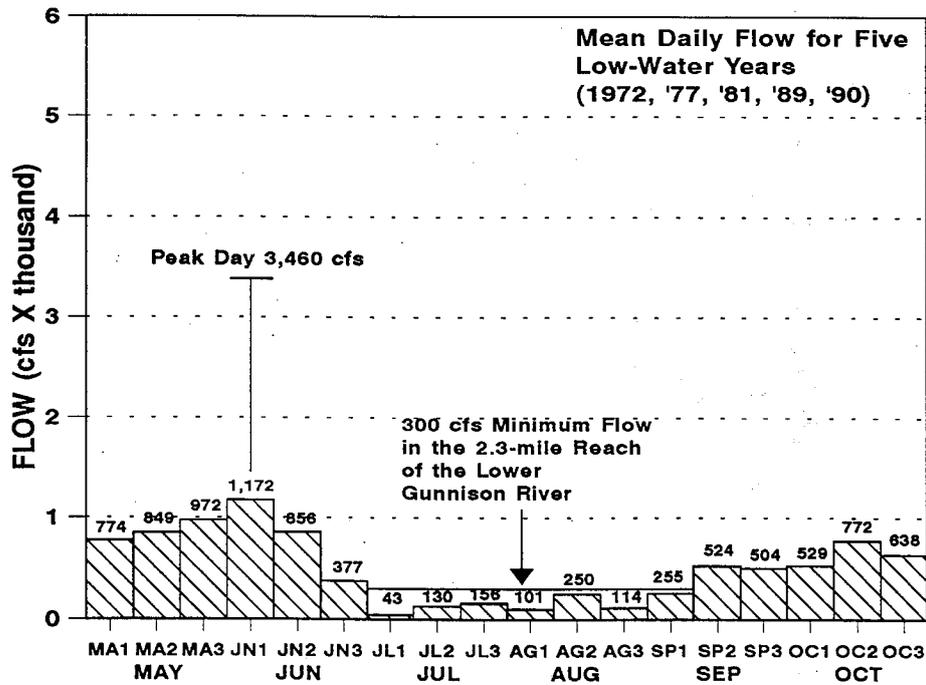
**Post-Aspinall Water Development, 1967-1995
Low-Water Years**

Figure 8. Mean daily flow (cfs) and shape of the hydrograph for five low-water years (1972, 1977, 1981, 1989, and 1990) compared to 1990, a low, low-water year from 1 May to 31 October in the 2.3-mile reach of the lower Gunnison River between the Redlands Diversion Dam and the confluence with the Colorado River (top). The bottom figure represents the mean daily flow for 1 May through 31 October for the 2.3-mile reach by 10- and 11-day step increments, e.g., May 1-10, May 11-20, May 21-31, etc.

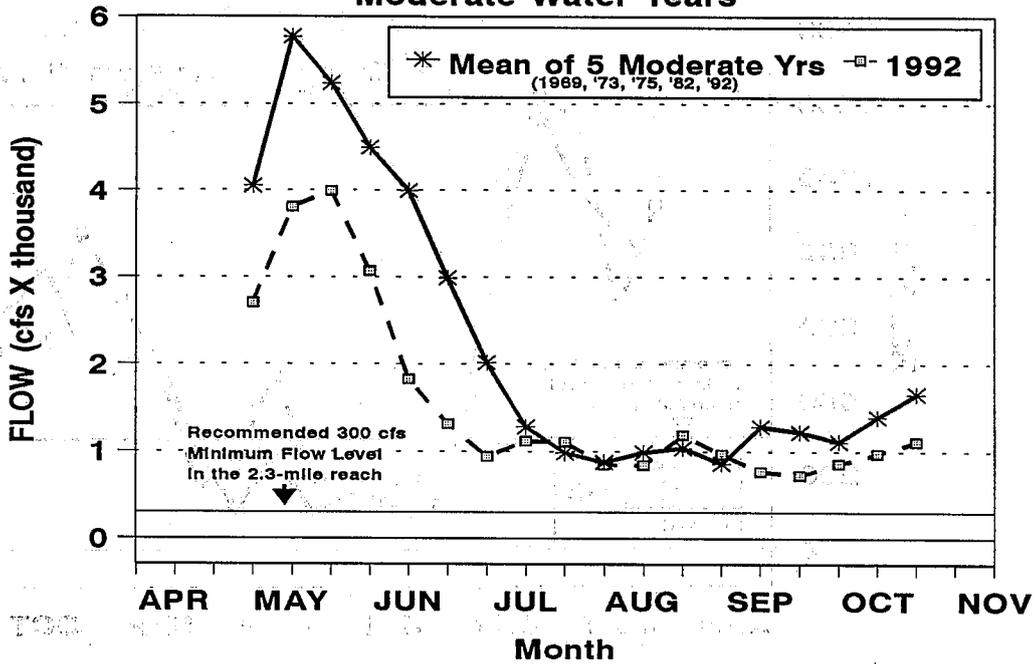
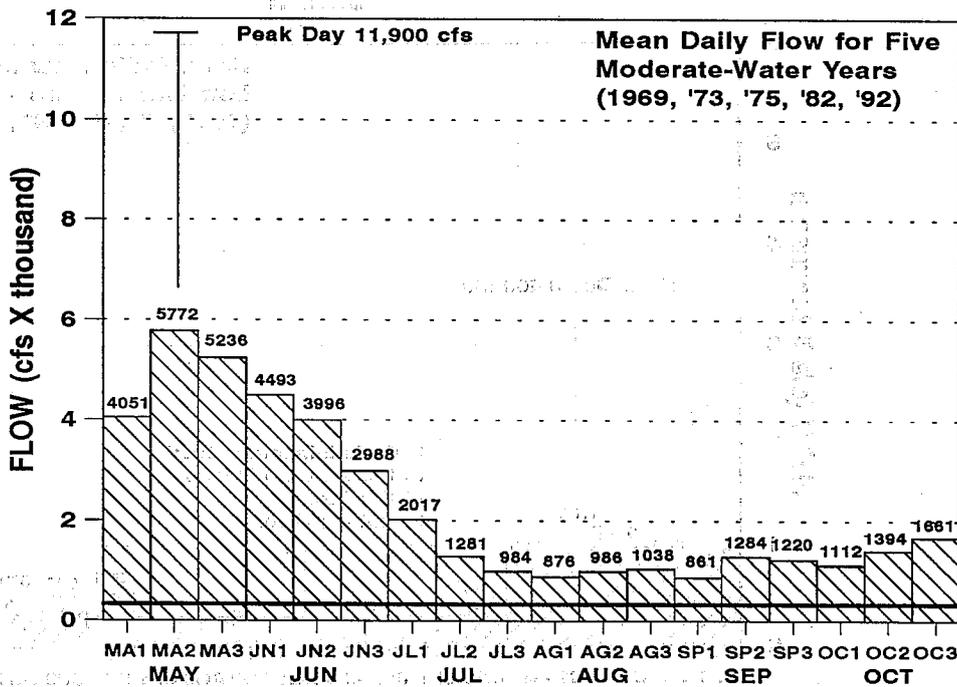
**Post-Aspinall Water Development, 1967-1995
Moderate Water Years**

Figure 9. Mean daily flow (cfs) and shape of the hydrograph for five moderate-water years (1969, 1973, 1975, 1982, and 1992) compared to 1992, a low, moderate-water year from 1 May to 31 October in the 2.3-mile reach of the lower Gunnison River between the Redlands Diversion Dam and the confluence with the Colorado River. The bottom figure represents the mean daily flow for 1 May through 31 October for the 2.3-mile reach by 10- and 11-day step increments, e.g., May 1-10, May 11-20, May 21-31, etc. Solid line in the bottom figure represents the recommended 300 cfs minimum flow in the 2.3-mile reach.

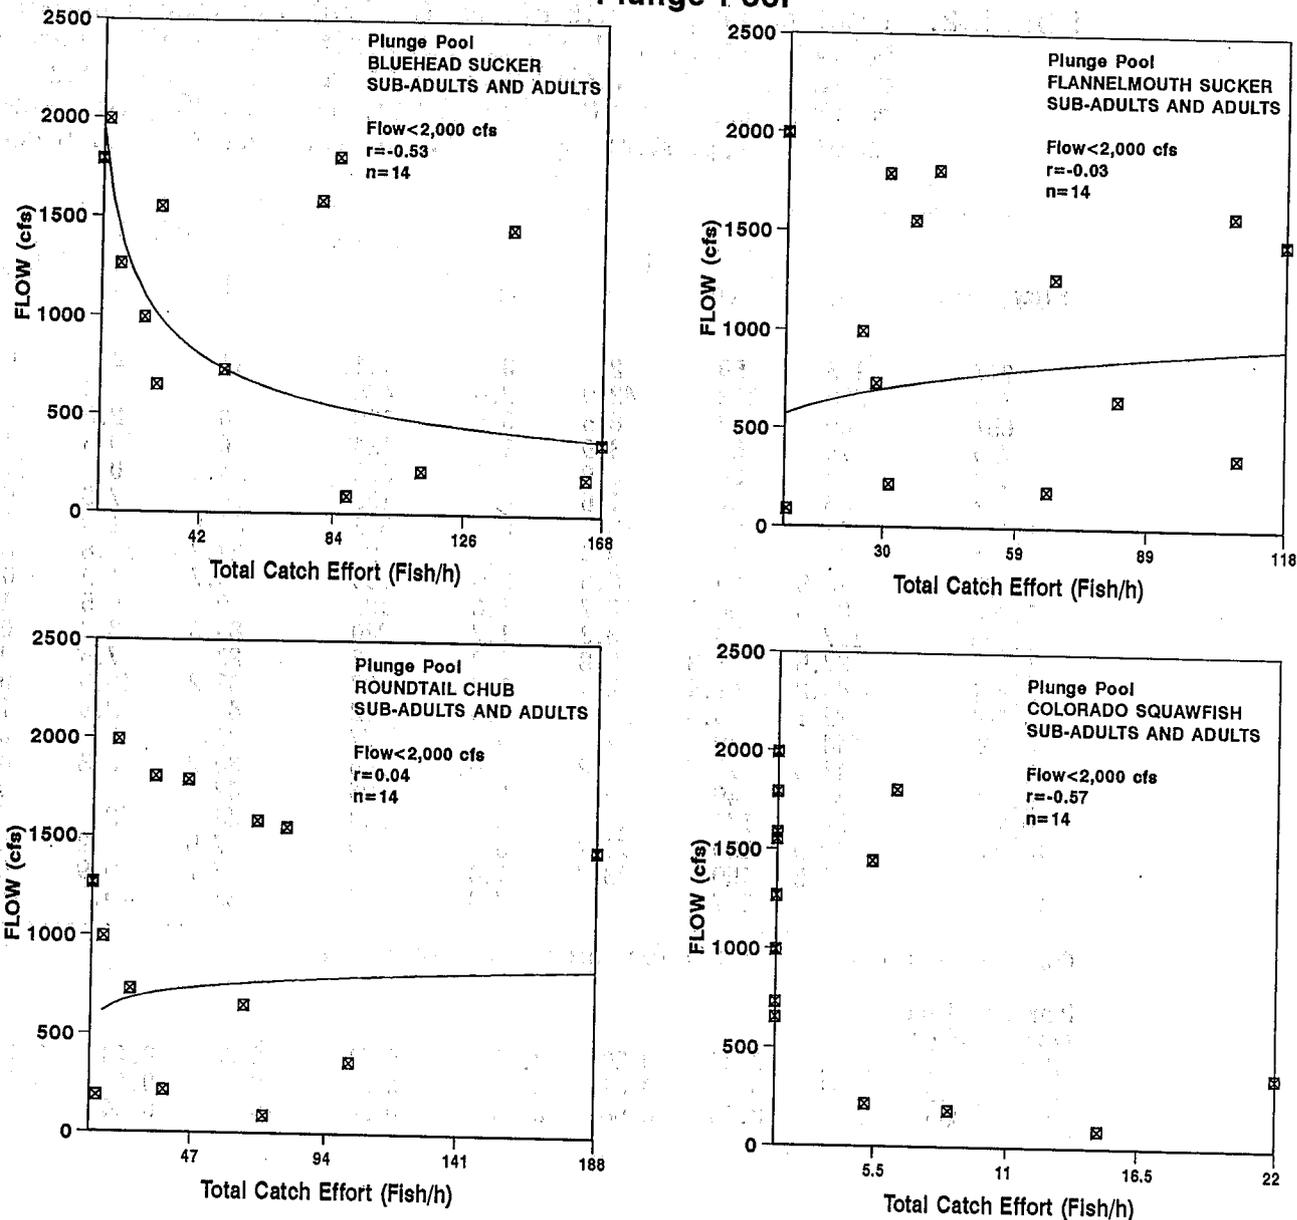
Figure E.1. Plot of total catch per unit effort (Fish/h) versus mean daily discharge for sub-adult and adult bluehead sucker, flannelmouth sucker, roundtail chub, and Colorado squawfish collected in the plunge pool (RM 3.0) of the Redlands Diversion Dam in the Lower Gunnison River, Colorado, March 1994 to November 1995. Note: 89-2,000 cfs was the range of flows analyzed; goodness-of-fit line fitted by computer.

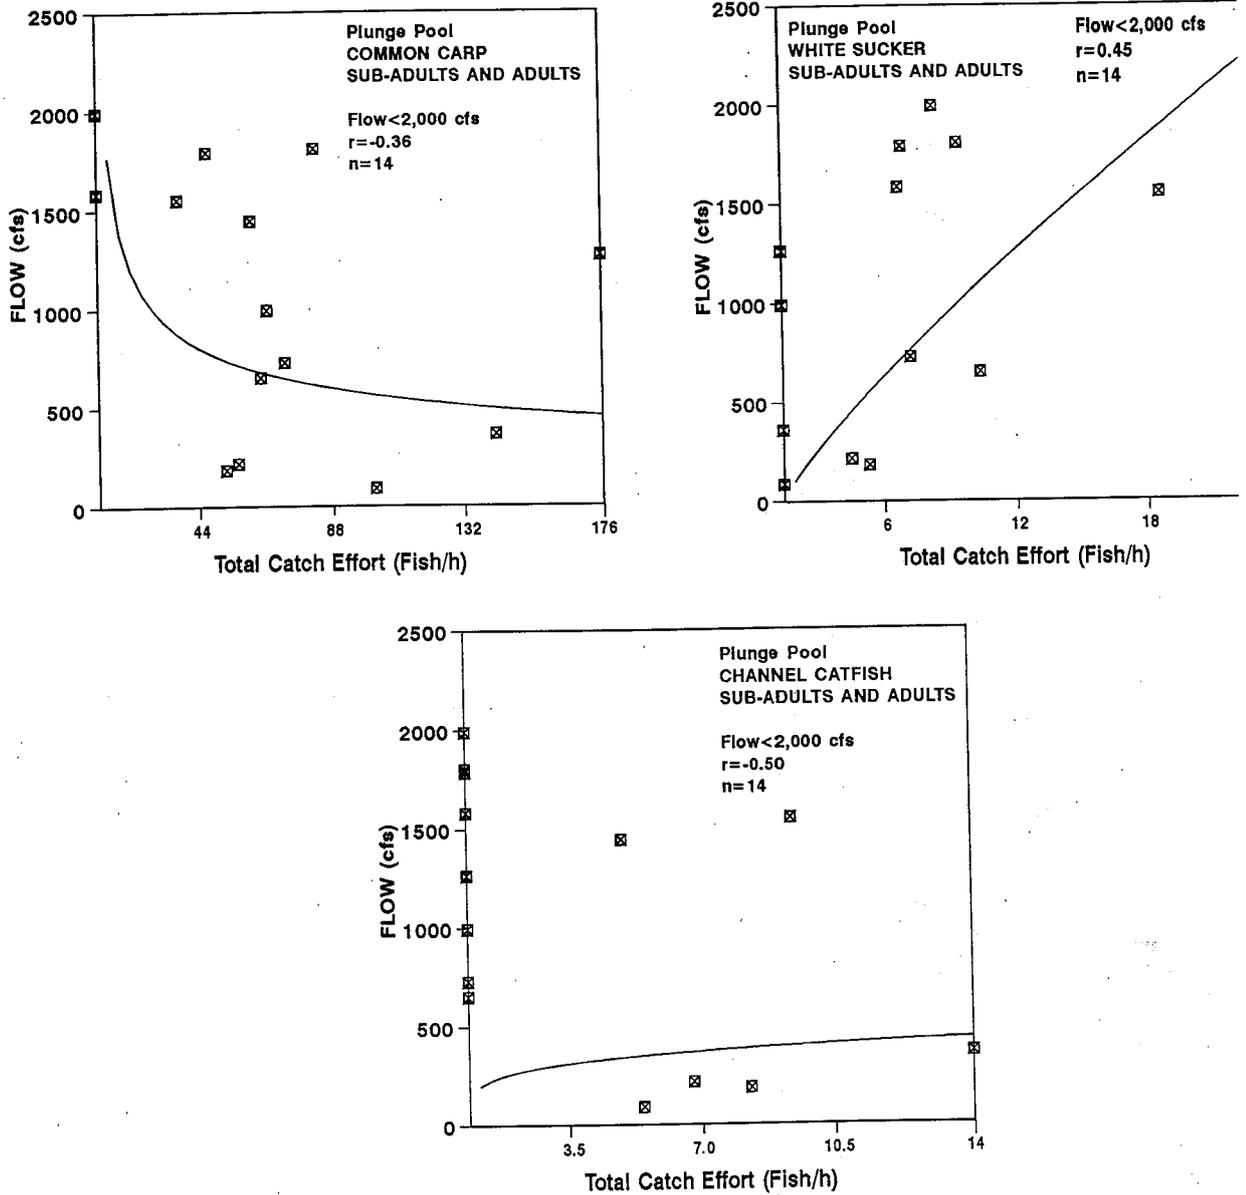
Figure E.2. Plot of total catch per unit effort (Fish/h) versus mean daily discharge for sub-adult and adult common carp, white sucker, and channel catfish collected in the plunge pool (RM 3.0) of the Redlands Diversion Dam in the Lower Gunnison River, Colorado, March 1994 to November 1995. Note: 89-2,000 cfs was the range of flows analyzed; goodness-of-fit line fitted by computer.

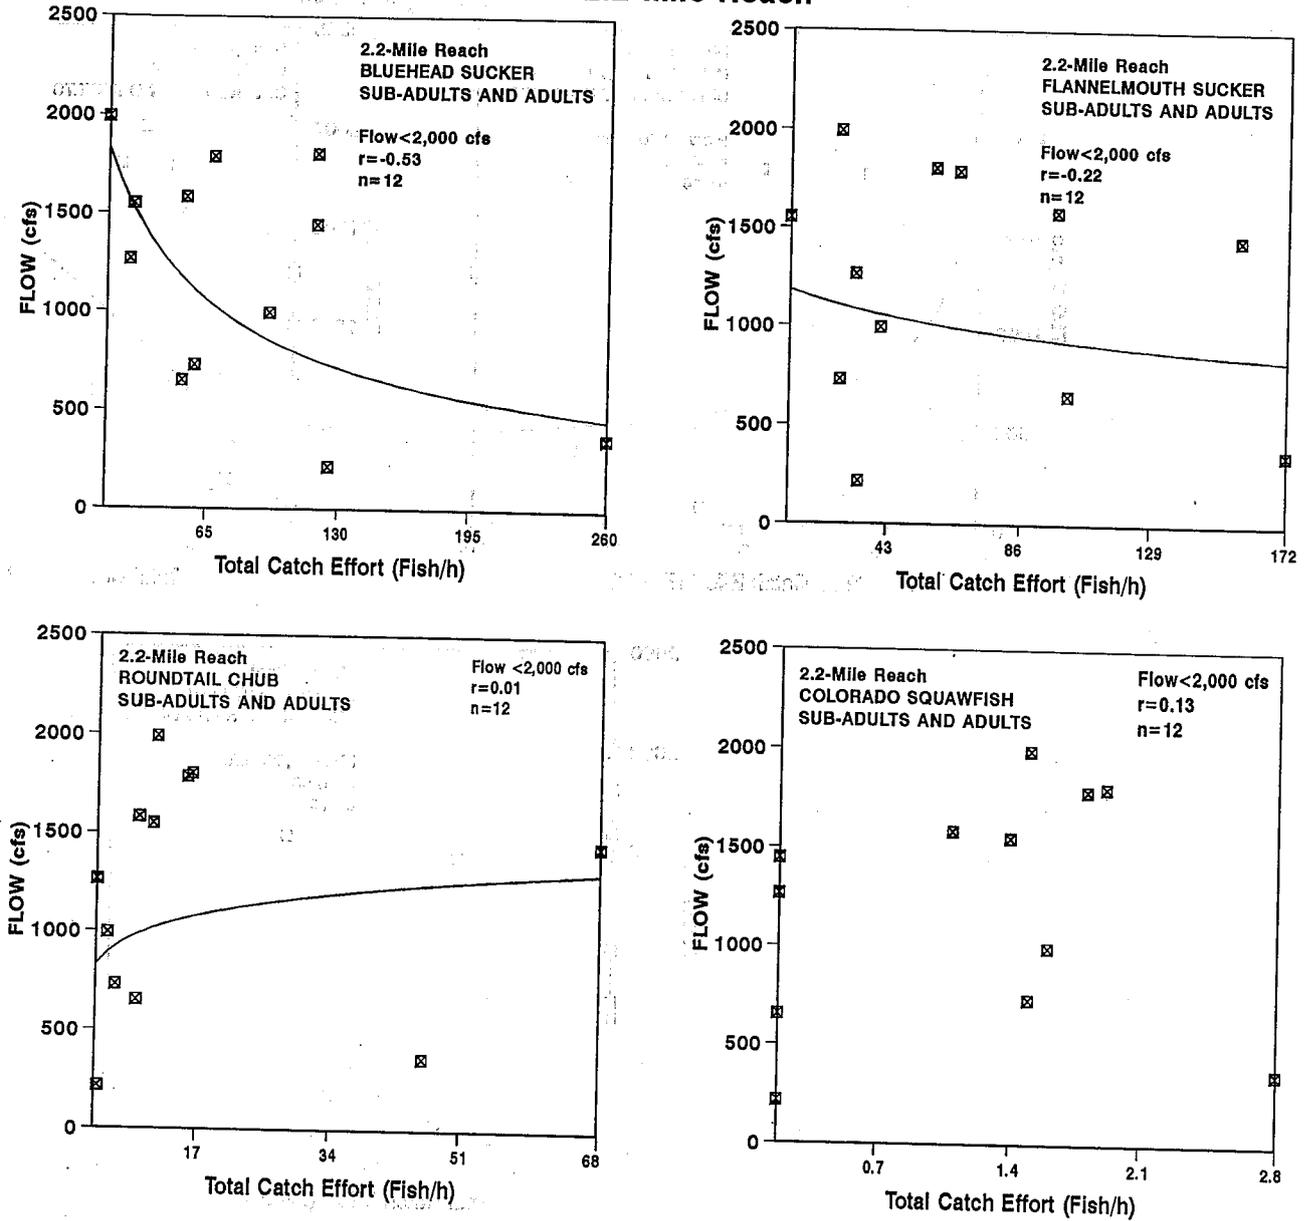
Figure E.3. Plot of total catch per unit effort (Fish/h) versus mean daily discharge for sub-adult and adult bluehead sucker, flannelmouth sucker, roundtail chub, and Colorado squawfish collected in the 2.2-mile reach of the Lower Gunnison River, Colorado, March 1994 to November 1995. Note: 217-2,000 cfs was the range of flows analyzed; goodness-of-fit line fitted by computer.

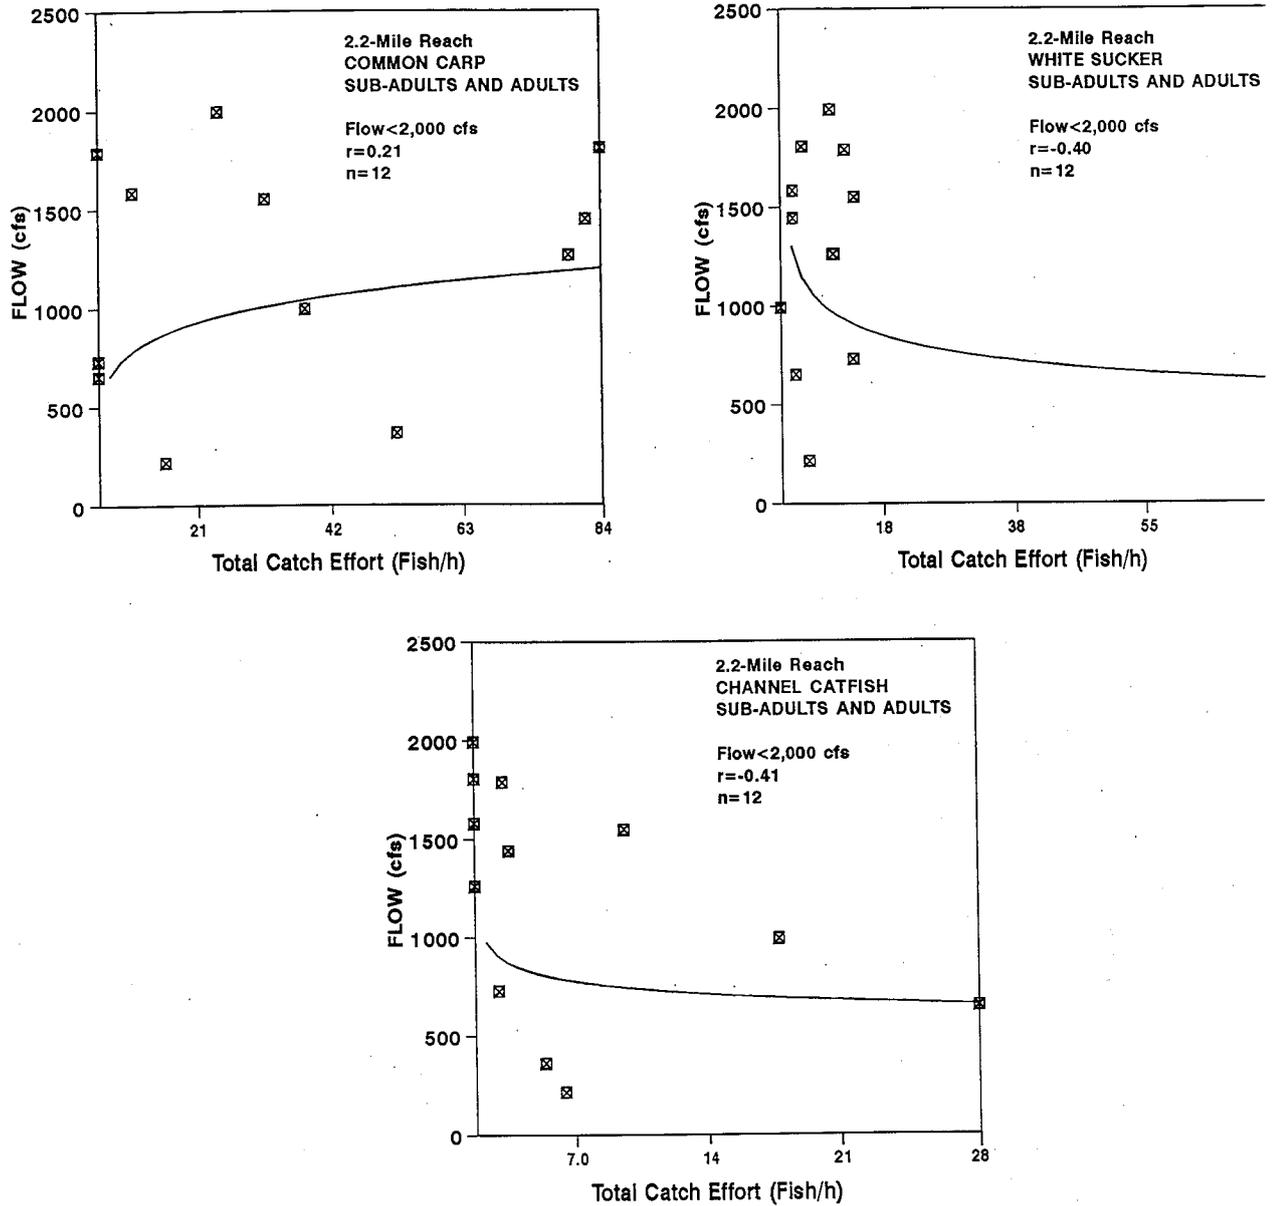
Figure E.4. Plot of total catch per unit effort (Fish/h) versus mean daily discharge for sub-adult and adult common carp, white sucker, and channel catfish collected in the 2.2-mile reach of the Lower Gunnison River, Colorado, March 1994 to November 1995. Note: 217-2,000 cfs was the range of flows analyzed; goodness-of-fit line fitted by computer.

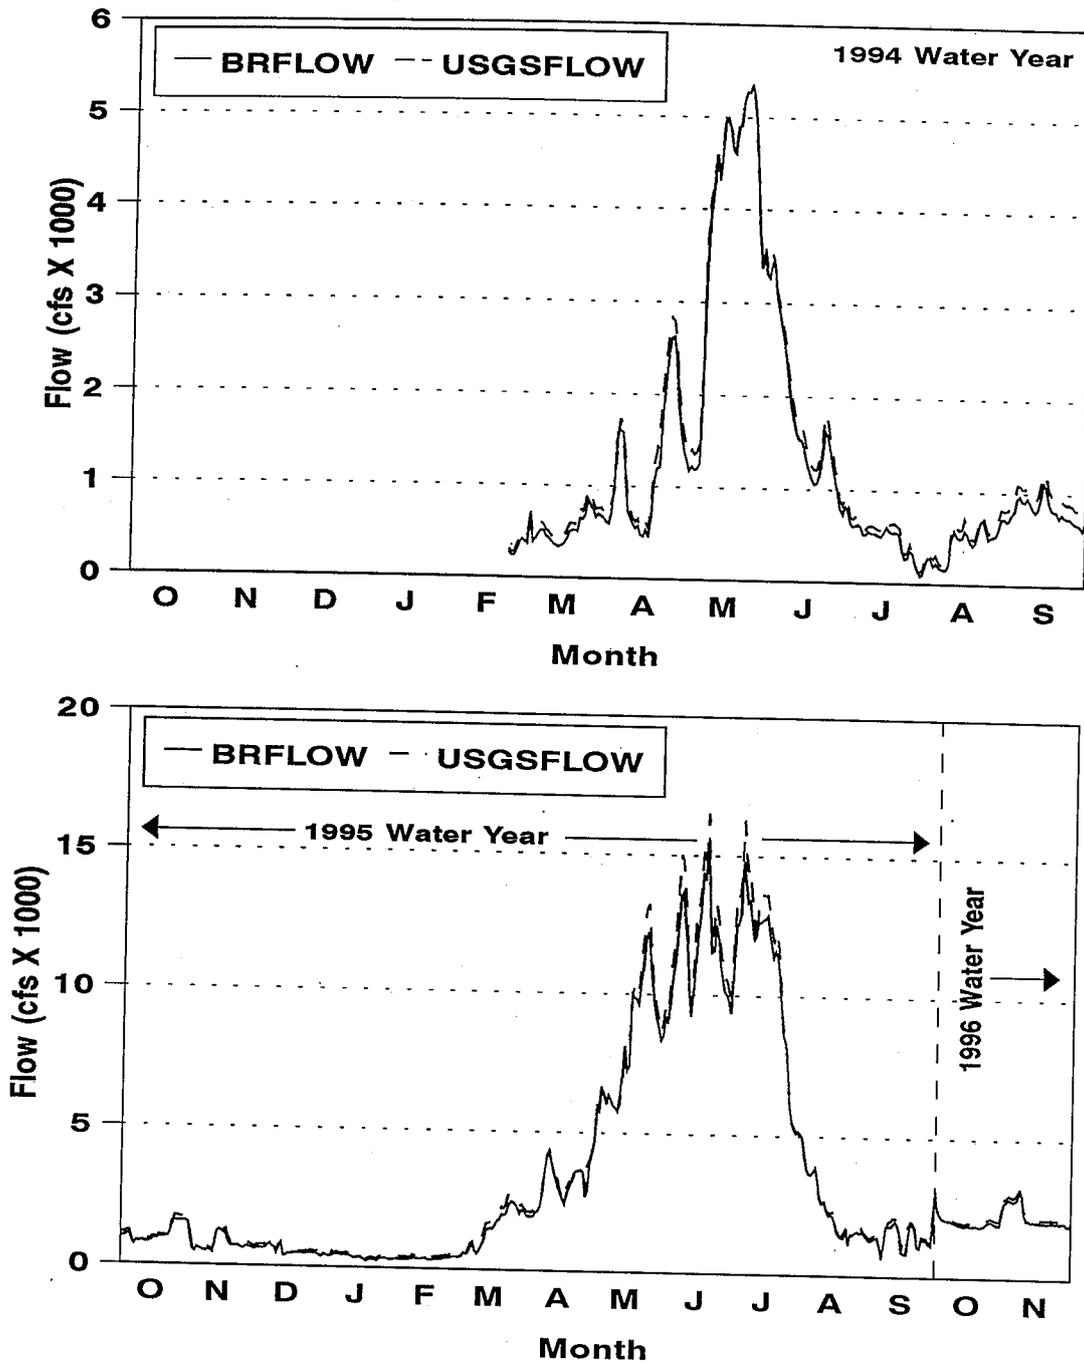
Figure F.1. Comparison of the mean daily streamflow of the USGS gage at Whitewater minus the Redlands Canal versus the mean daily streamflow of the Bureau of Reclamation (BR) gage in the 2.3-mile reach of the lower Gunnison River between the Redlands Diversion Dam and the confluence with the Colorado River during the study period, 1994 (top) and 1995 (bottom).

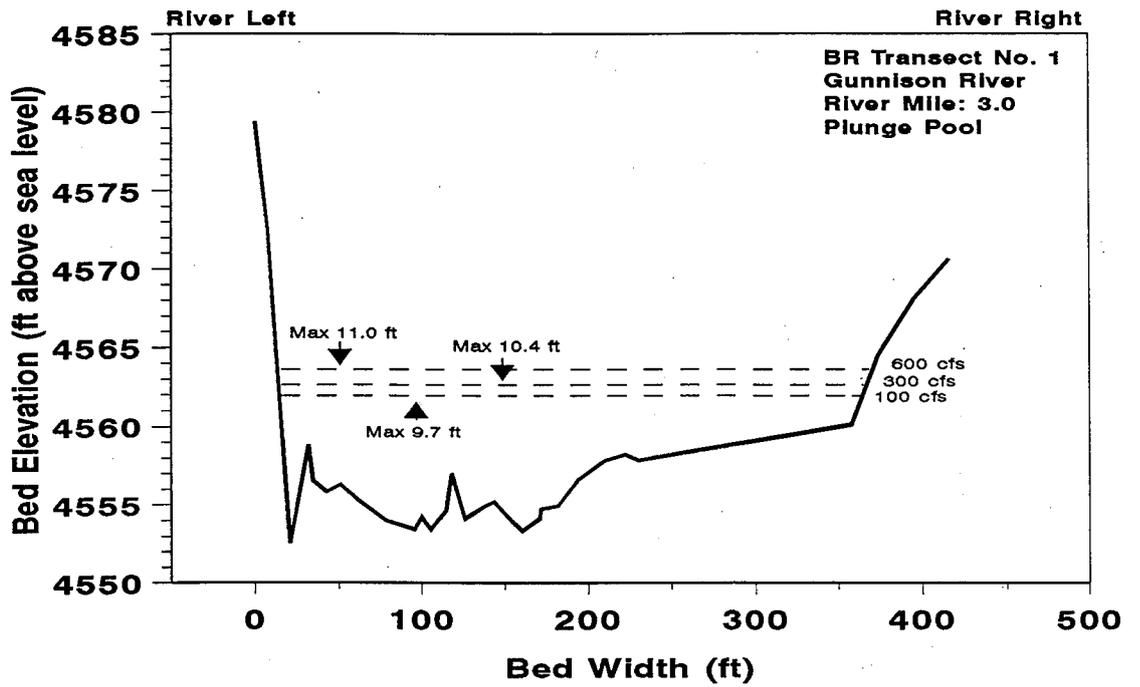
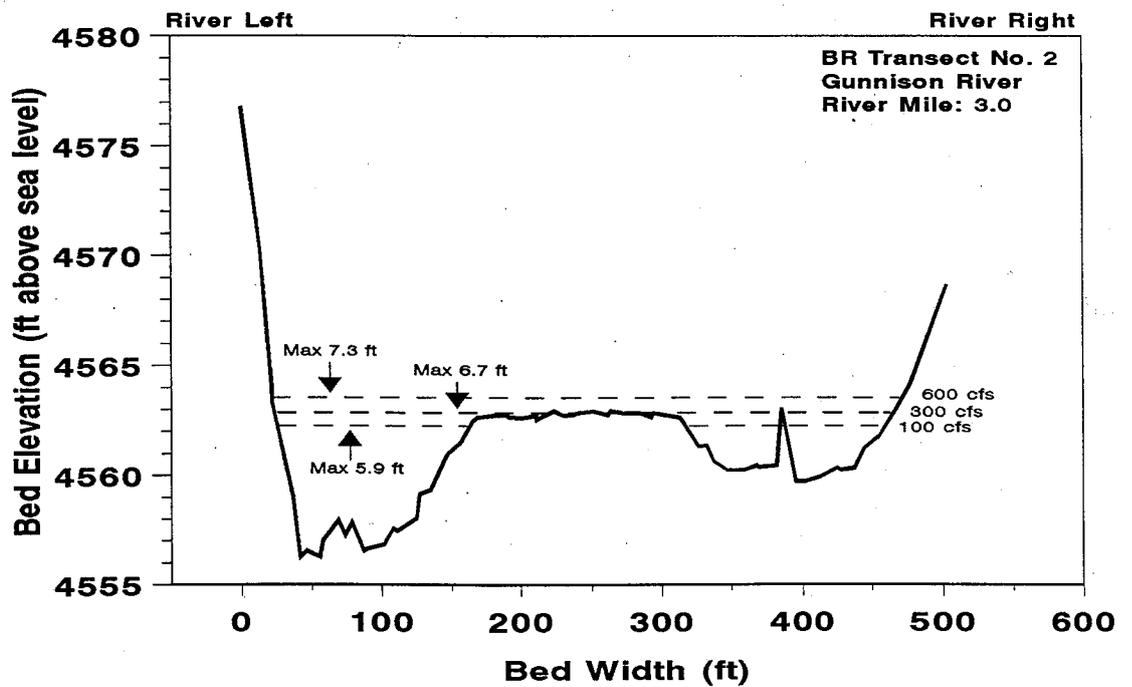
Figure G.1. River profile and variation in stage and maximum depth at various flow levels (100, 300, and 600 cfs) at Transects 1 (top) and 2 (bottom). Transects conducted by BR personnel.
