**MINIMUM FLOW RECOMMENDATION FOR PASSAGE OF
COLORADO SQUAWFISH AND RAZORBACK SUCKER
IN THE 2.3-MILE REACH OF THE LOWER GUNNISON RIVER:
REDLANDS DIVERSION DAM TO THE
COLORADO RIVER CONFLUENCE**

Recovery Program Project Number 57

Final Report

**Bob D. Burdick
Fishery Biologist**

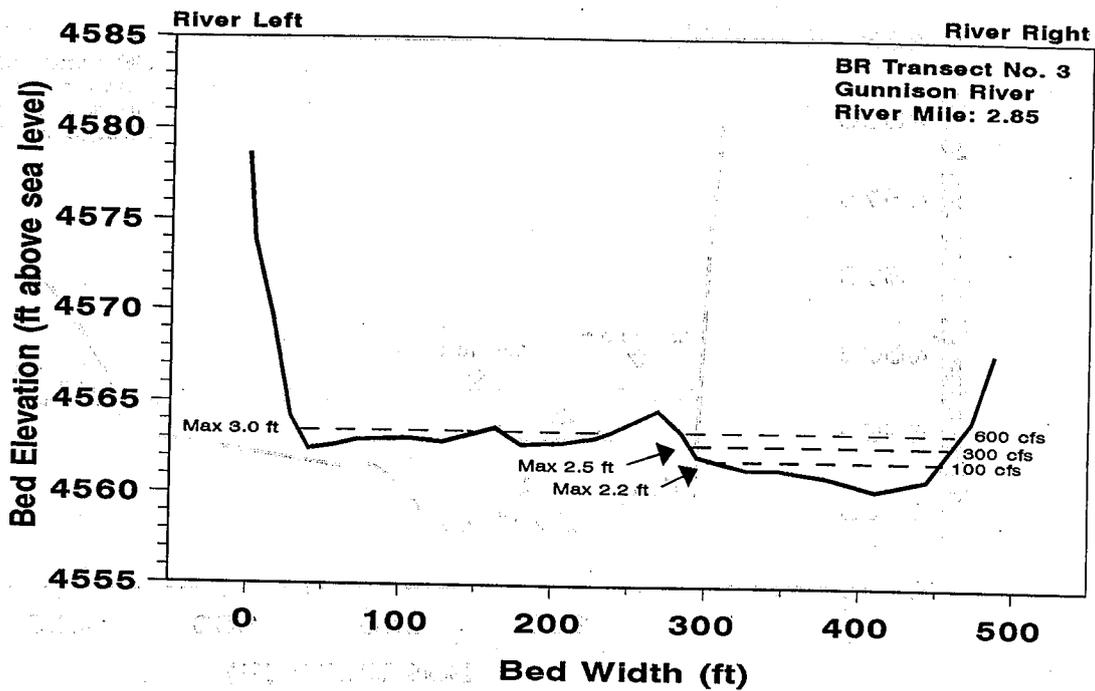
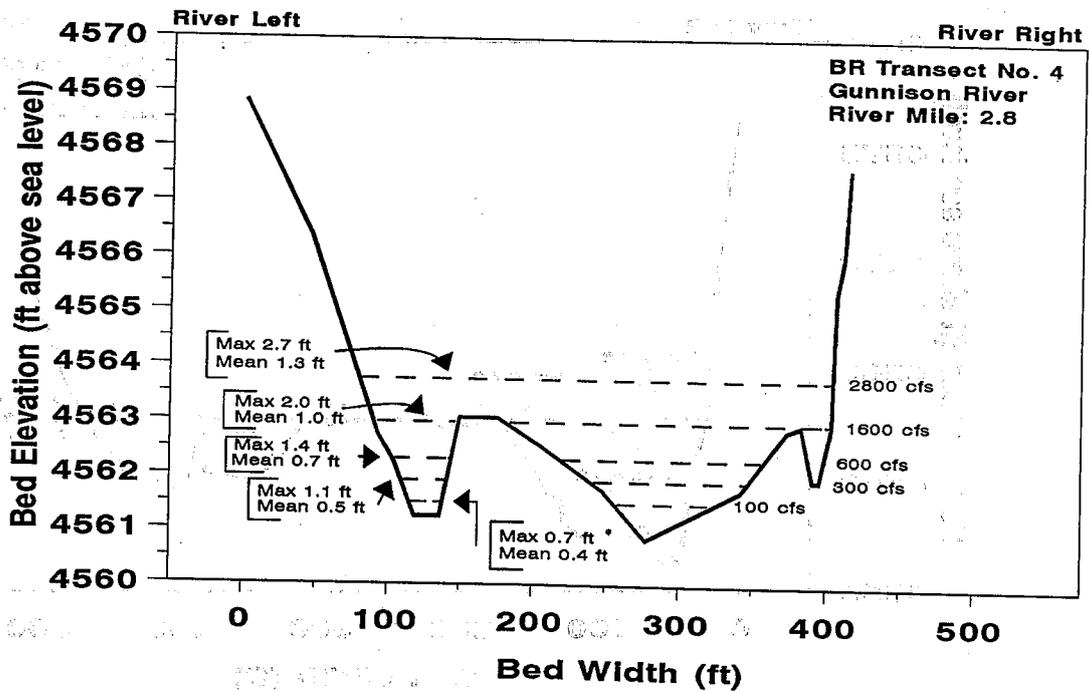
Figure G.2. River profile and variation in stage and maximum depth at various flow levels at Transect 3 (100, 300, and 600 cfs; top) and Transect 4 (100, 300, 600, 1,600, and 2,800 cfs; bottom). Transects conducted by BR personnel.

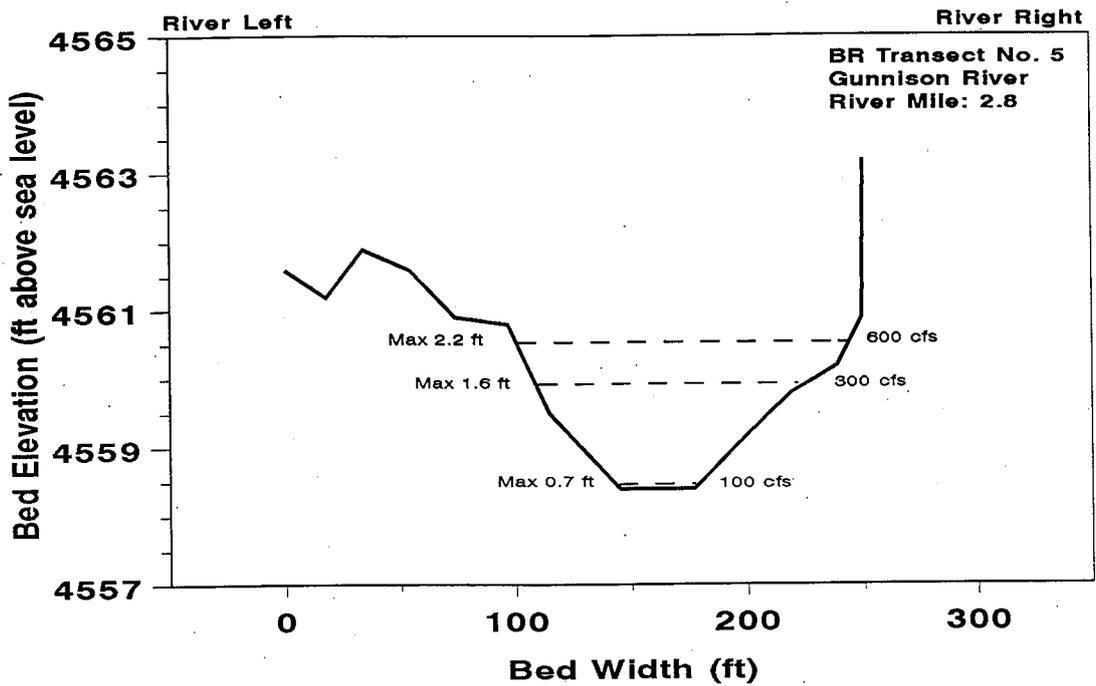
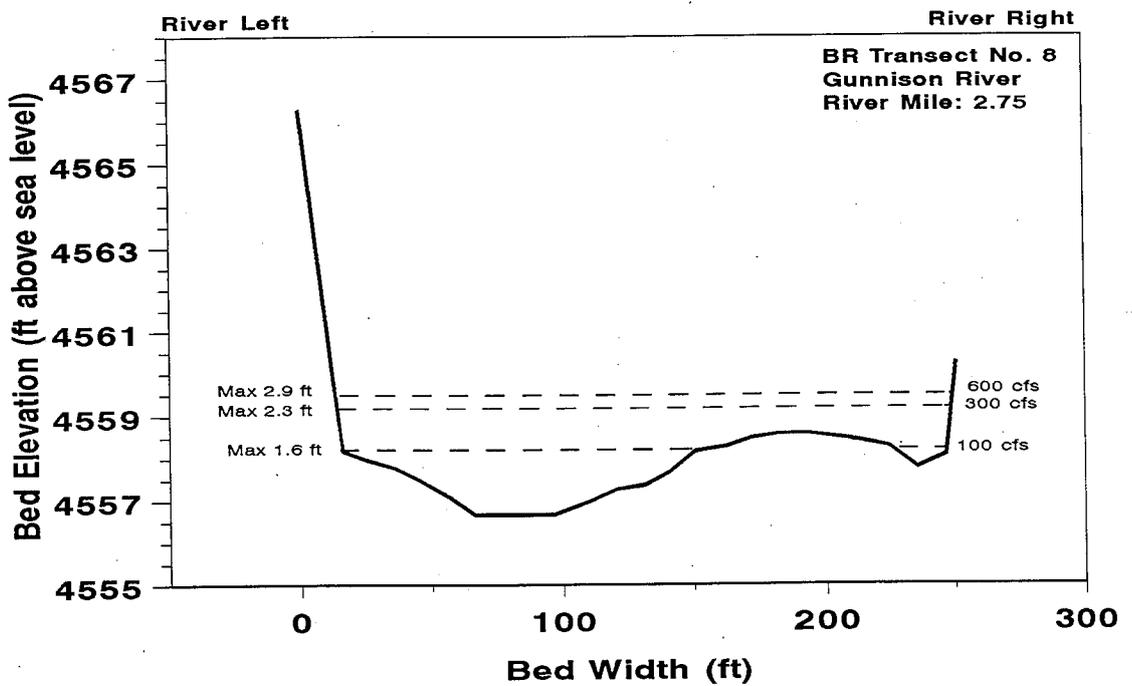
Figure G.3. River profile and variation in stage and maximum depth at various flow levels (100, 300, and 600 cfs) at Transects 5 (top) and 8 (bottom). Transects conducted by BR personnel.

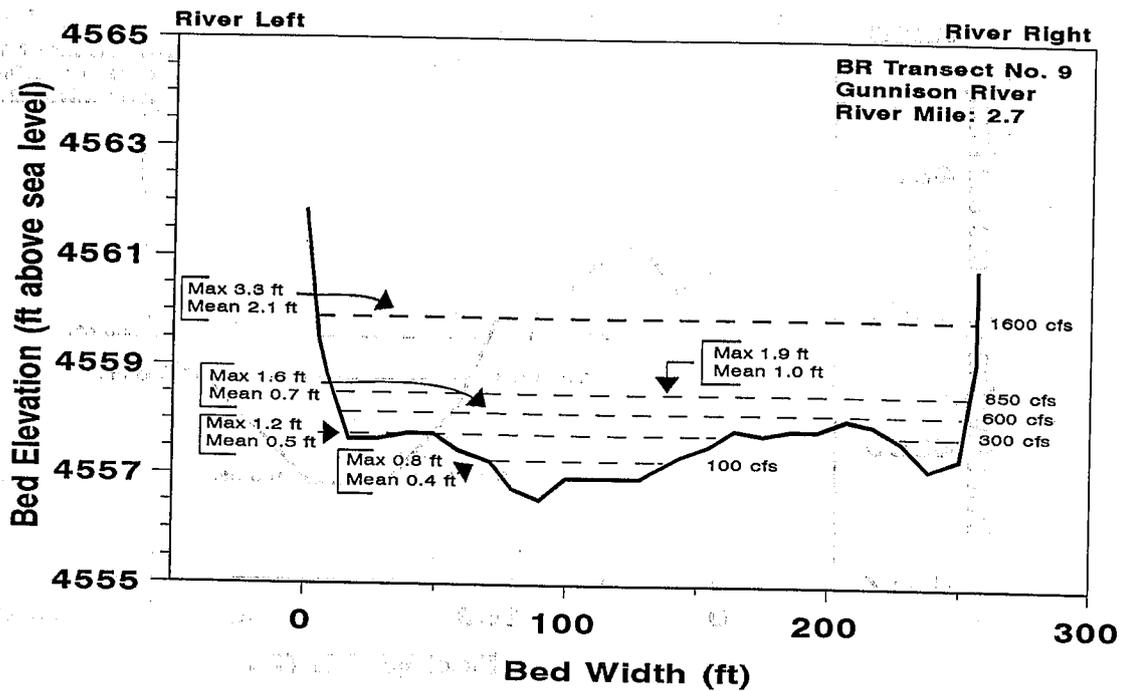
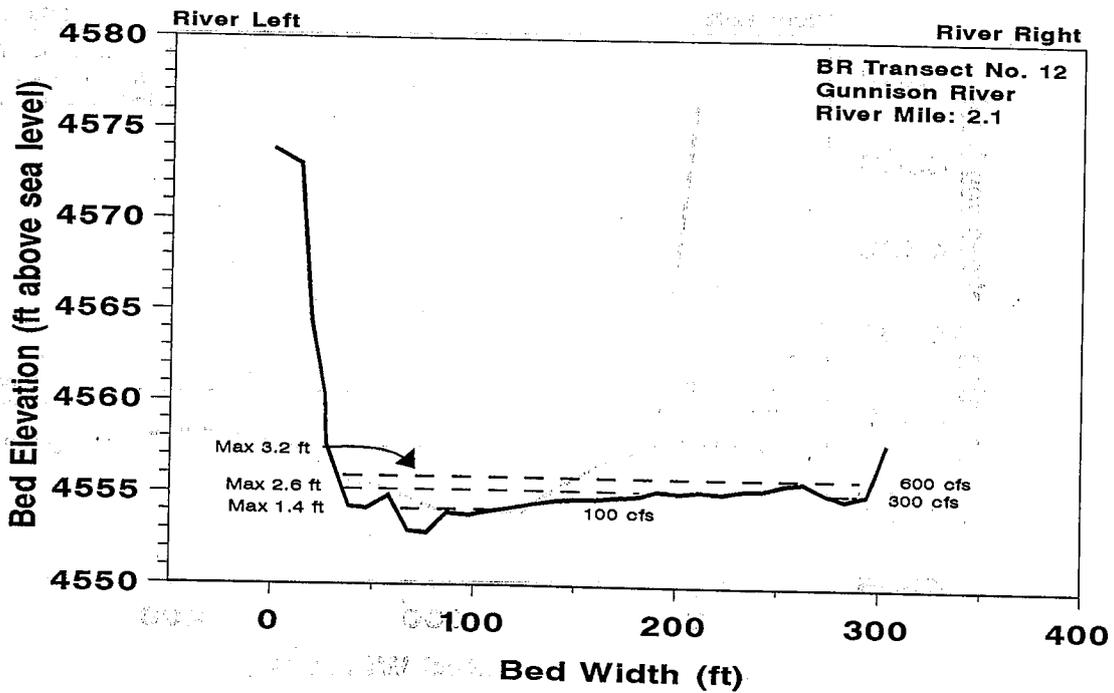
Figure G.4. River profile and variation in stage and maximum depth at various flow levels at Transect 9 (100, 300, 600, 850, and 1,600 cfs; top) and Transect 12 (100, 300, 600 cfs; bottom). Transects conducted by BR personnel.

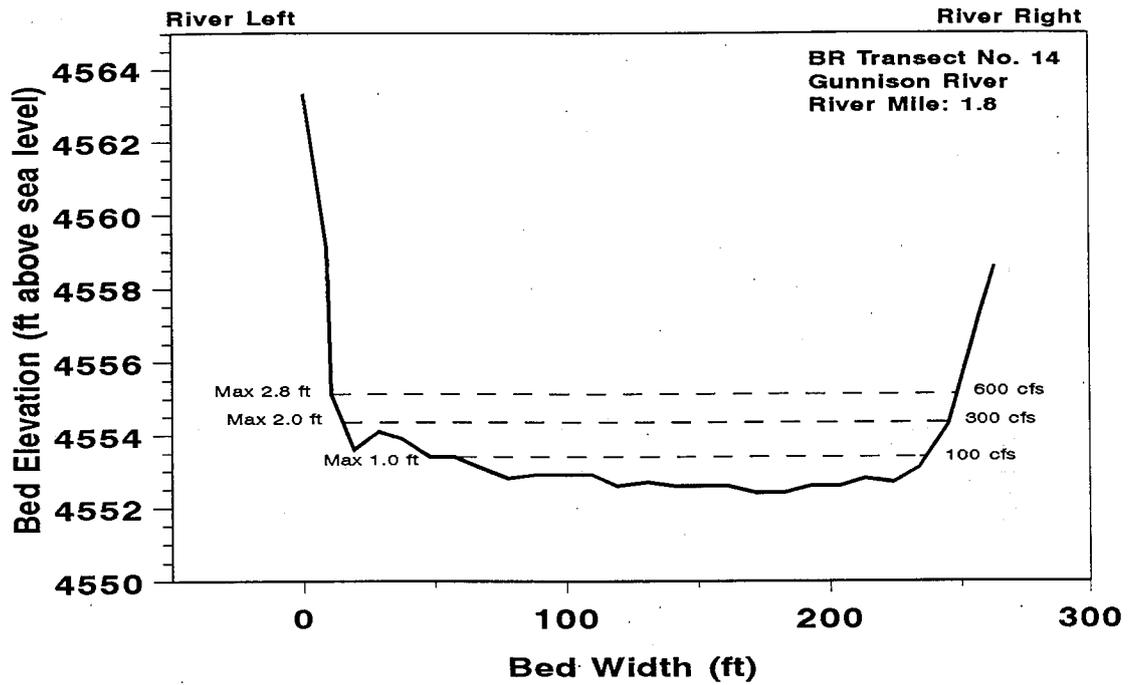
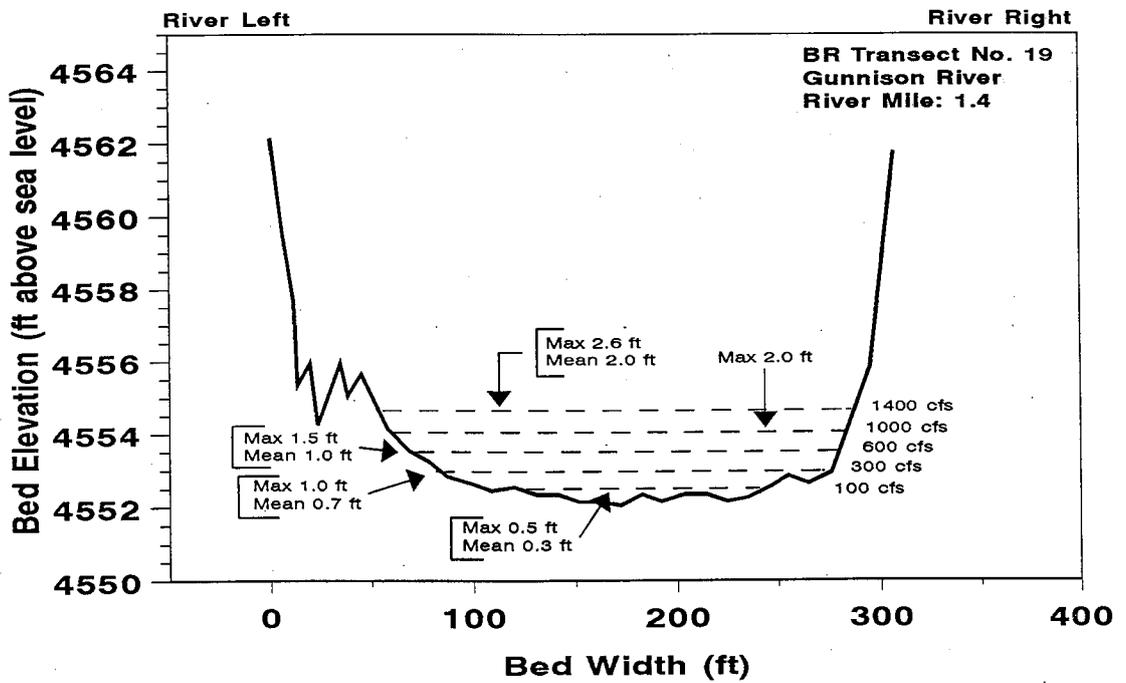
Figure G.5. River profile and variation in stage and maximum depth at various flow levels at Transect 14 (100, 300, and 600 cfs; top) and Transect 19 (100, 300, 600, 1,000, and 1,400 cfs; bottom). Transects conducted by BR personnel.

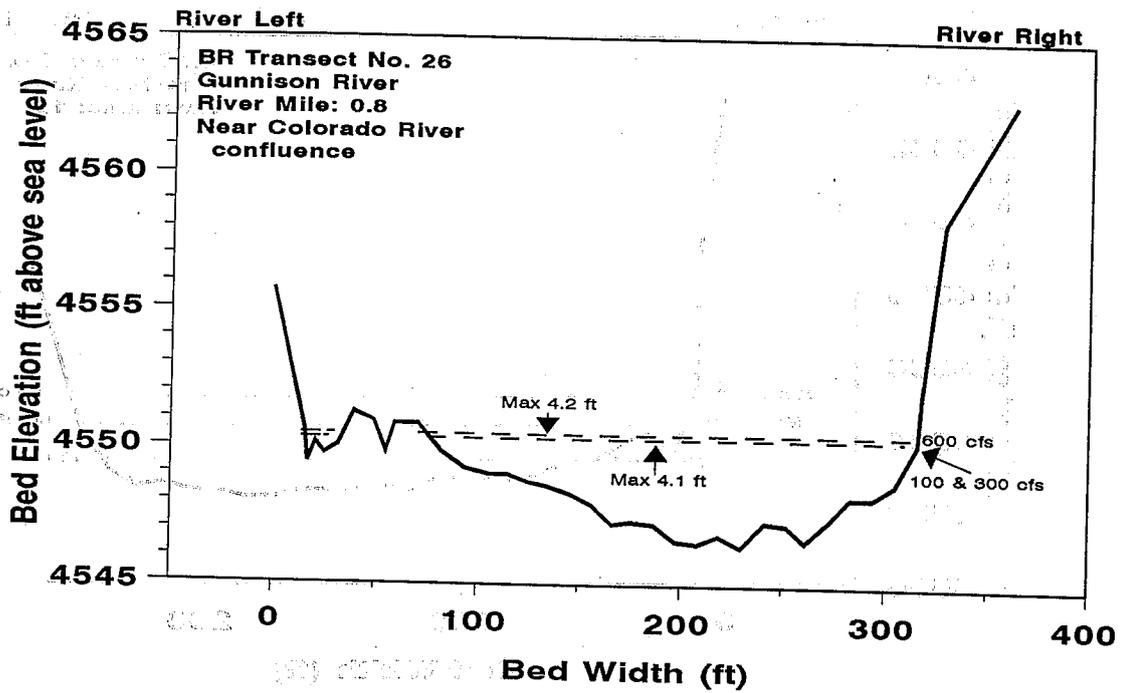
Figure G.6. River profile and variation in stage and maximum depth at various flow levels (100, 300, and 600 cfs) at Transect 26. Transect conducted by BR personnel.

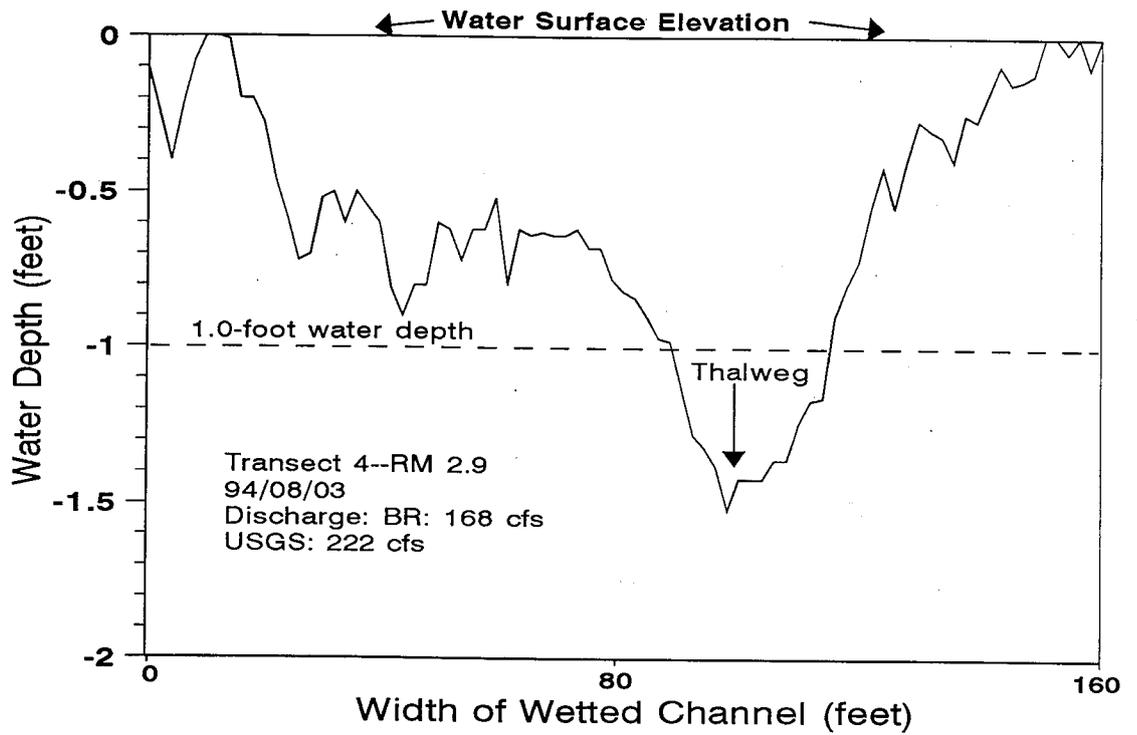
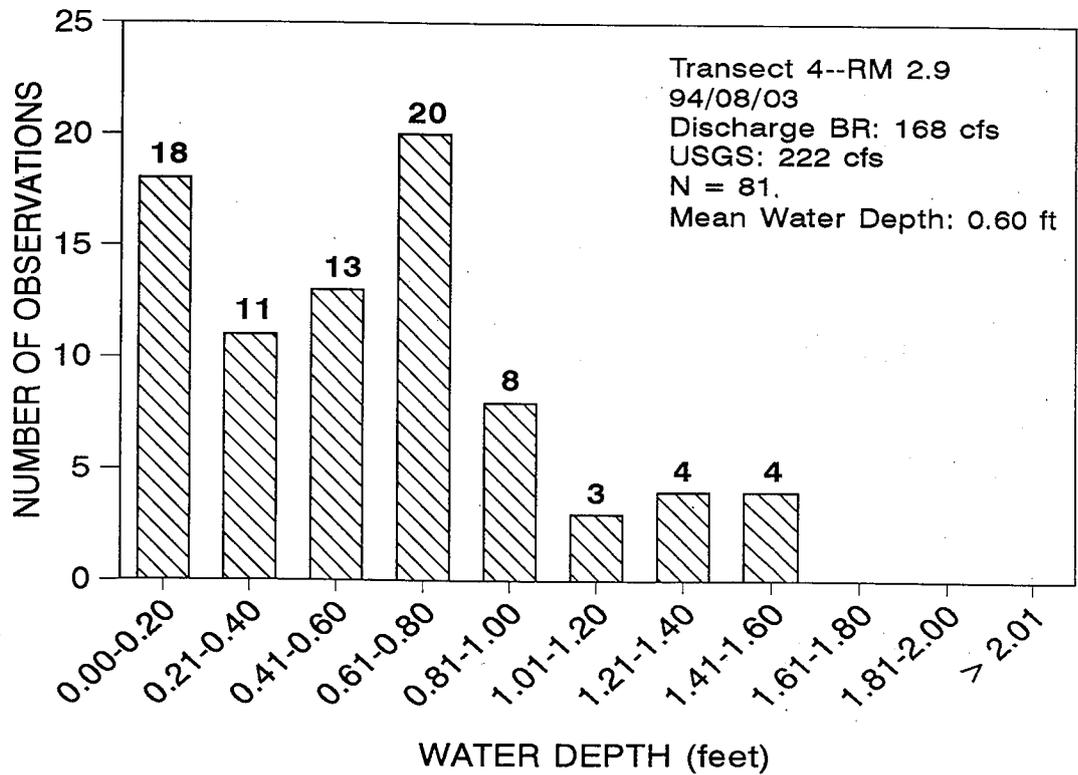
Figure G.7. River profile (top) and the distribution of water depths (feet) observed by 0.2-foot increments (bottom) for transect 4, river mile 2.9, Gunnison River, Colorado, 3 August 1994.

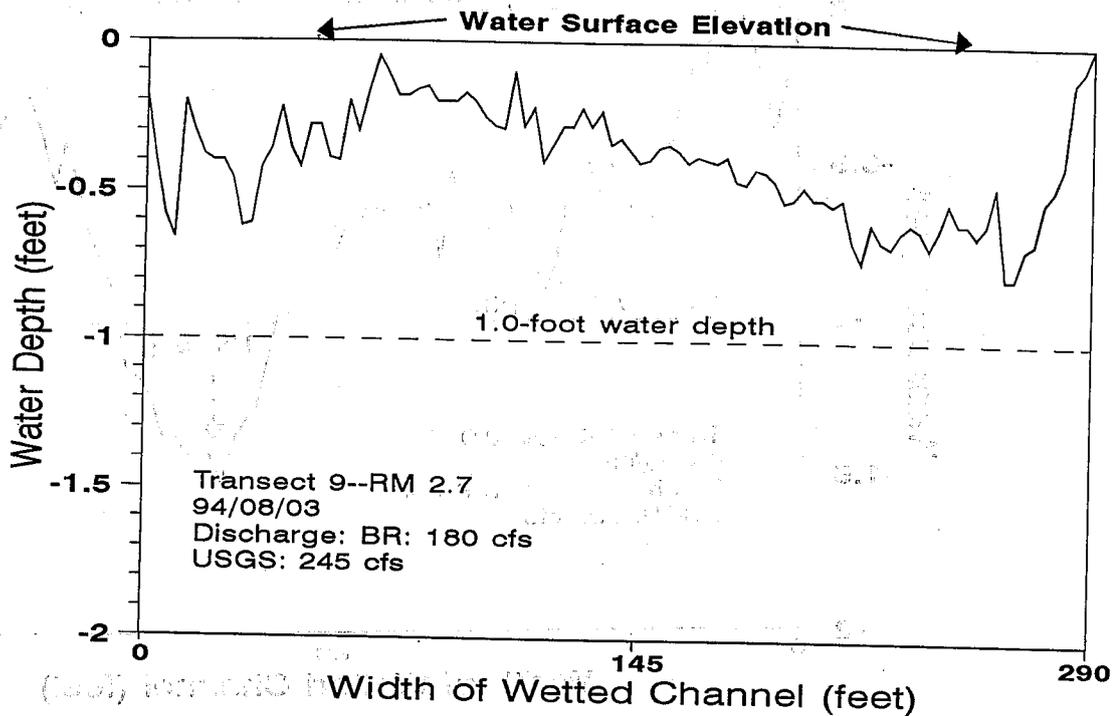
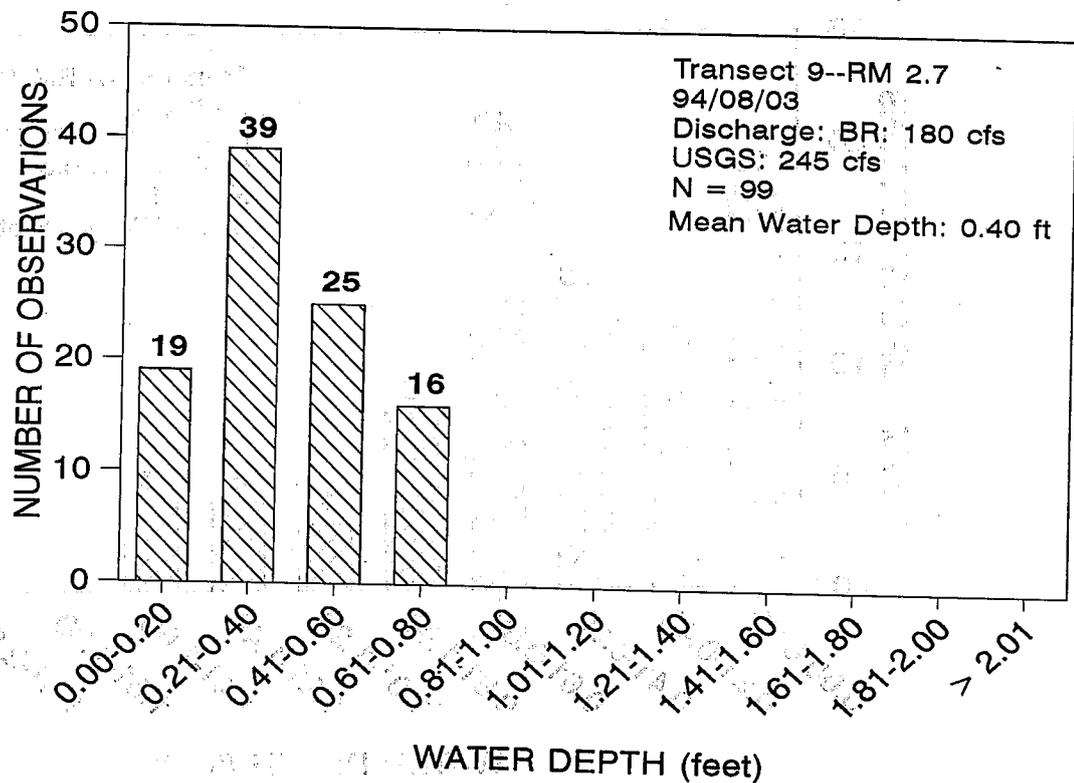
Figure G.8. River profile (top) and the distribution of water depths (feet) observed by 0.2-foot increments (bottom) for transect 9, river mile 2.4, Gunnison River, Colorado, 3 August 1994.

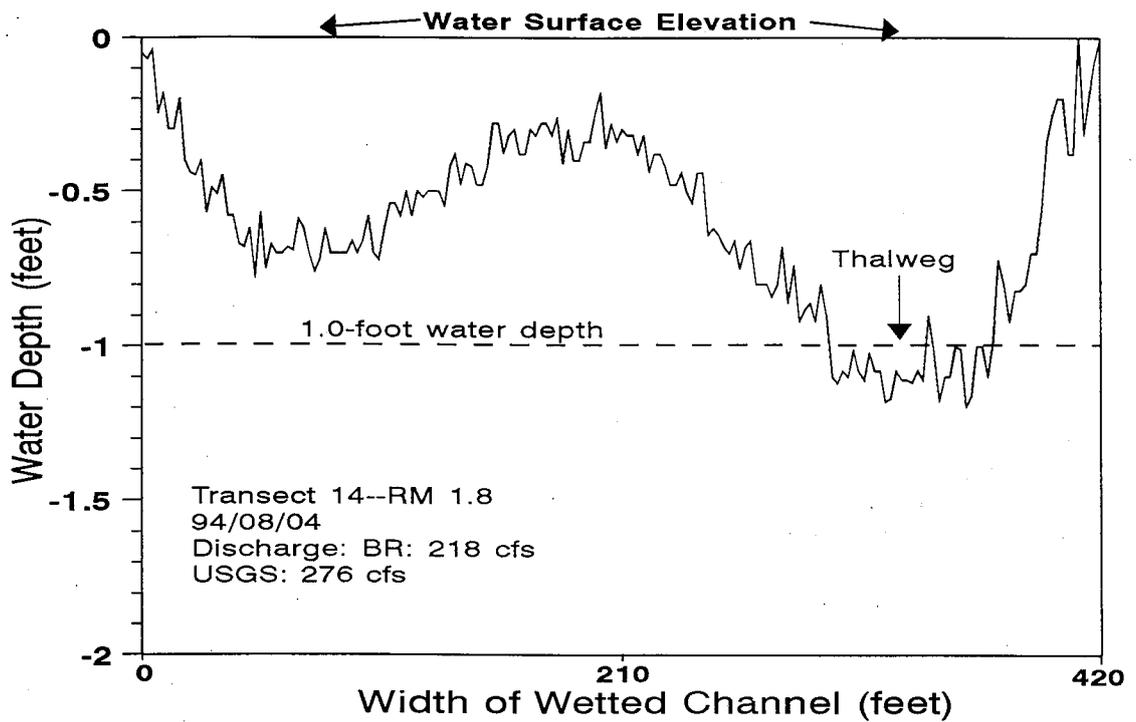
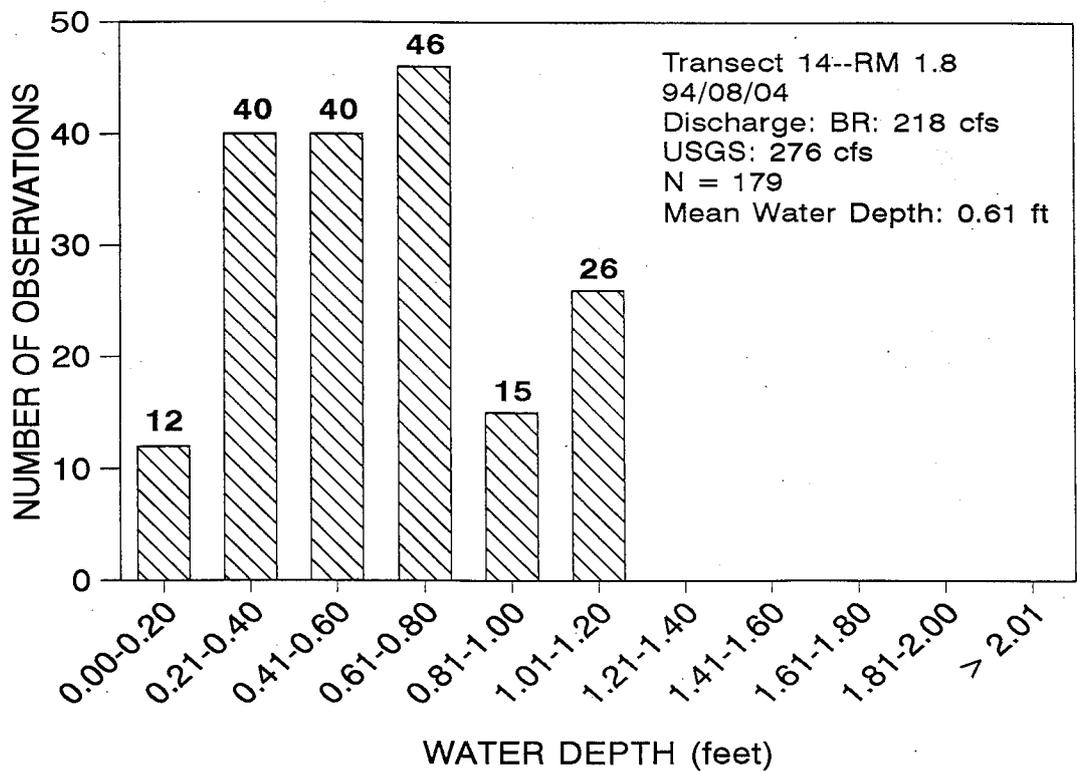
Figure G.9. River profile (top) and the distribution of water depths (feet) observed by 0.2-foot increments (bottom) for transect 14, river mile 1.8, Gunnison River, Colorado, 4 August 1994.

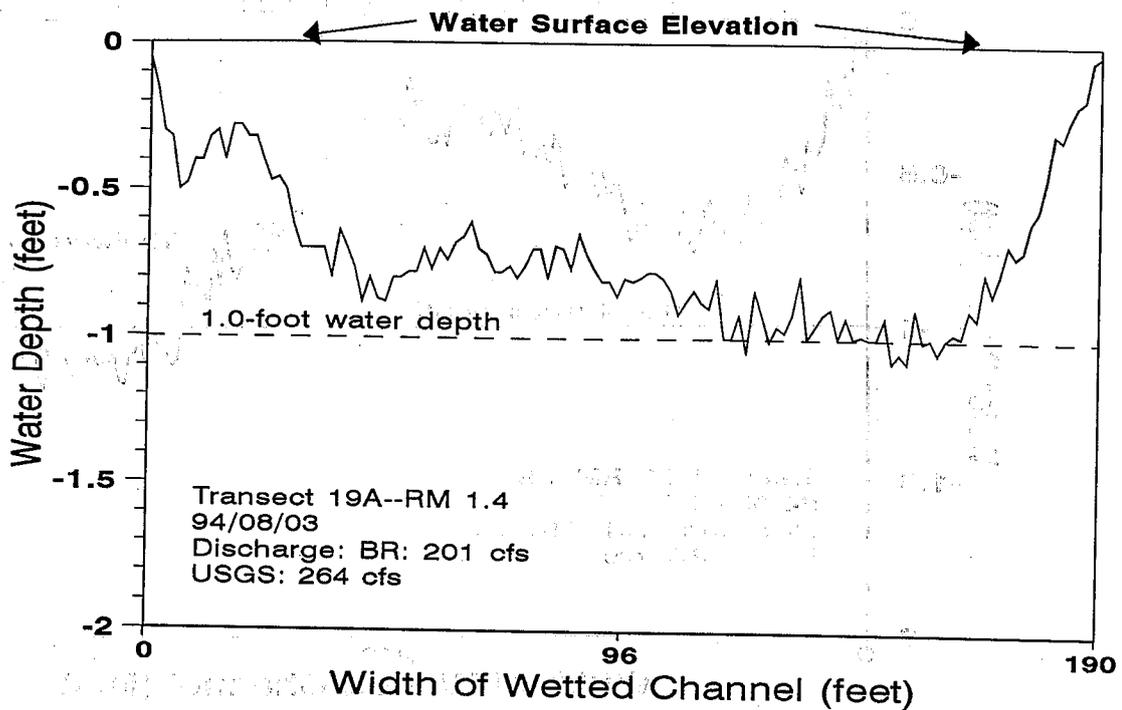
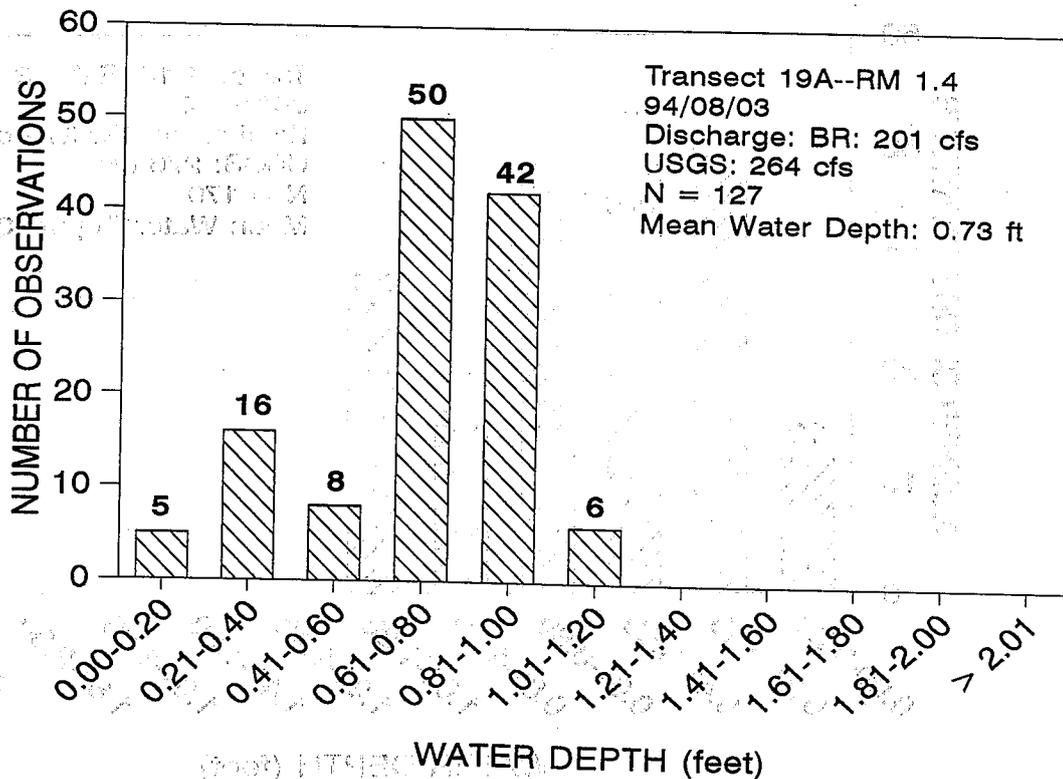
Figure G.10. River profile (top) and the distribution of water depths (feet) observed by 0.2-foot increments (bottom) for transect 19A, river mile 1.4, Gunnison River, Colorado, 3 August 1994.

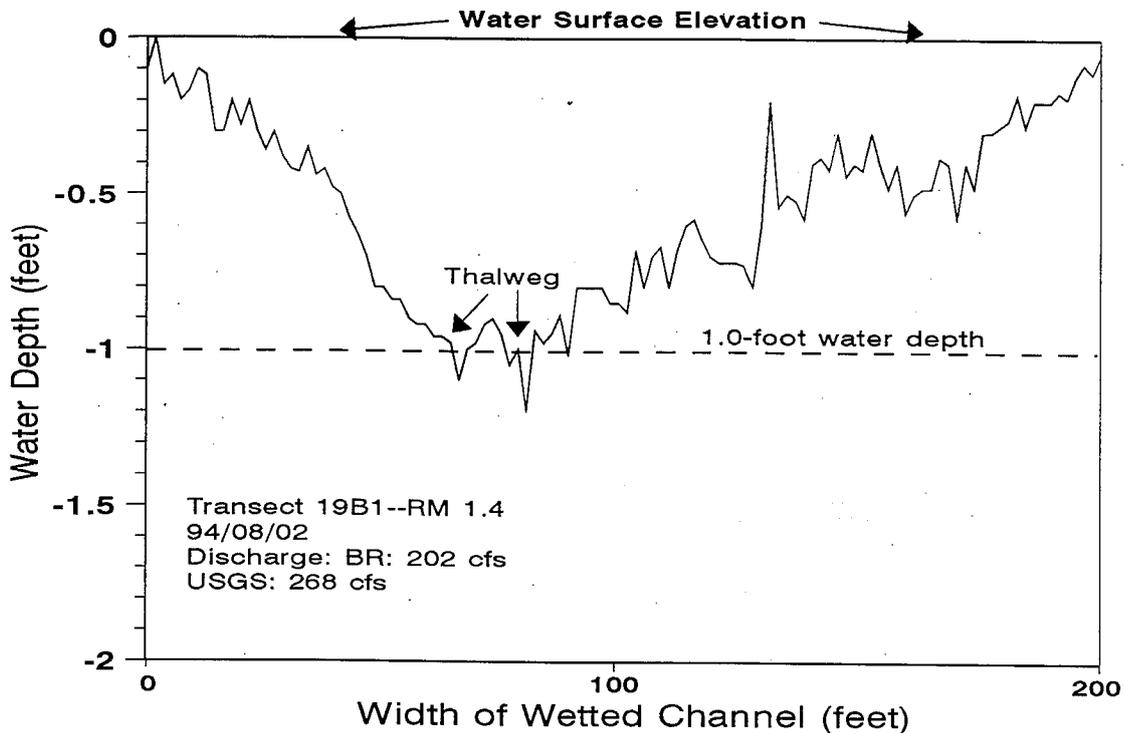
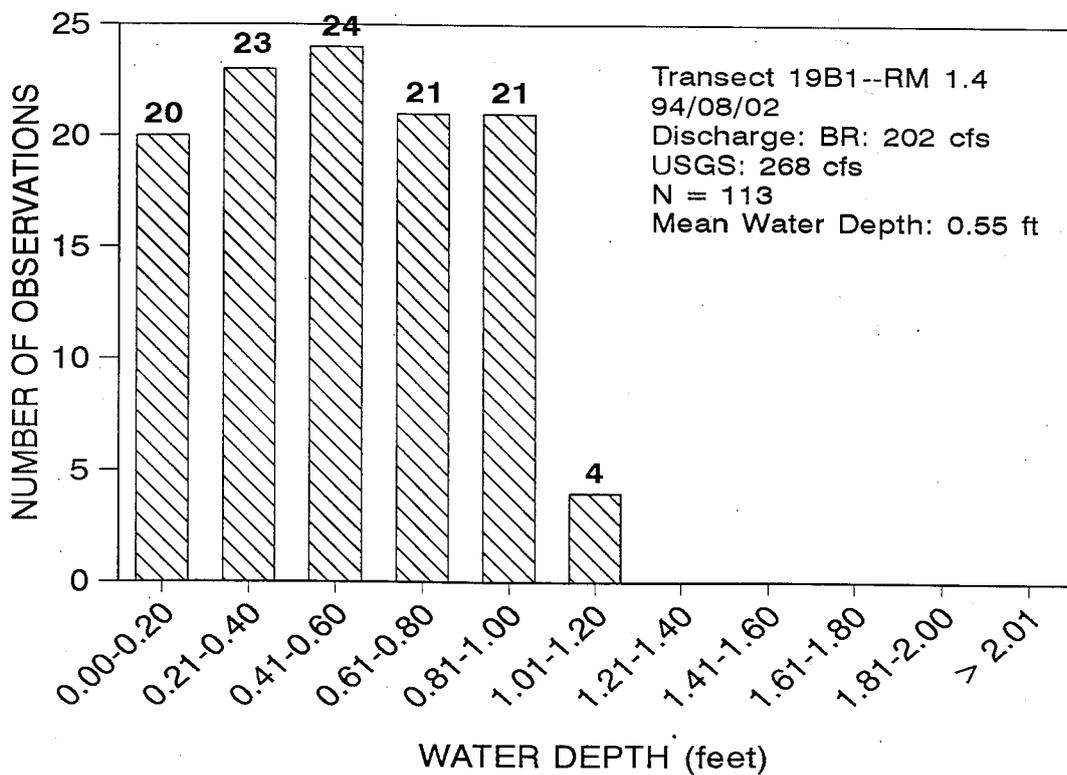
Figure G.11. River profile (top) and the distribution of water depths (feet) observed by 0.2-foot increments (bottom) for transect 19B1, river mile 1.4, Gunnison River, Colorado, 2 August 1994.

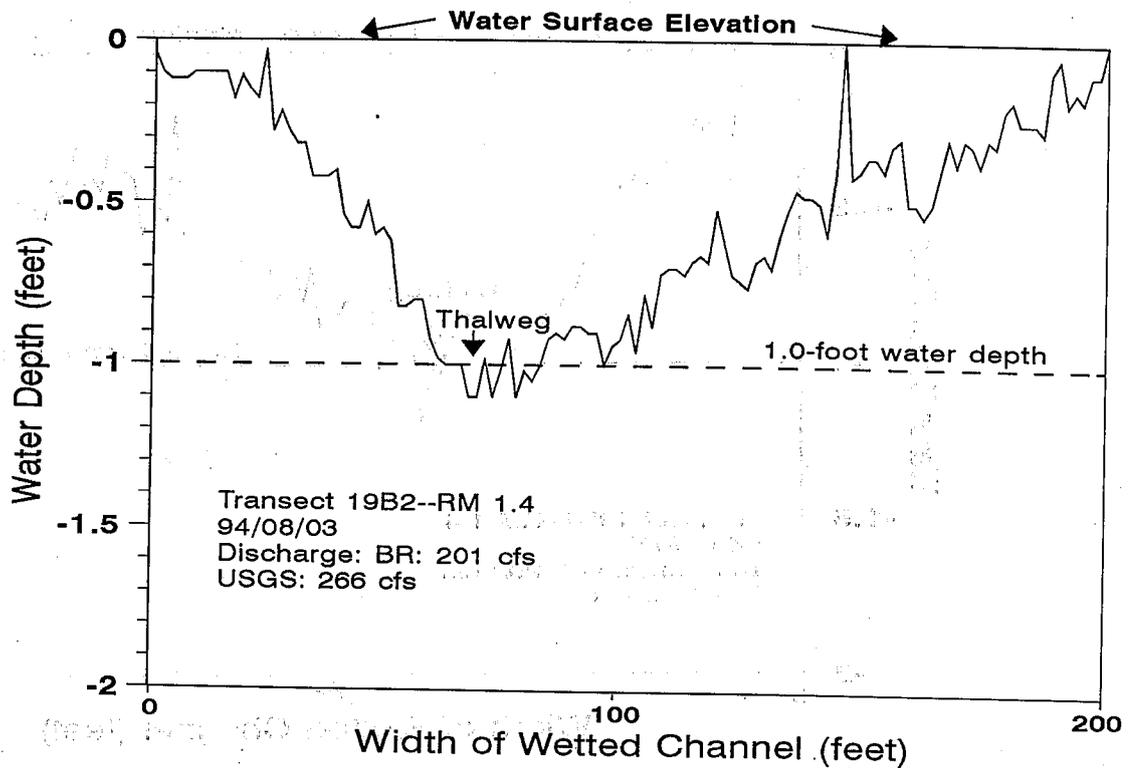
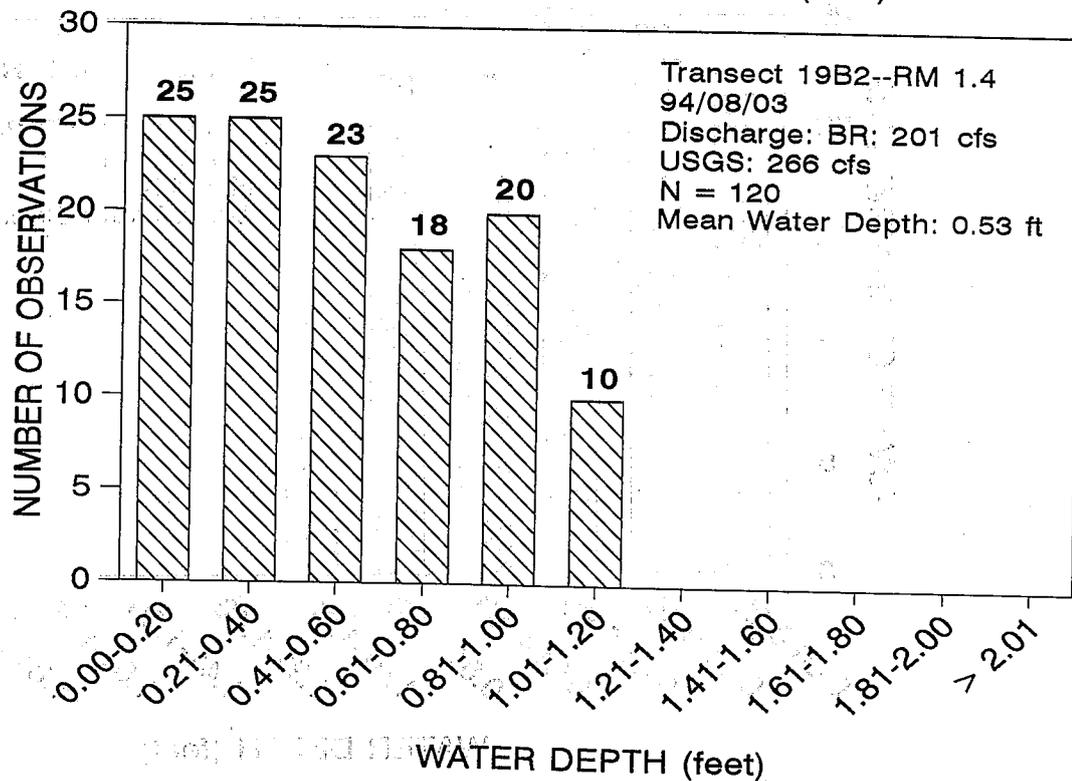
Figure G.12. River profile (top) and the distribution of water depths (feet) observed by 0.2-foot increments (bottom) for transect 19B2, river mile 1.4, Gunnison River, Colorado, 3 August 1994.

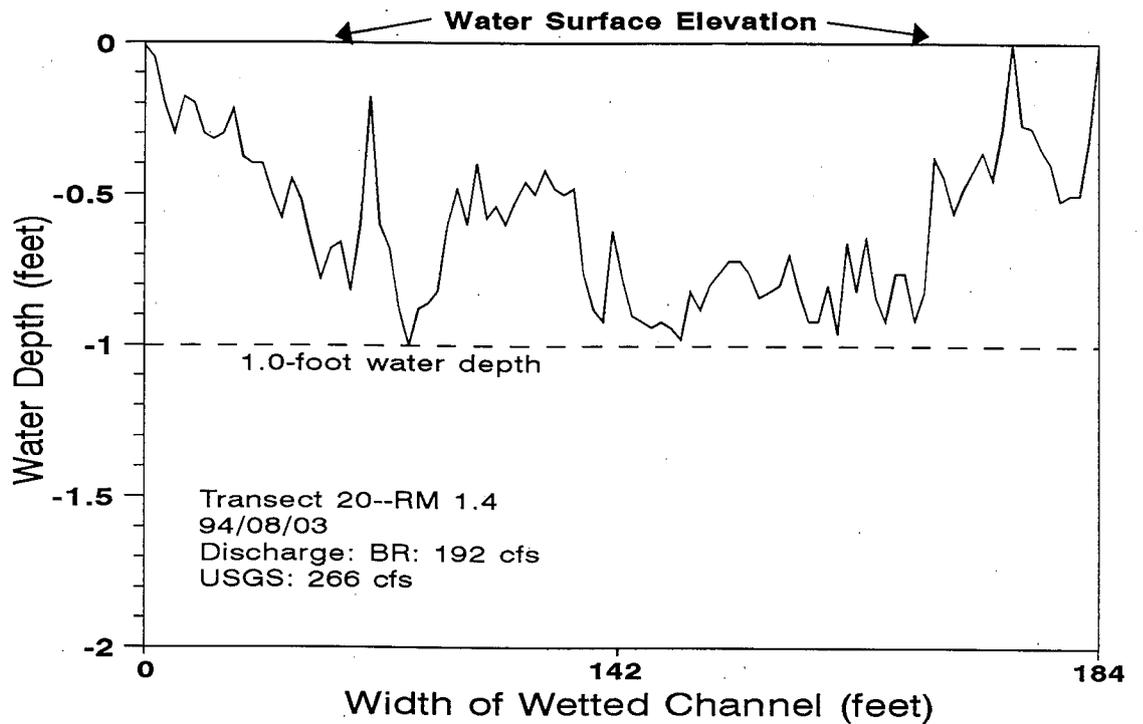
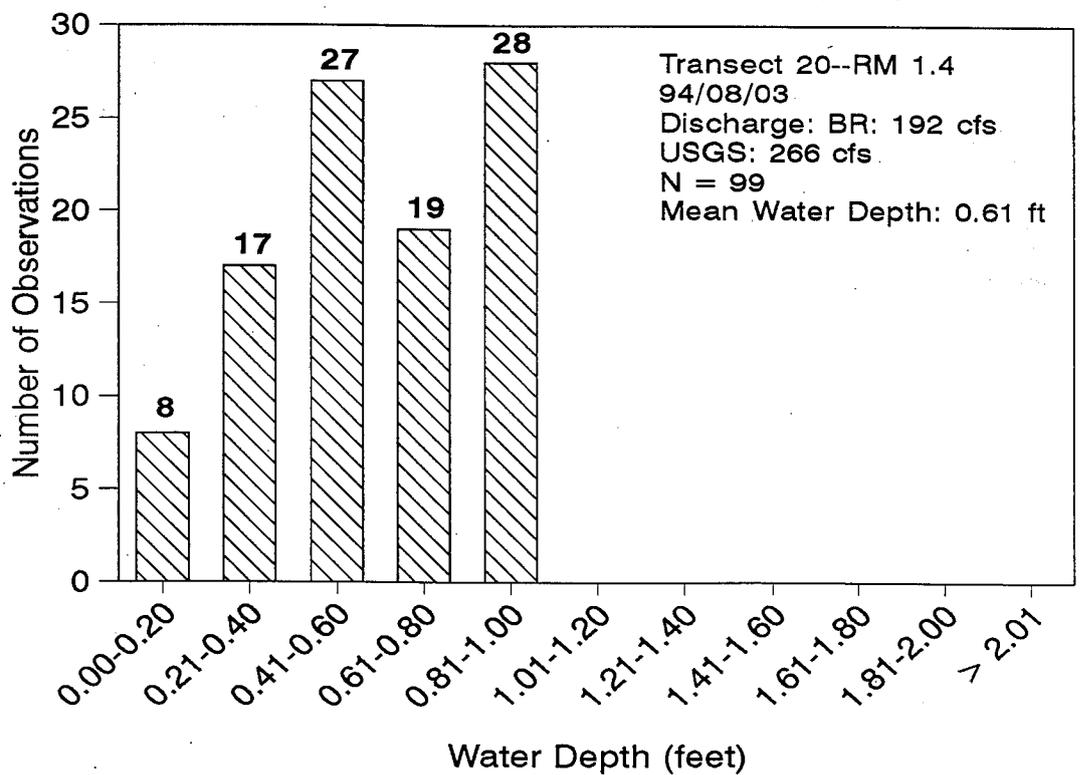
Figure G.13. River profile (top) and the distribution of water depths (feet) observed by 0.2-foot increments (bottom) for transect 20, river mile 1.4, Gunnison River, Colorado, 3 August 1994.

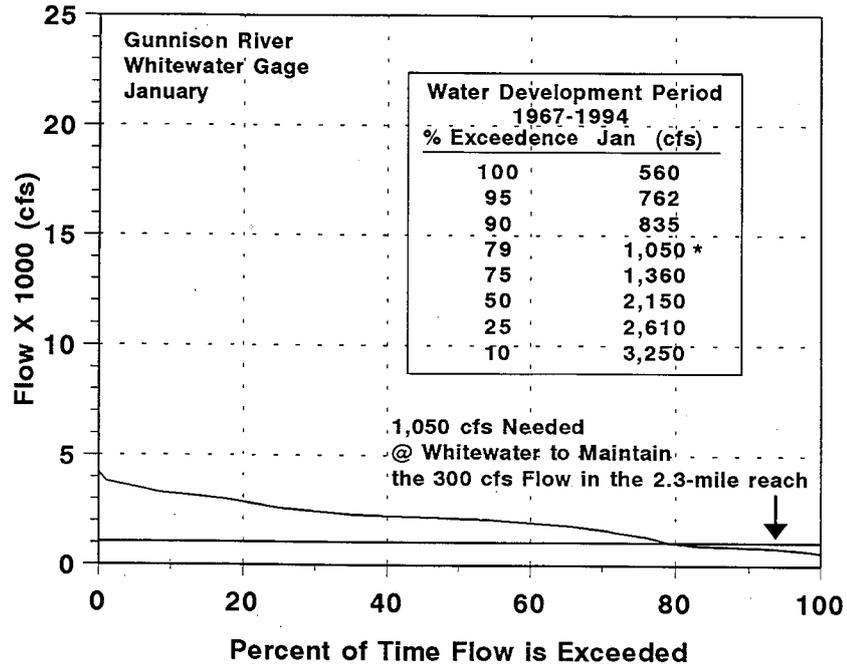
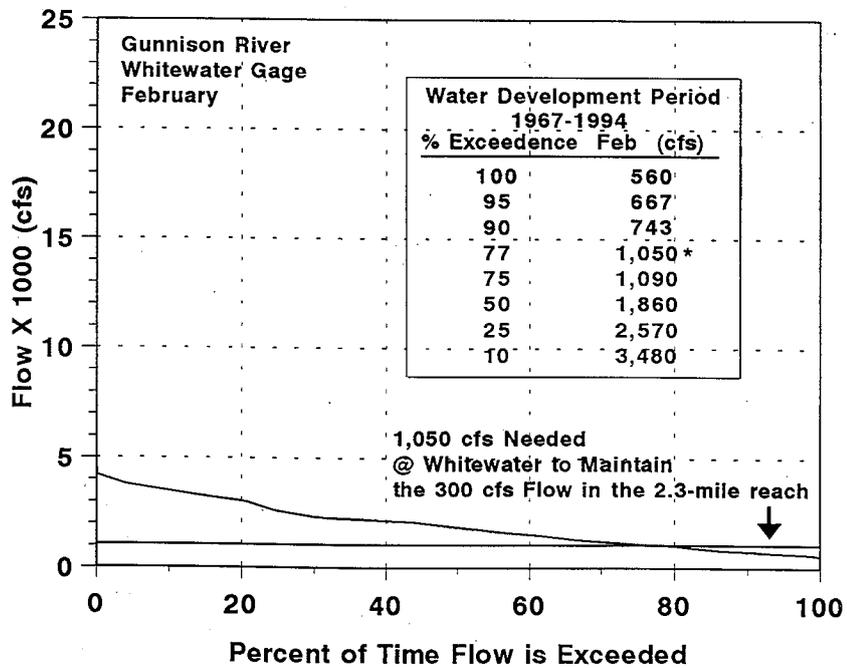
Figure H.1. Mean daily flow exceedences for January (top) and February (bottom) for the Gunnison River at the Whitewater USGS stream gage during the post-water development period, 1967-1994. The horizontal line at 1,050 represents the minimum amount of water (cfs) needed at the USGS stream gage at Whitewater to provide a minimum of 300 cfs in the 2.3-mile reach of the lower Gunnison River immediately downstream of Redlands Diversion Dam. This assumes that Redlands Canal withdraws at least 750 cfs from the river, thus $750+300=1,050$.

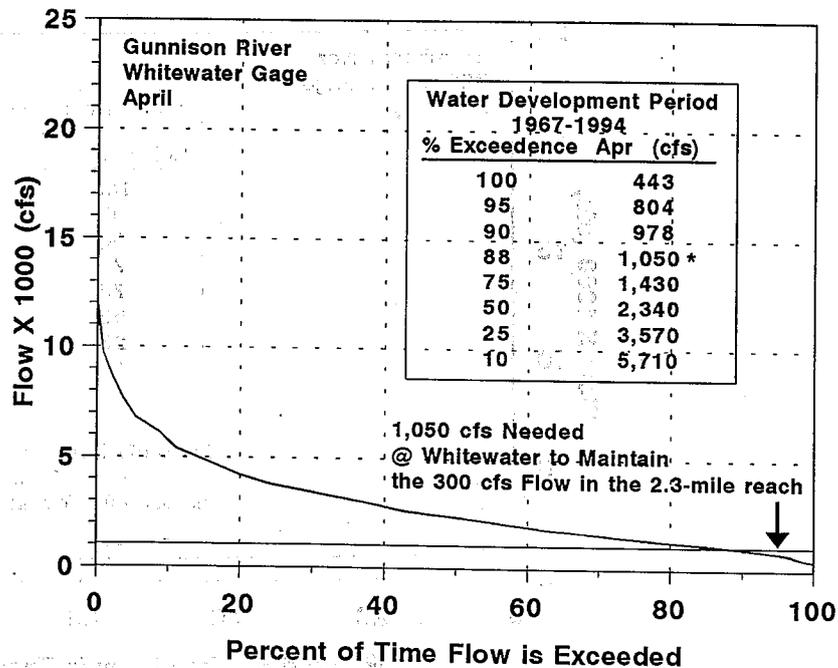
Figure H.2. Mean daily flow exceedences for March (top) and April (bottom) for the Gunnison River at the Whitewater USGS stream gage during the post-water development period, 1967-1994. The horizontal line at 1,050 represents the minimum amount of water (cfs) needed at the USGS stream gage at Whitewater to provide a minimum of 300 cfs in the 2.3-mile reach of the lower Gunnison River immediately downstream of Redlands Diversion Dam. This assumes that Redlands Canal withdraws at least 750 cfs from the river, thus $750+300=1,050$.

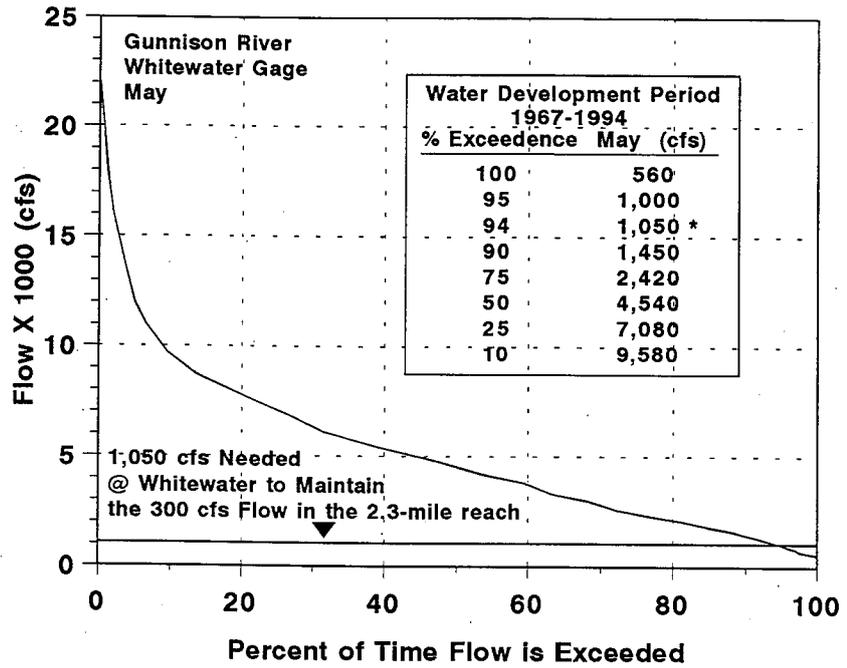
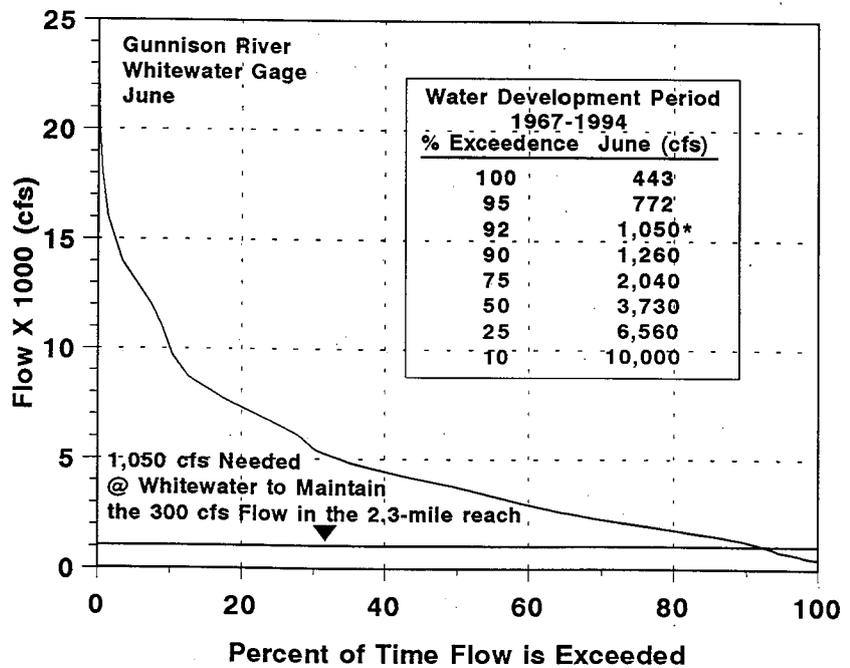
Figure H.3. Mean daily flow exceedences for May (top) and June (bottom) for the Gunnison River at the Whitewater USGS stream gage during the post-water development period, 1967-1994. The horizontal line at 1,050 represents the minimum amount of water (cfs) needed at the USGS stream gage at Whitewater to provide a minimum of 300 cfs in the 2.3-mile reach of the lower Gunnison River immediately downstream of Redlands Diversion Dam. This assumes that Redlands Canal withdraws at least 750 cfs from the river, thus $750+300=1,050$.

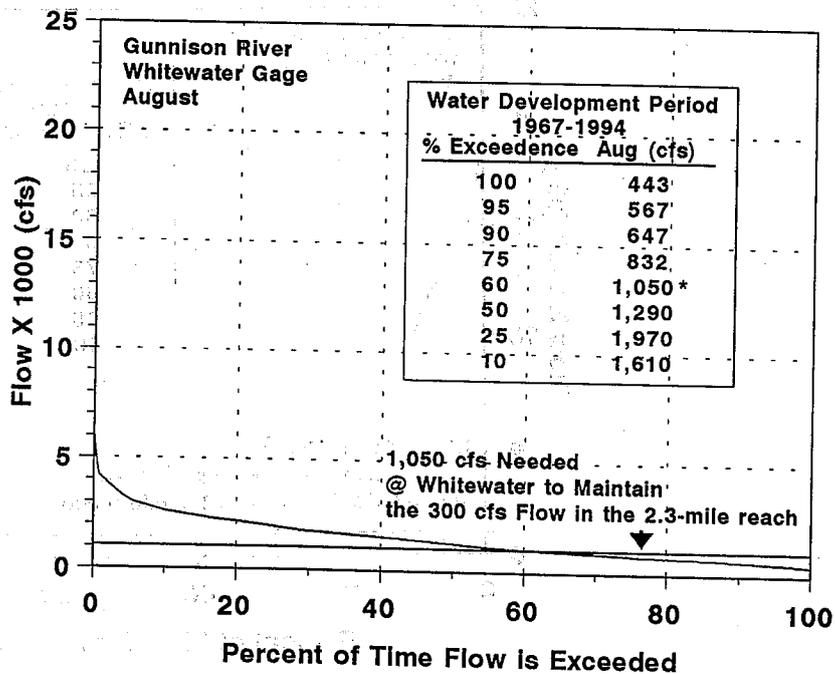
Figure H.4. Mean daily flow exceedences for July (top) and August (bottom) for the Gunnison River at the Whitewater USGS stream gage during the post-water development period, 1967-1994. The horizontal line at 1,050 represents the minimum amount of water (cfs) needed at the USGS stream gage at Whitewater to provide a minimum of 300 cfs in the 2.3-mile reach of the lower Gunnison River immediately downstream of Redlands Diversion Dam. This assumes that Redlands Canal withdraws at least 750 cfs from the river, thus $750+300=1,050$.
