**MINIMUM FLOW RECOMMENDATION FOR PASSAGE OF
COLORADO SQUAWFISH AND RAZORBACK SUCKER
IN THE 2.3-MILE REACH OF THE LOWER GUNNISON RIVER:
REDLANDS DIVERSION DAM TO THE
COLORADO RIVER CONFLUENCE**

Recovery Program Project Number 57

Final Report

**Bob D. Burdick
Fishery Biologist**

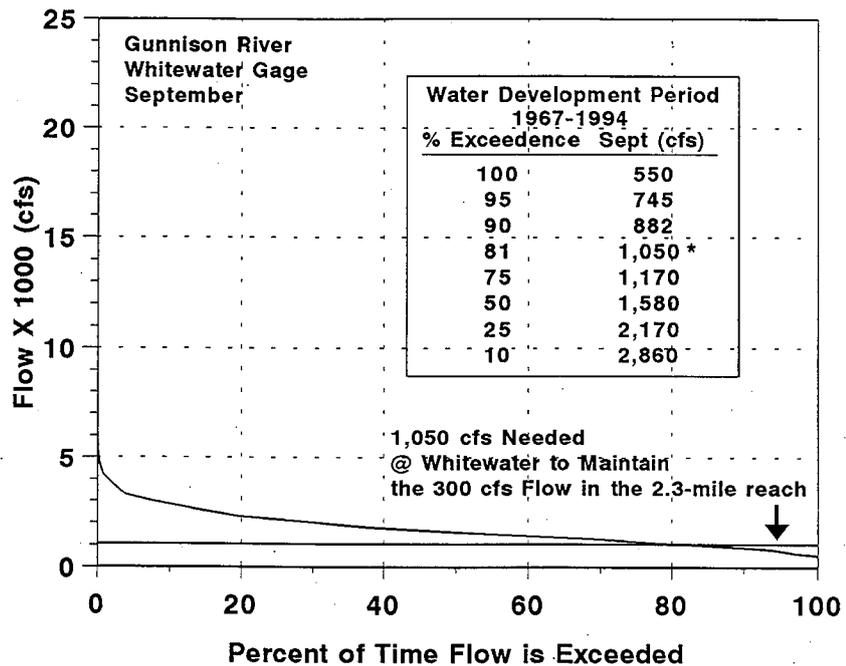
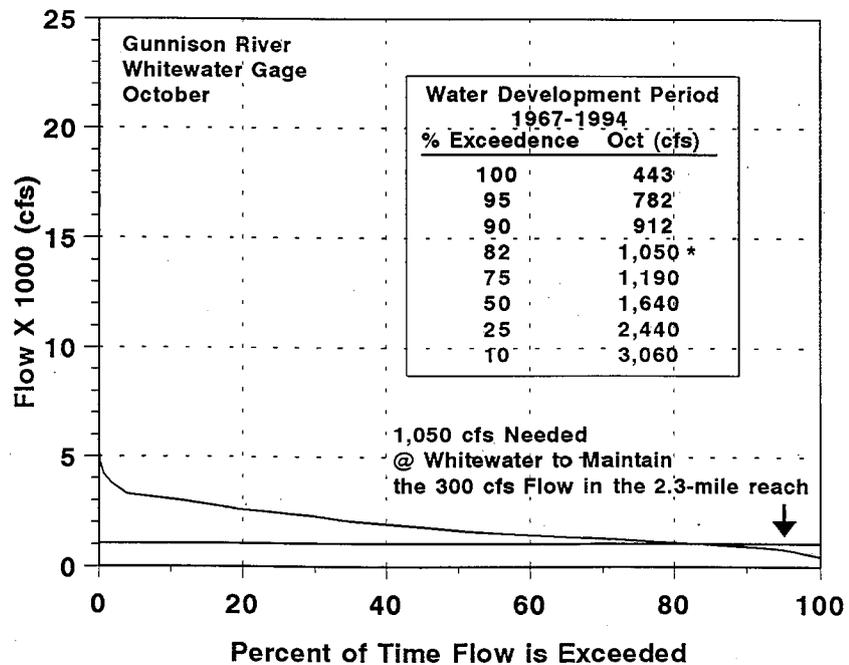
Figure H.5. Mean daily flow exceedences for September (top) and October (bottom) for the Gunnison River at the Whitewater USGS stream gage during the post-water development period, 1967-1994. The horizontal line at 1,050 represents the minimum amount of water (cfs) needed at the USGS stream gage at Whitewater to provide a minimum of 300 cfs in the 2.3-mile reach of the lower Gunnison River immediately downstream of Redlands Diversion Dam. This assumes that Redlands Canal withdraws at least 750 cfs from the river, thus $750+300=1,050$.

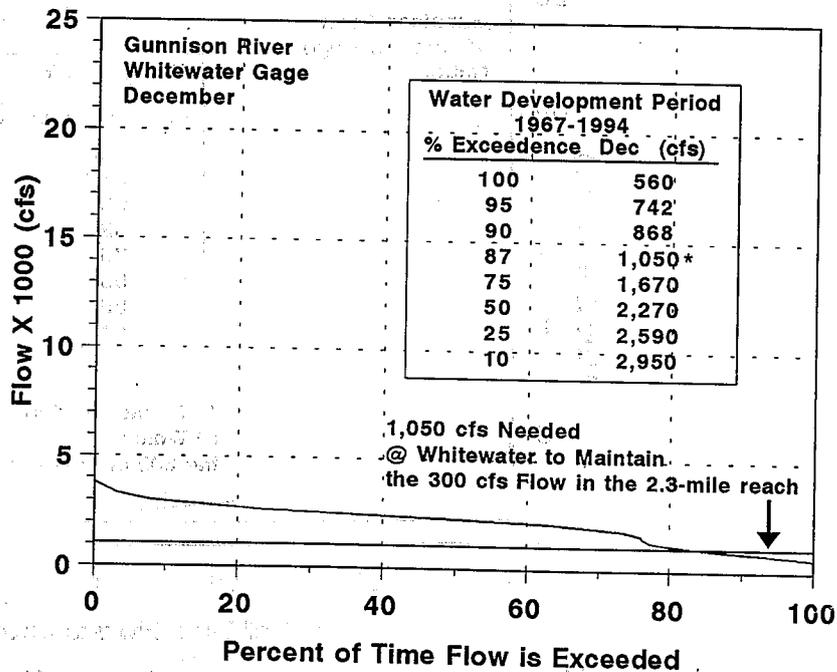
Figure H.6. Mean daily flow exceedences for November (top) and December (bottom) for the Gunnison River at the Whitewater USGS stream gage during the post-water development period, 1967-1994. The horizontal line at 1,050 represents the minimum amount of water (cfs) needed at the USGS stream gage at Whitewater to provide a minimum of 300 cfs in the 2.3-mile reach of the lower Gunnison River immediately downstream of Redlands Diversion Dam. This assumes that Redlands Canal withdraws at least 750 cfs from the river, thus $750+300=1,050$.

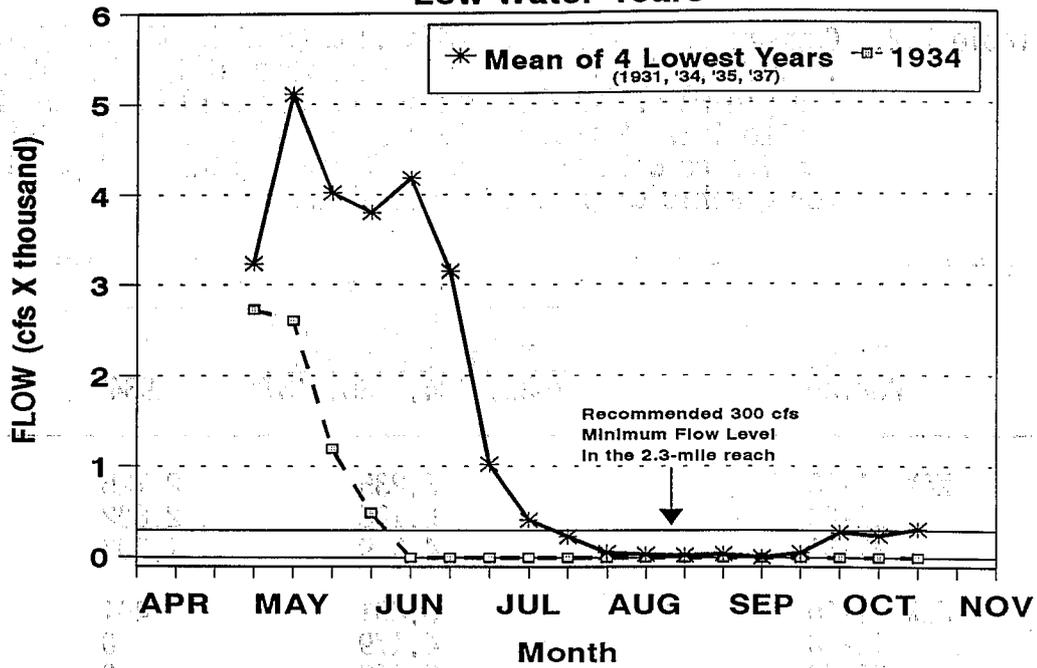
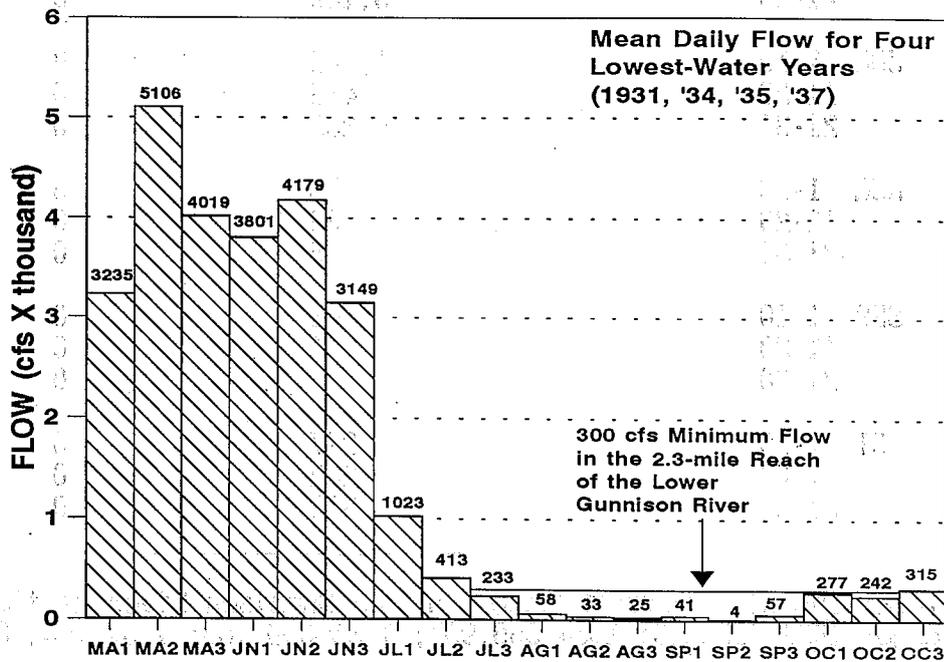
Figure I.1. Mean daily flow (cfs) and shape of the hydrograph for four lowest-water years (1931, 1934, 1935, and 1937) compared to 1934, a low, low-water year from 1 May to 31 October in the 2.3-mile reach of the lower Gunnison River between the Redlands Diversion Dam and the confluence with the Colorado River. The bottom figure represents the mean daily flow for 1 May through 31 October for the 2.3-mile reach by 10- and 11-day step increments, e.g., May 1-10, May 11-20, May 21-31, etc.
