**COLORADO RIVER RECOVERY PROGRAM
FY 2009 ANNUAL PROJECT REPORT**

**RECOVERY PROGRAM
PROJECT NUMBER: RZ-RECR**

I. Project Title: Razorback emigration from the Stirrup floodplain (RM 275.7)

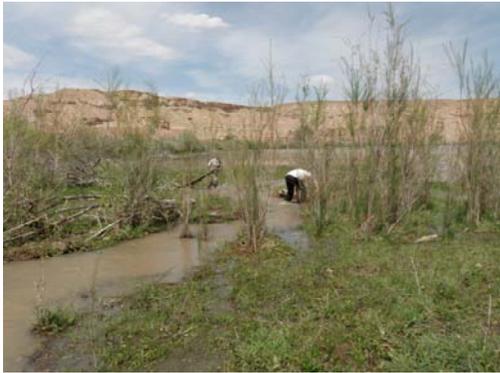
Figure 1. Channel between breach and Stirrup floodplain on 14 May, 2009.

We did not pump water into the Stirrup prior to the 2009 spring flows. The river connected to the floodplain on May 14 at an estimated flow (considering a 24 hour travel time from the USGS gage near Jensen, Utah) of 14,000 cfs (Figures 1-3). Unfortunately, it took eight days of river connection to fill the floodplain to a point that sufficient depth (determined to be >20cm) occurred throughout the breach to allow native fish movement.

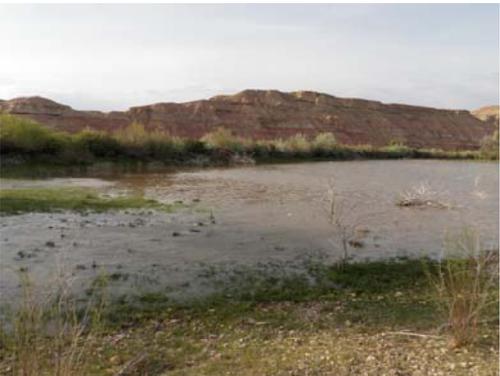
Figure 2. Channel between breach and Stirrup floodplain 16 May, 2009. Breach is immediately to right.

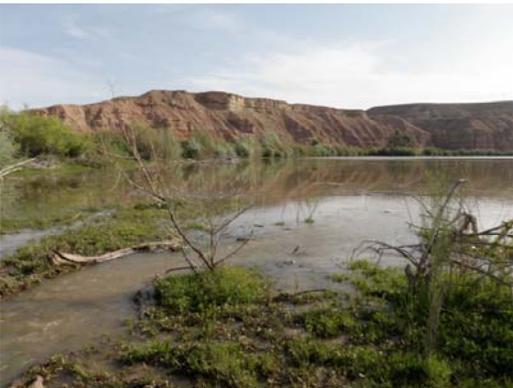
Figure 3. Channel between breach and Stirrup floodplain 19 May, 2009.
